NATIONAL TRANSPORTATION SAFETY BOARD

RAILROAD ACCIDENT REPORT

DERAILMENT OF AMTRAK TRAIN ON
LOUISVILLE AND NASHVILLE RAILROAD

REPORT NUMBER: NTSB-RAR-77-9

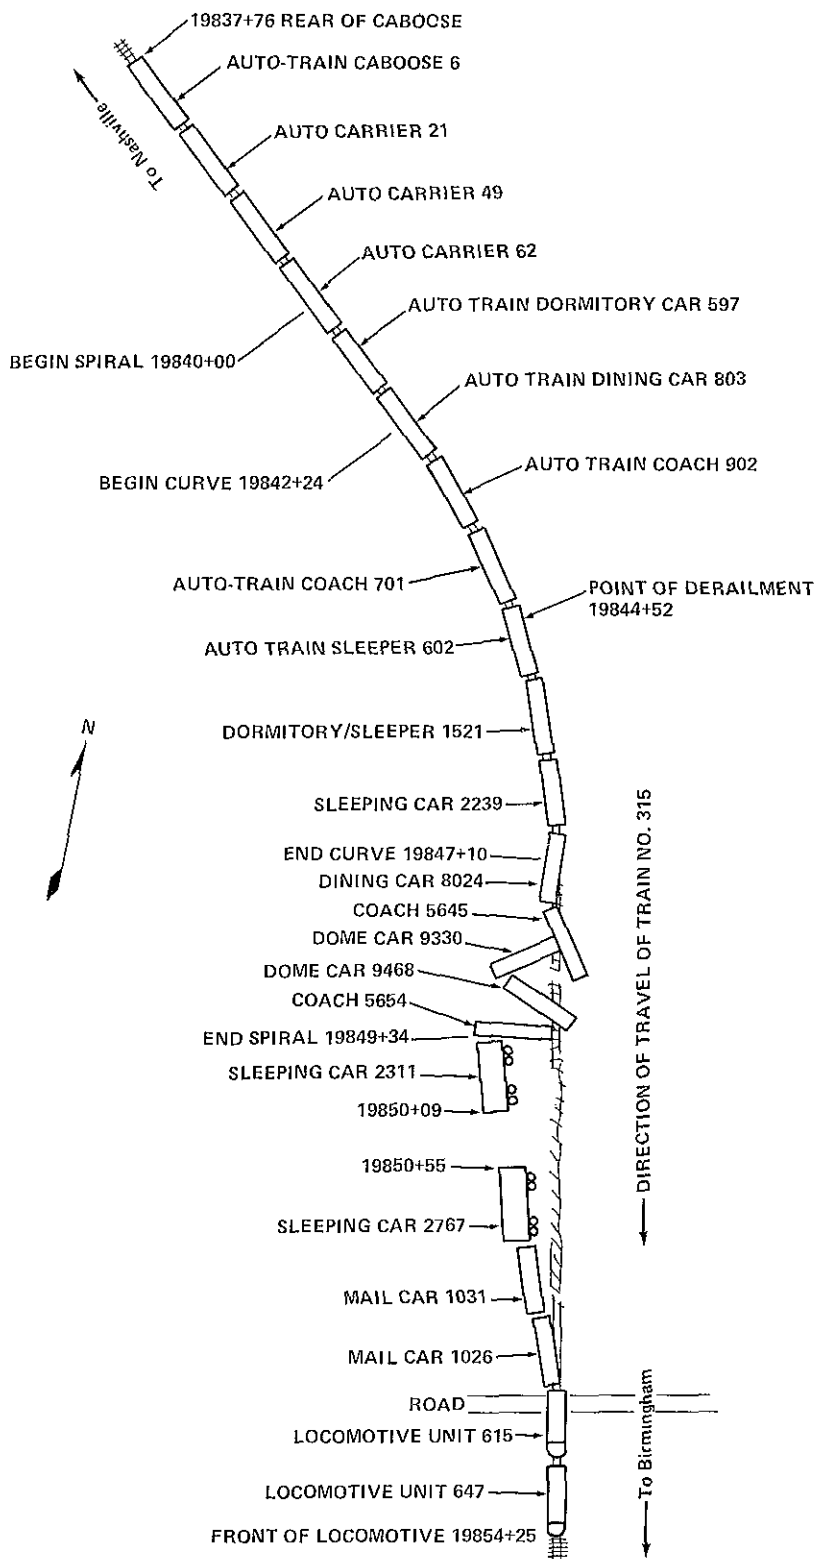
Figure 1. Plan of accident site.

No. 315 derailed as it moved around a 5° curve on an ascending grade of 0.4 percent at New Castle. The curve began 452 feet north of the derailment point and extended southward for 710 feet. The track was laid on a side-hill cut to the point of derailment and then southward on a fill which was 21 feet high at its midpoint. (See figure 1.)

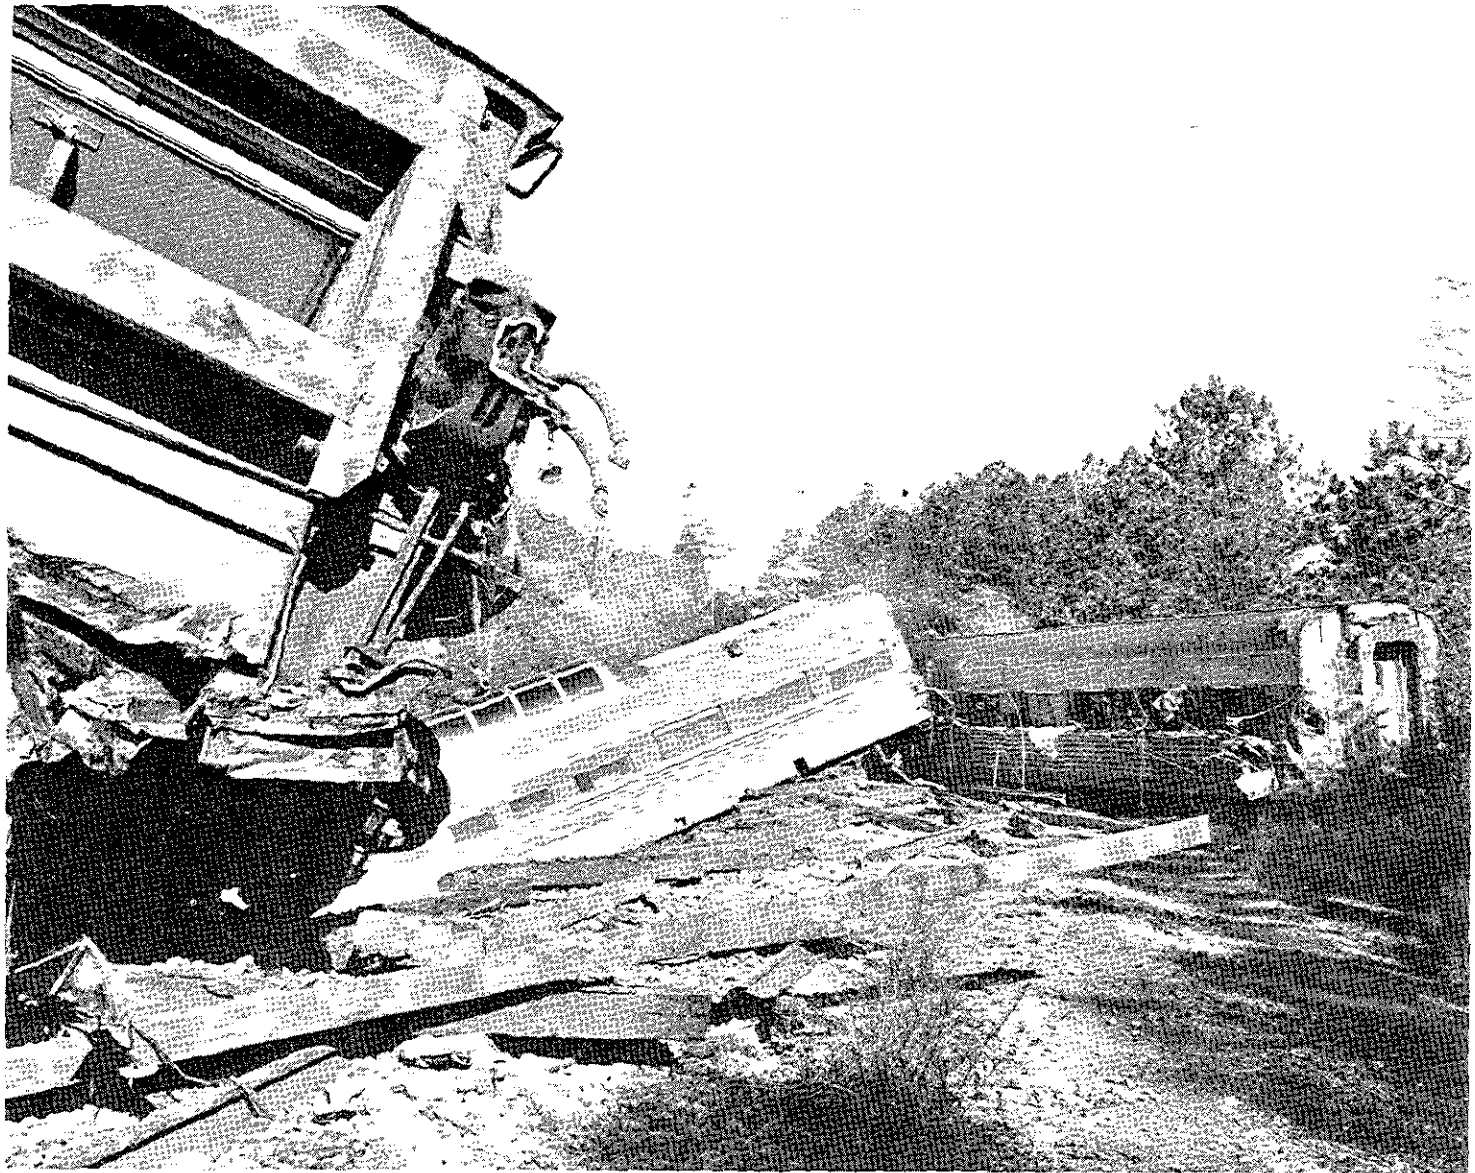
During the derailment, several cars separated and failed to remain in line because the shanks of their tightlock couplers fractured. The most serious of these separations resulted in the north end of the seventh car, a dome car, striking and destroying the windows and window posts on the west side of the eighth car, a coach. (See figure 2.)

Figure 2. Damaged seventh and eighth cars (background) of train No. 315.

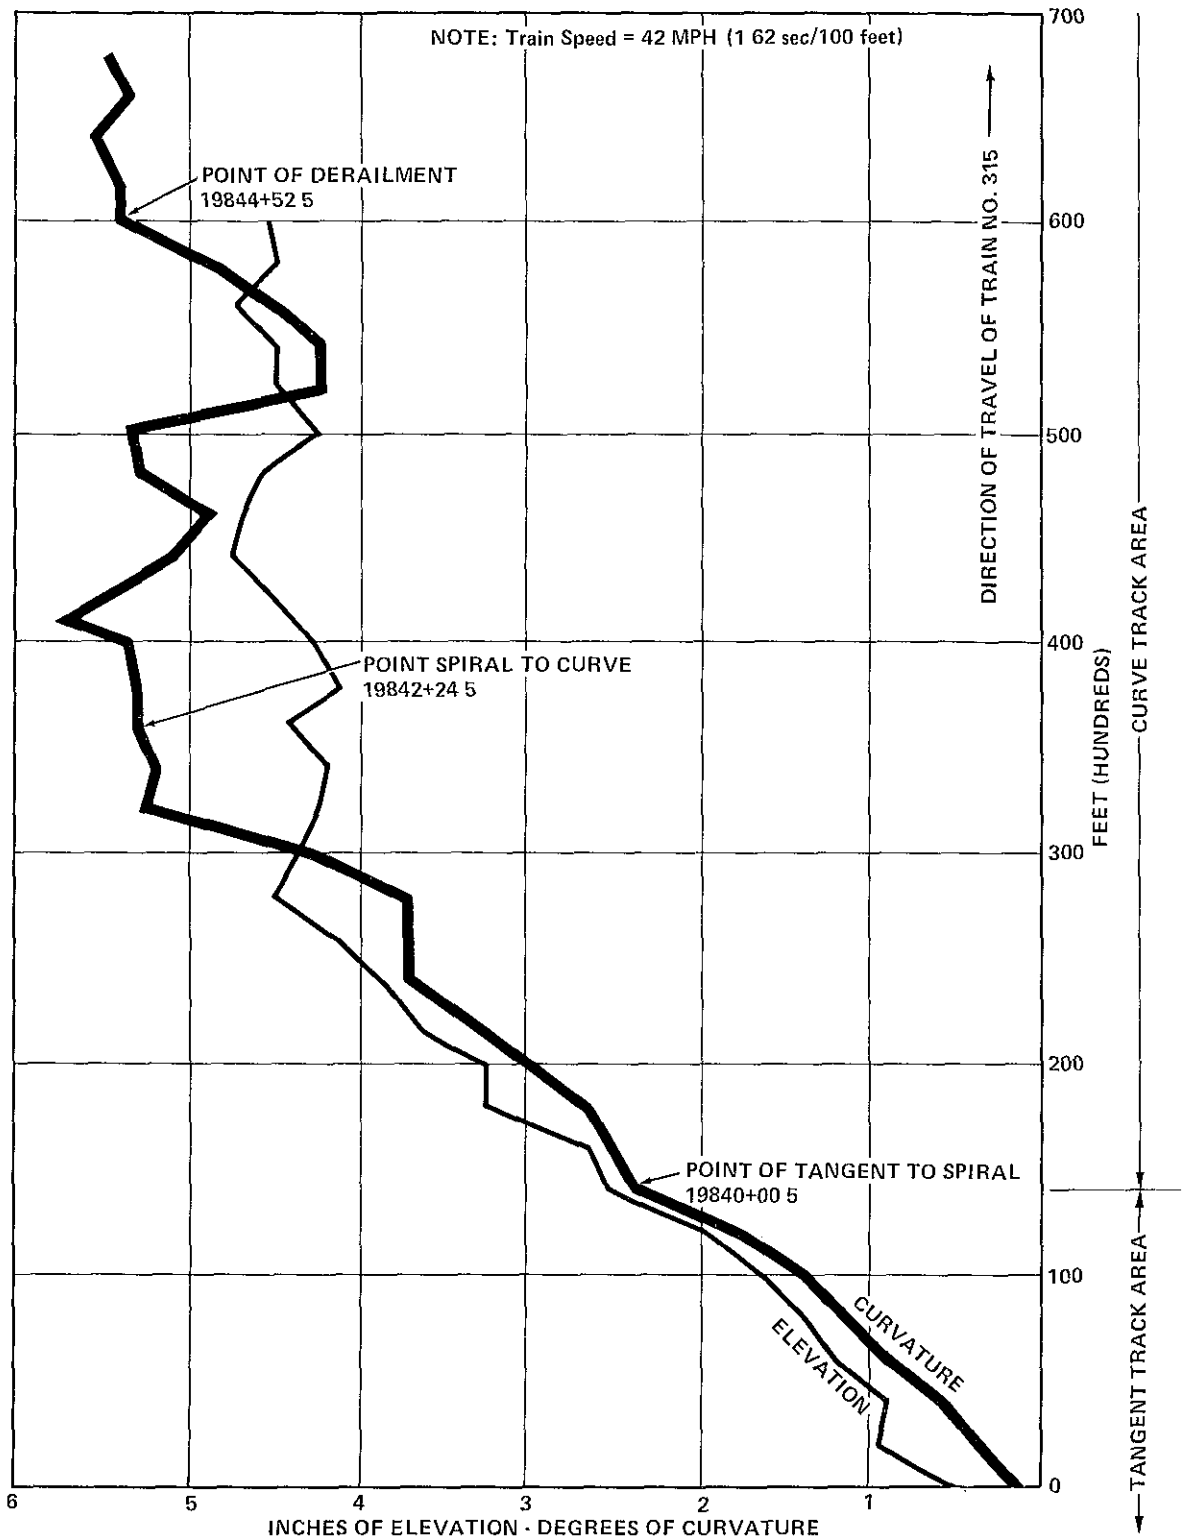
Inspection of the track north of the derailment area revealed irregularities in curvature, gage, and superelevation as follows:

1. Gage varied from standard 56 1/2 inches to 57 7/16 inches.
2. Curvature, when measured by using the midordinate measurement of a 62-foot chord, varied from a minimum of 4°15' to a maximum of 5°56'.
3. Superelevation varied from the designed 4 inches to between 4 and 5 inches.

All of the above deviations were within the requirements for Class 3 track. (See figure 3.) These measurements were taken with the track structure unloaded.

A postaccident examination of the track indicated variations in line, gage, and elevation in the undisturbed track for 600 feet north of the point of derailment. Although the curve deviated from the planned 5° with 4 inches superelevation, these variations did not exceed those allowed by the Federal Track Safety Standards for Class 3 track. From 220 feet north to the point of derailment, track curvature varied from an approximate maximum of 5°45'; to a minimum of 4°15'; the greatest rate of change was within the last 100 feet before the point of derailment. Within this same area, superelevation varied from 4 1/4 inches to 4 3/4 inches, with the greatest rate of change 60 feet in approach to the point of derailment. In examining the relationship of the track's curvature to its elevation immediately prior to the point of derailment, as shown in figure 3, it is evident that the greatest variance occurred in the 200 feet before the derailment point. Many of these changes occurred in a short distance.

Figure 3. Deviations in curvature and superelevation.

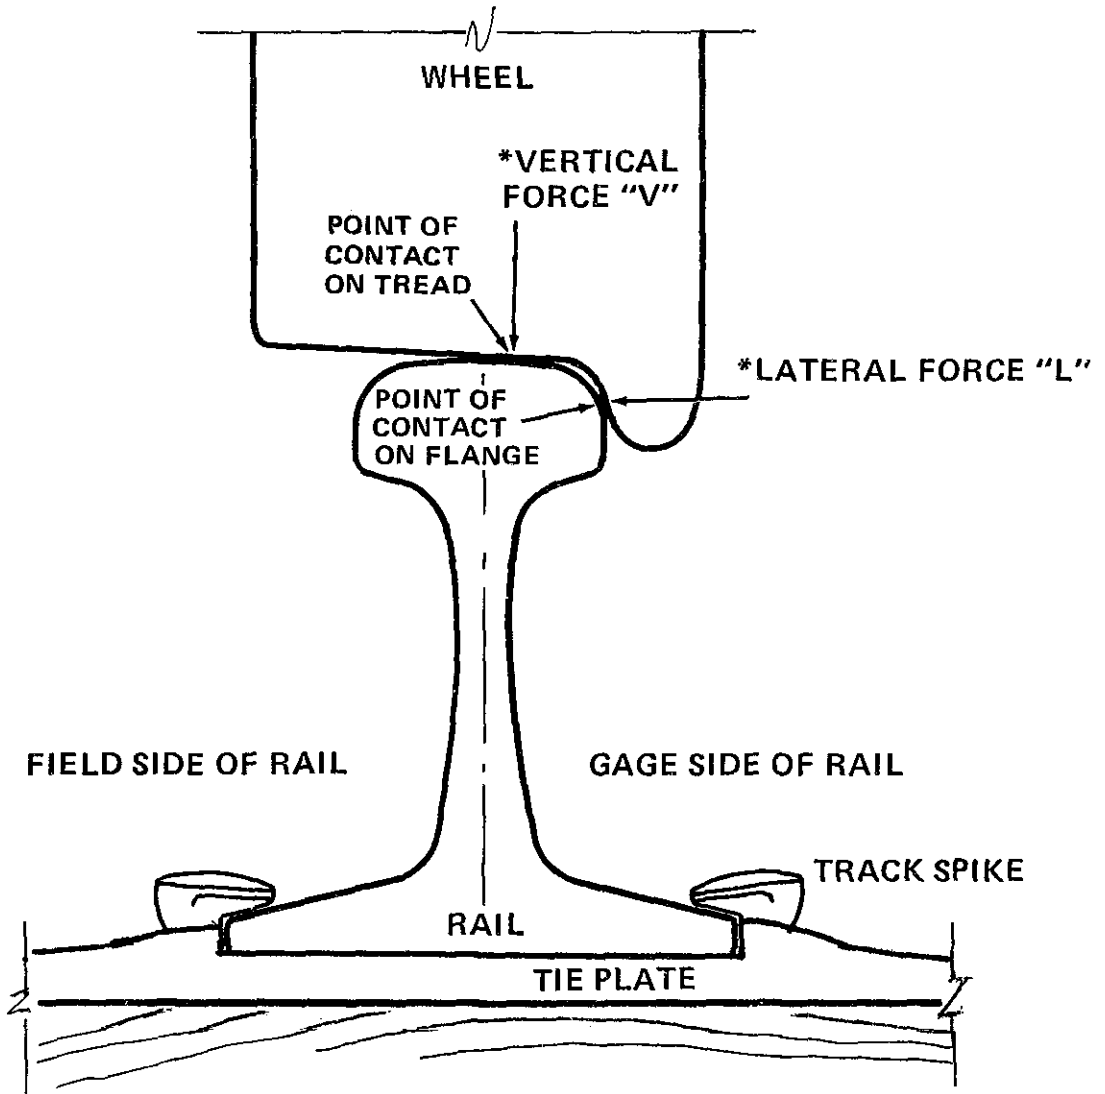
APPENDIX B

*The lateral to vertical ratio (L/V) is the lateral force pushing outward against the rail compared to the vertical force pushing downward on the top of the rail. The tendency for the rail to tip and/or move laterally, or for the wheel to climb the rail increases as the L/V ratio approaches unity.

Vertical forces due to the weight and movement of the train are transferred through the wheels of the locomotive and cars to the rail and tend to hold the rail in a vertical position on the tie plates, whereas whenever the wheel flanges come in contact with the side of the rail head as the train moves along the track they exert an overturning or tipping lateral force on the rail.
