RAILROAD ACCIDENT REPORT

DERAILMENT OF
AMTRAK TRAIN NO. 820
(THE CRESCENT)
ON SOUTHERN RAILWAY SYSTEM TRACK
ROCKFISH, VIRGINIA
APRIL 3, 1983

NTSB/RAR-83/10

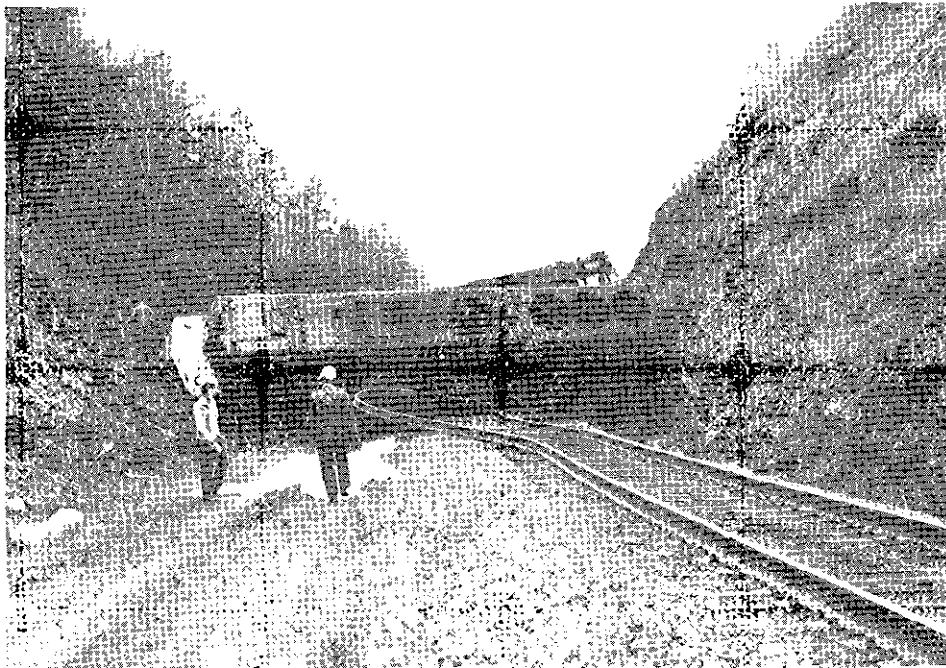
Figure 1.--Lead locomotive unit of train No. 820.

The trucks were torn from under the first locomotive unit. The unit's fuel tanks and much of the equipment under the floor were damaged extensively. The trucks also were torn from under the second locomotive unit, and the unit's fuel tanks were damaged. The baggage car, the first car behind the locomotive, was damaged moderately. The damage to the derailed passenger cars was minimal.

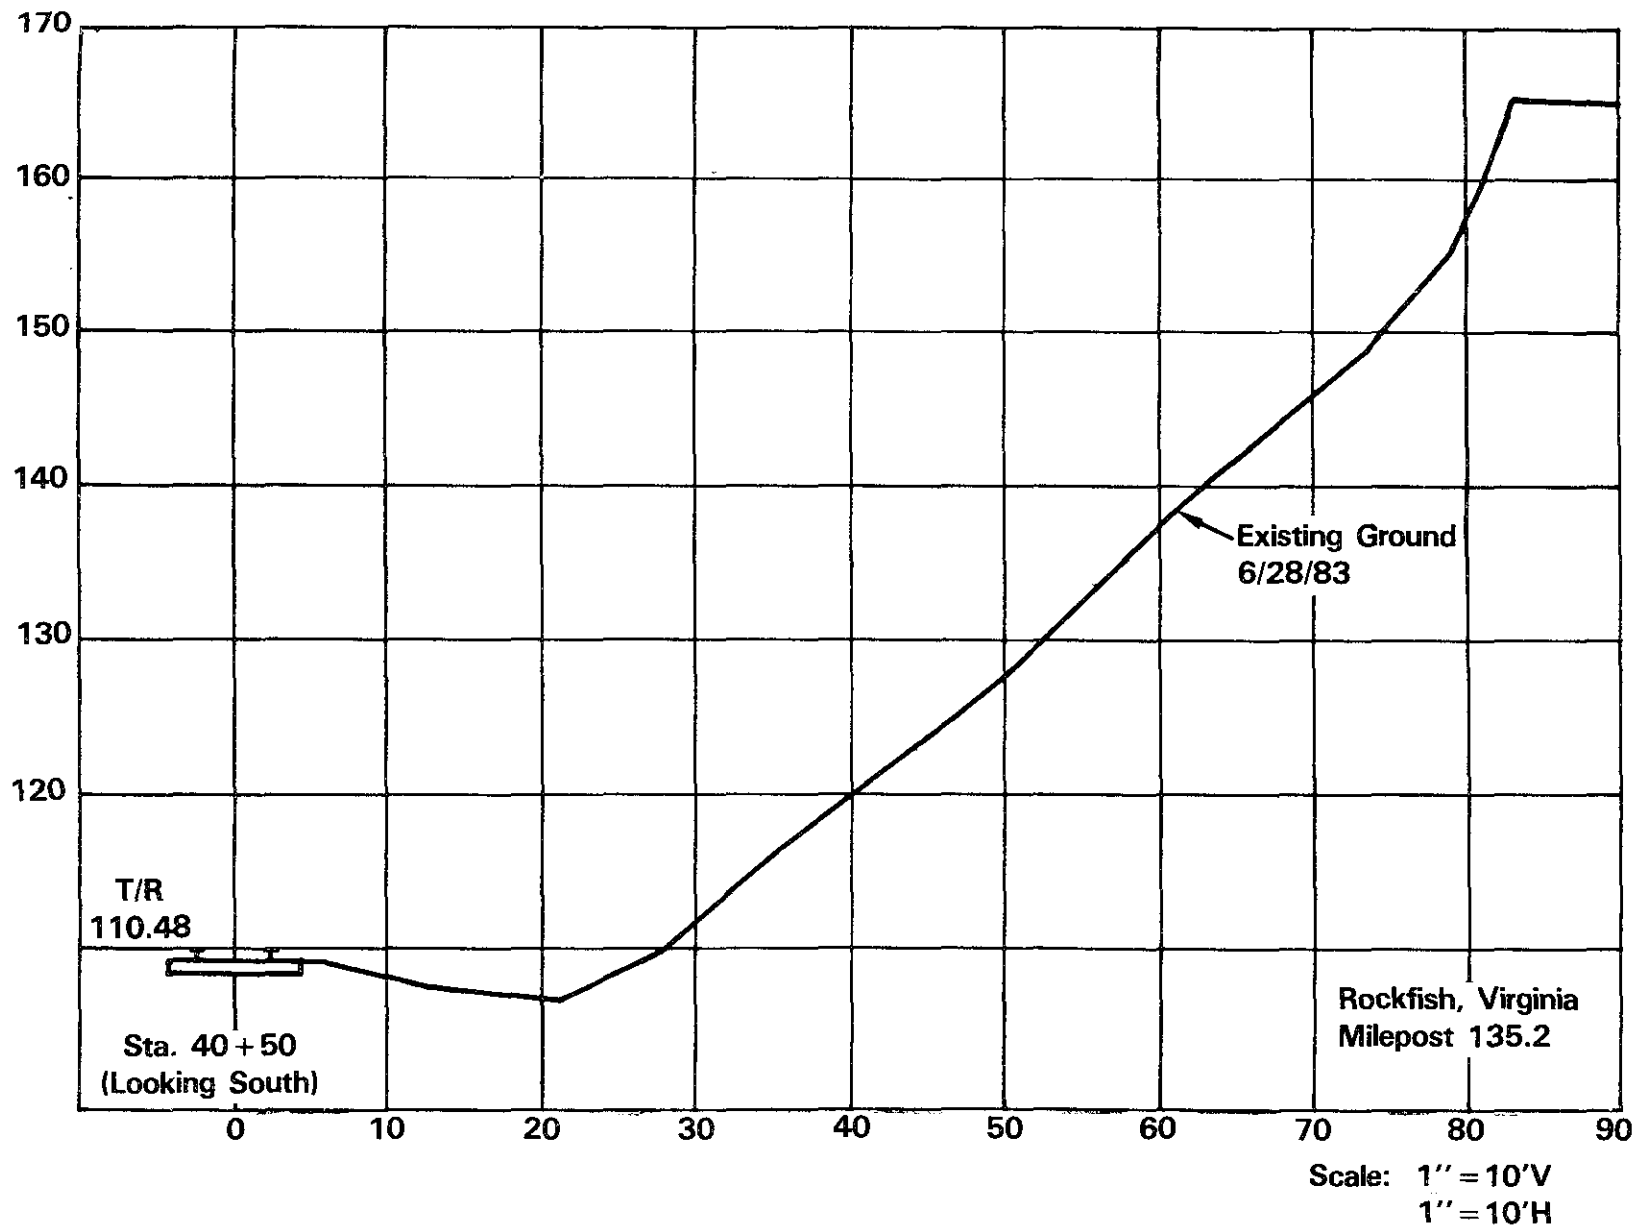
The west slope of the cut rises from zero feet near the end of the railroad bridge near MP 135 to 56 feet (measured from the top of the rail) over a distance of 200 feet. (See figure 3.) The highest point of the slope is 61 feet. In the slide area, the slope rose about 55 feet with a 1 1/2 to 1 slope at the north end of the slide area. About 10 feet of the slope was displaced in the landslide. The amount of earth movement was estimated to be about 150 to 200 tons, or 100 cubic yards. (See figure 4.) The earth covered the west rail to a depth of about 6 feet and covered the east rail to a depth of about 2 feet.

Figure 3.--Height of slope.

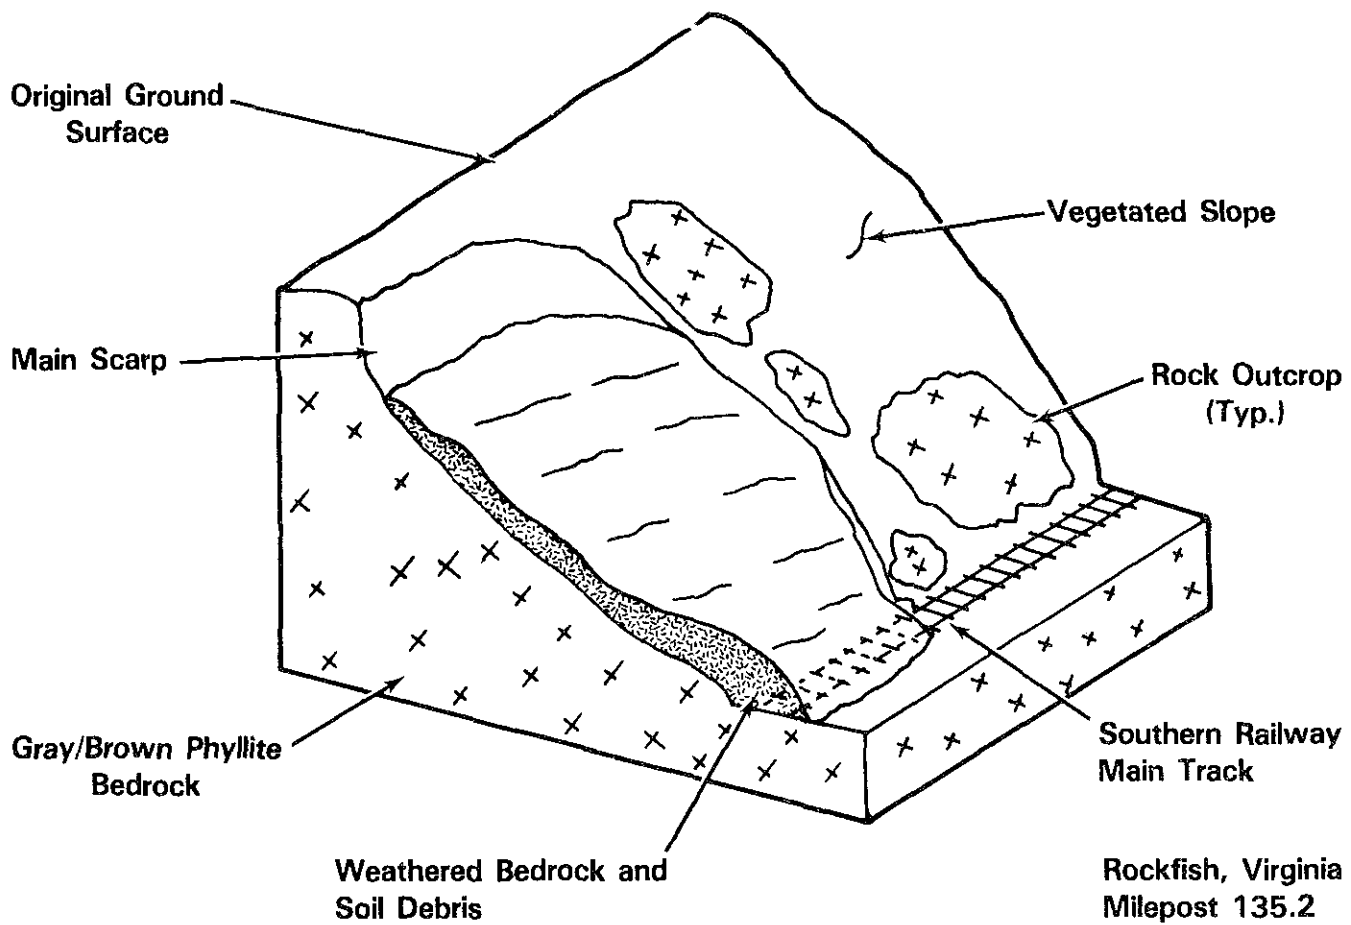
The surface structure at the slope and adjacent to the slide area consisted of sandy soil and rock outcroppings of bedrock and saprolite. The soil was classified as 50 percent sandy loam and 50 percent silt loam, based upon the classification system used by the U.S. Department of Agriculture. The grain size distribution was found to be 0.2 percent gravel, 50.4 percent sand, and 49.4 percent fines. (See figure 5.) Natural moisture content was equal to 18.0 percent. The slope generally rose about 1 foot for every foot of horizontal depth--about 59 feet in 60 feet of horizontal depth. Near the top of the scarp, the slope increased to about a 2-foot rise in 1 foot of depth for a distance of about 10 feet.

Figure 5.--Structure of slope.

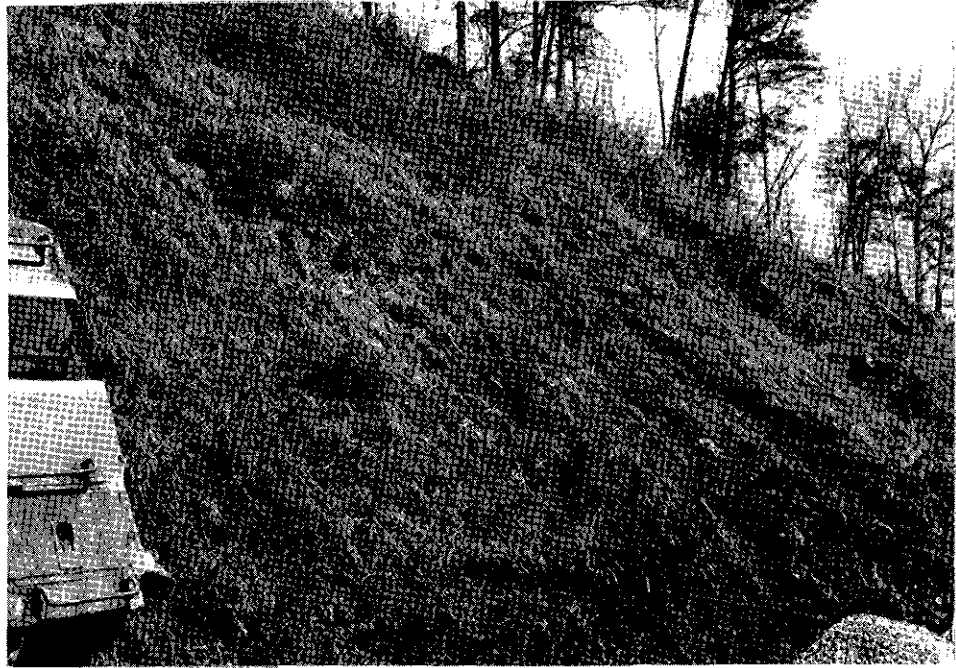
The vegetation had been burned and cut from the west slope by the SR. (See figure 6.) Tree stumps about 8 inches in diameter were in the slide debris. Similar stumps were also on the west slope at other stable areas. The east slope had vegetation. (See figure 7.)

Figure 6.—West slope.

A review of the maintenance of the west slope at MP 135 indicated that the SR had last cleared the slope in December 1982. However, the entire slope had not been burned, just the area at the top of the slide. While no record of slope movement before this accident was indicated in the railroad's records, it was apparent that movement had occurred before this landslide on both the east and west slopes at MP 135.2 because of the manner in which the trees on the slopes tilted.
