# NATIONAL TRANSPORTATION SAFETY BOARD

## RAILROAD/HIGHWAY ACCIDENT REPORT

COLLISION OF AMTRAK TRAIN NO. 88  
WITH TRACTOR LOWBOY SEMITRAILER  
COMBINATION TRUCK  
ROWLAND, NORTH CAROLINA  
AUGUST 25, 1983

NTSB/RHR-84/01.

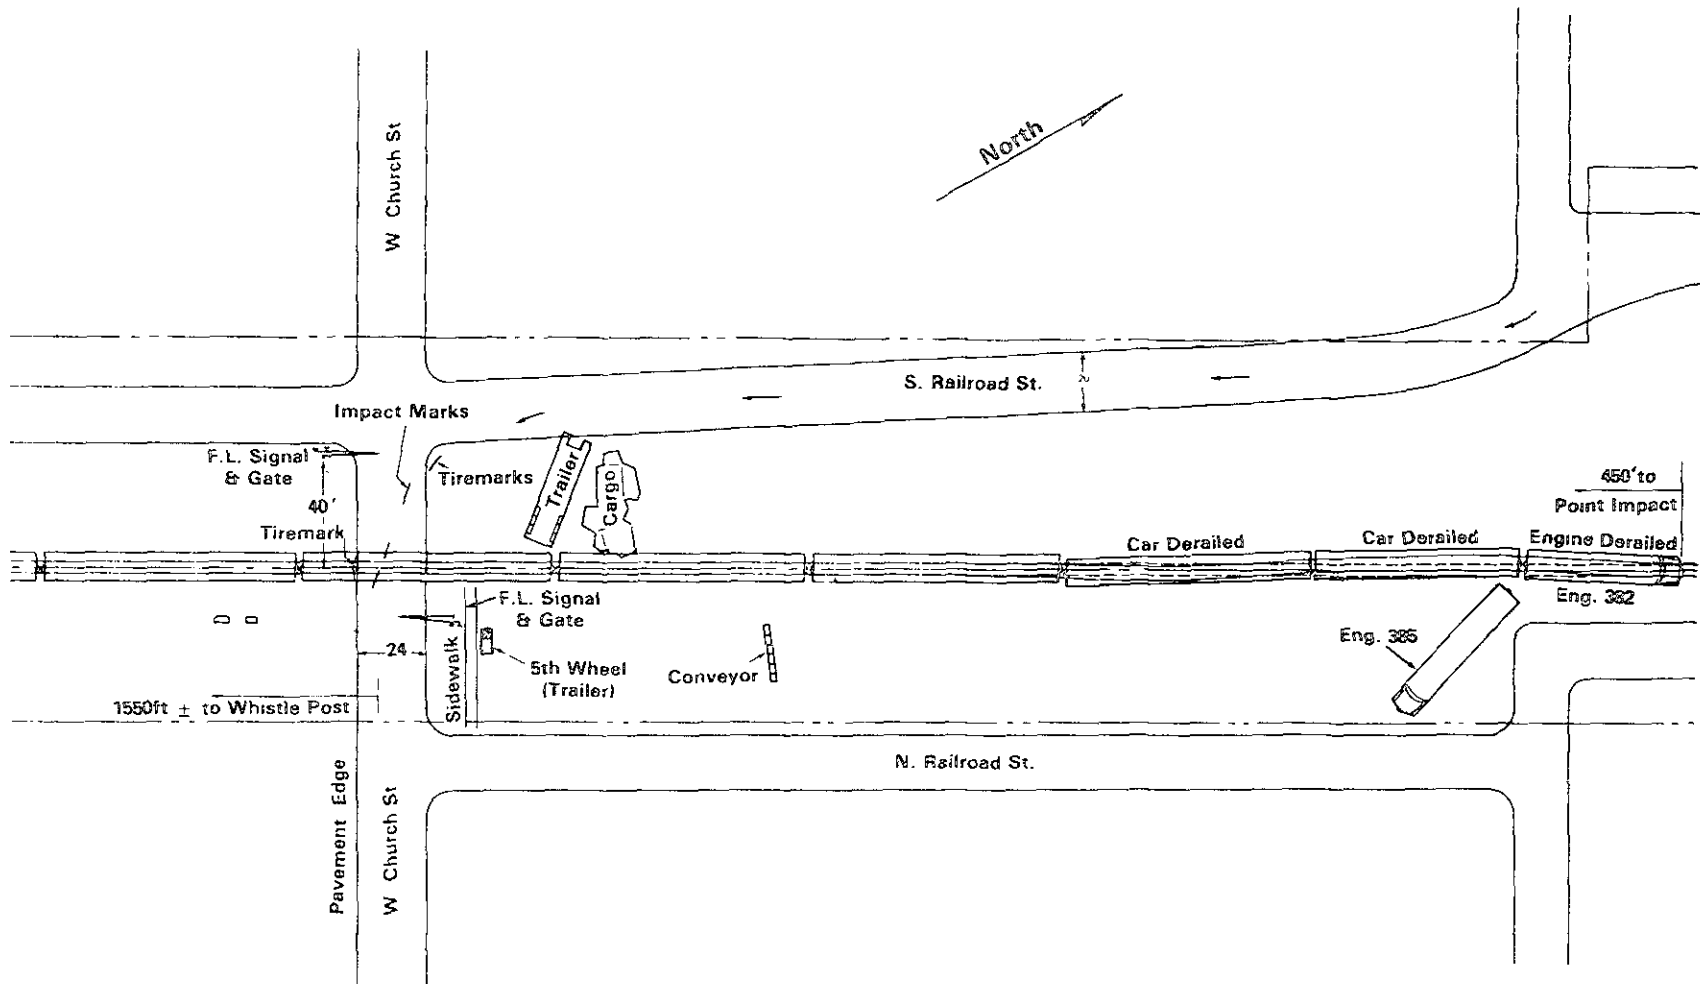
Figure 1.--Plan view of accident site.

When the train struck the truck, the fifth wheel attachment to the truck-tractor frame separated, leaving the tractor relatively undamaged. The goose neck separated from its attachment to the lowboy trailer bed and came to rest in the northeast quadrant of the crossing. The lowboy trailer came to rest upright after being rotated about 180 degrees from its original heading and into the northwest quadrant of the crossing. The piece of construction equipment broke loose of the lowboy trailer and came to rest north of the trailer. (See figure 1.)

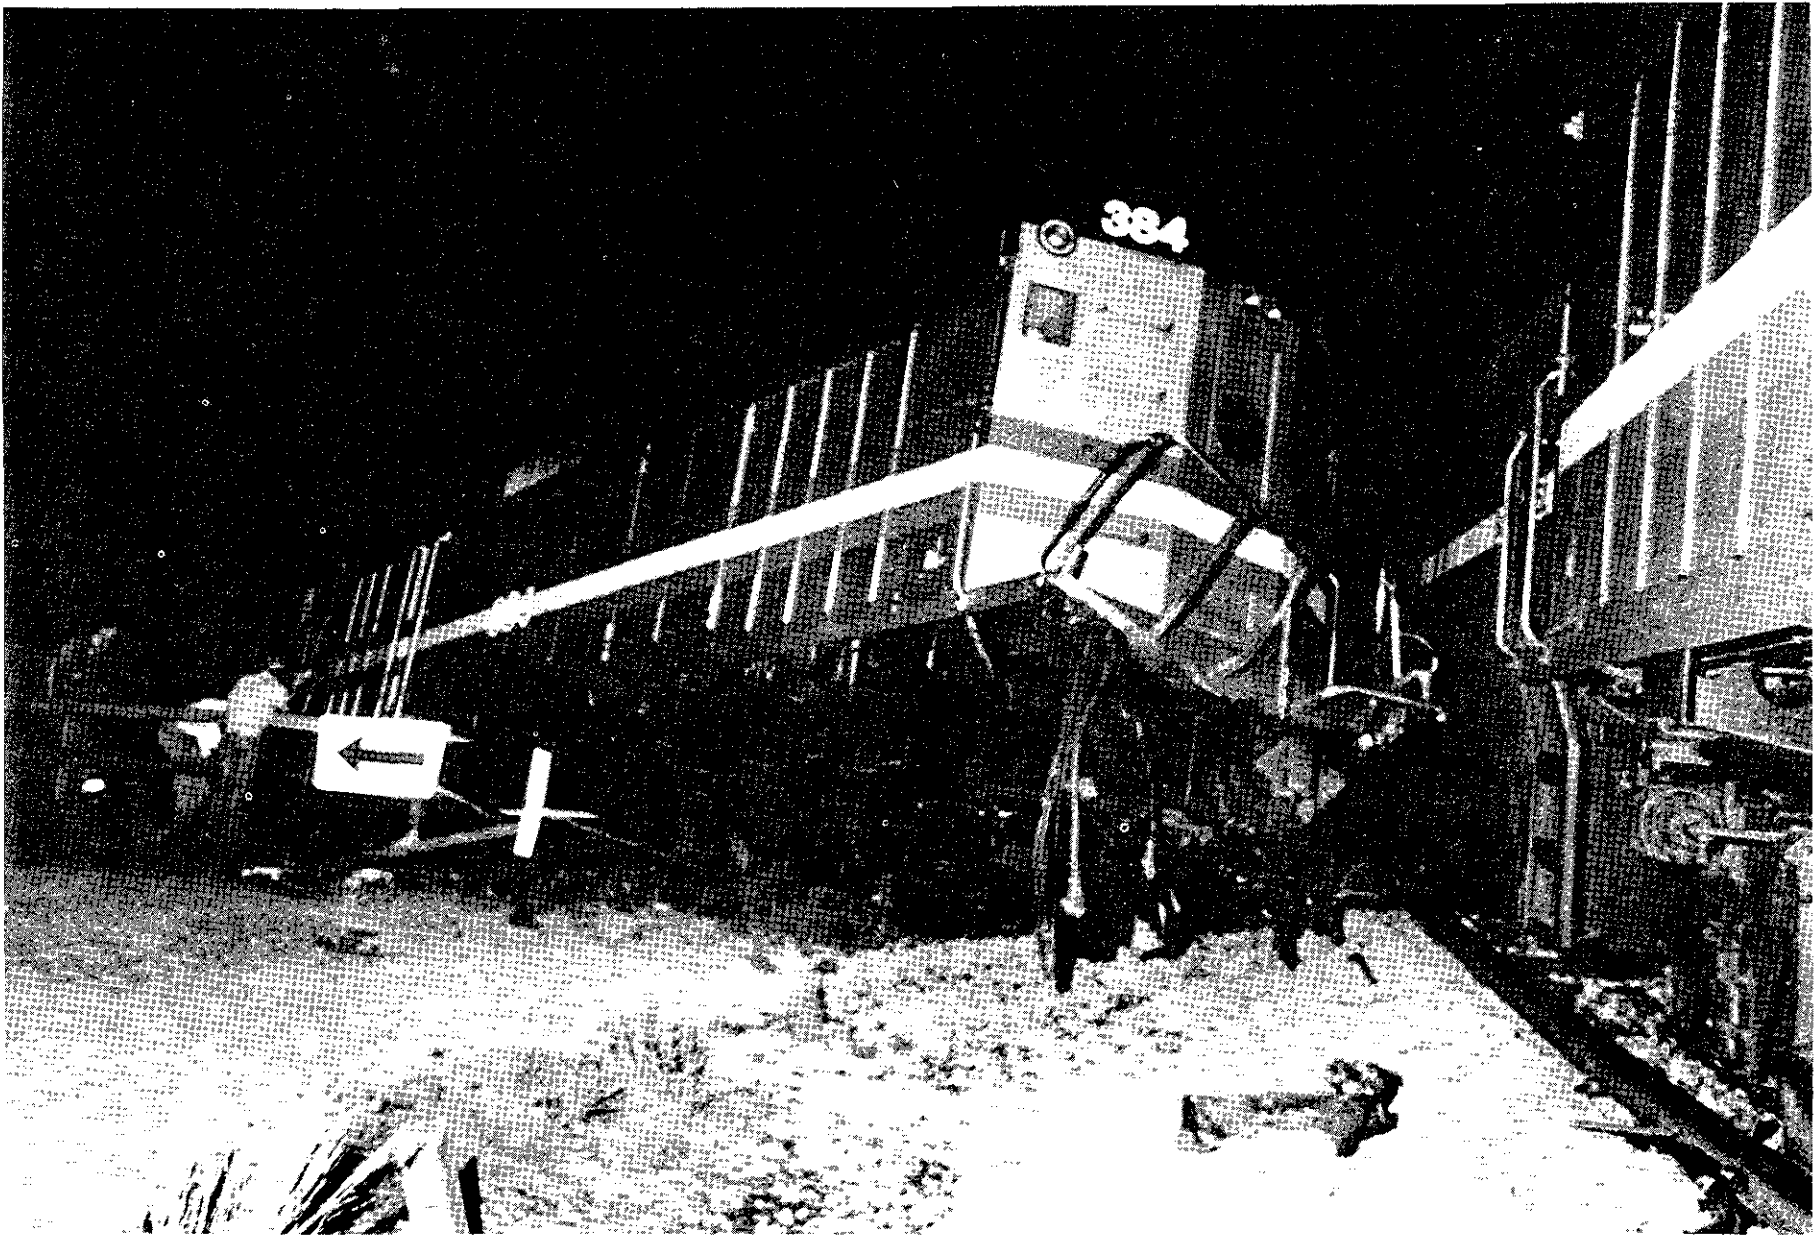
Figure 2.--Lead locomotive unit of train No. 88.

The lead locomotive unit was damaged substantially. The second locomotive unit, the baggage mail car, and the baggage-dormitory car all received minor damage.

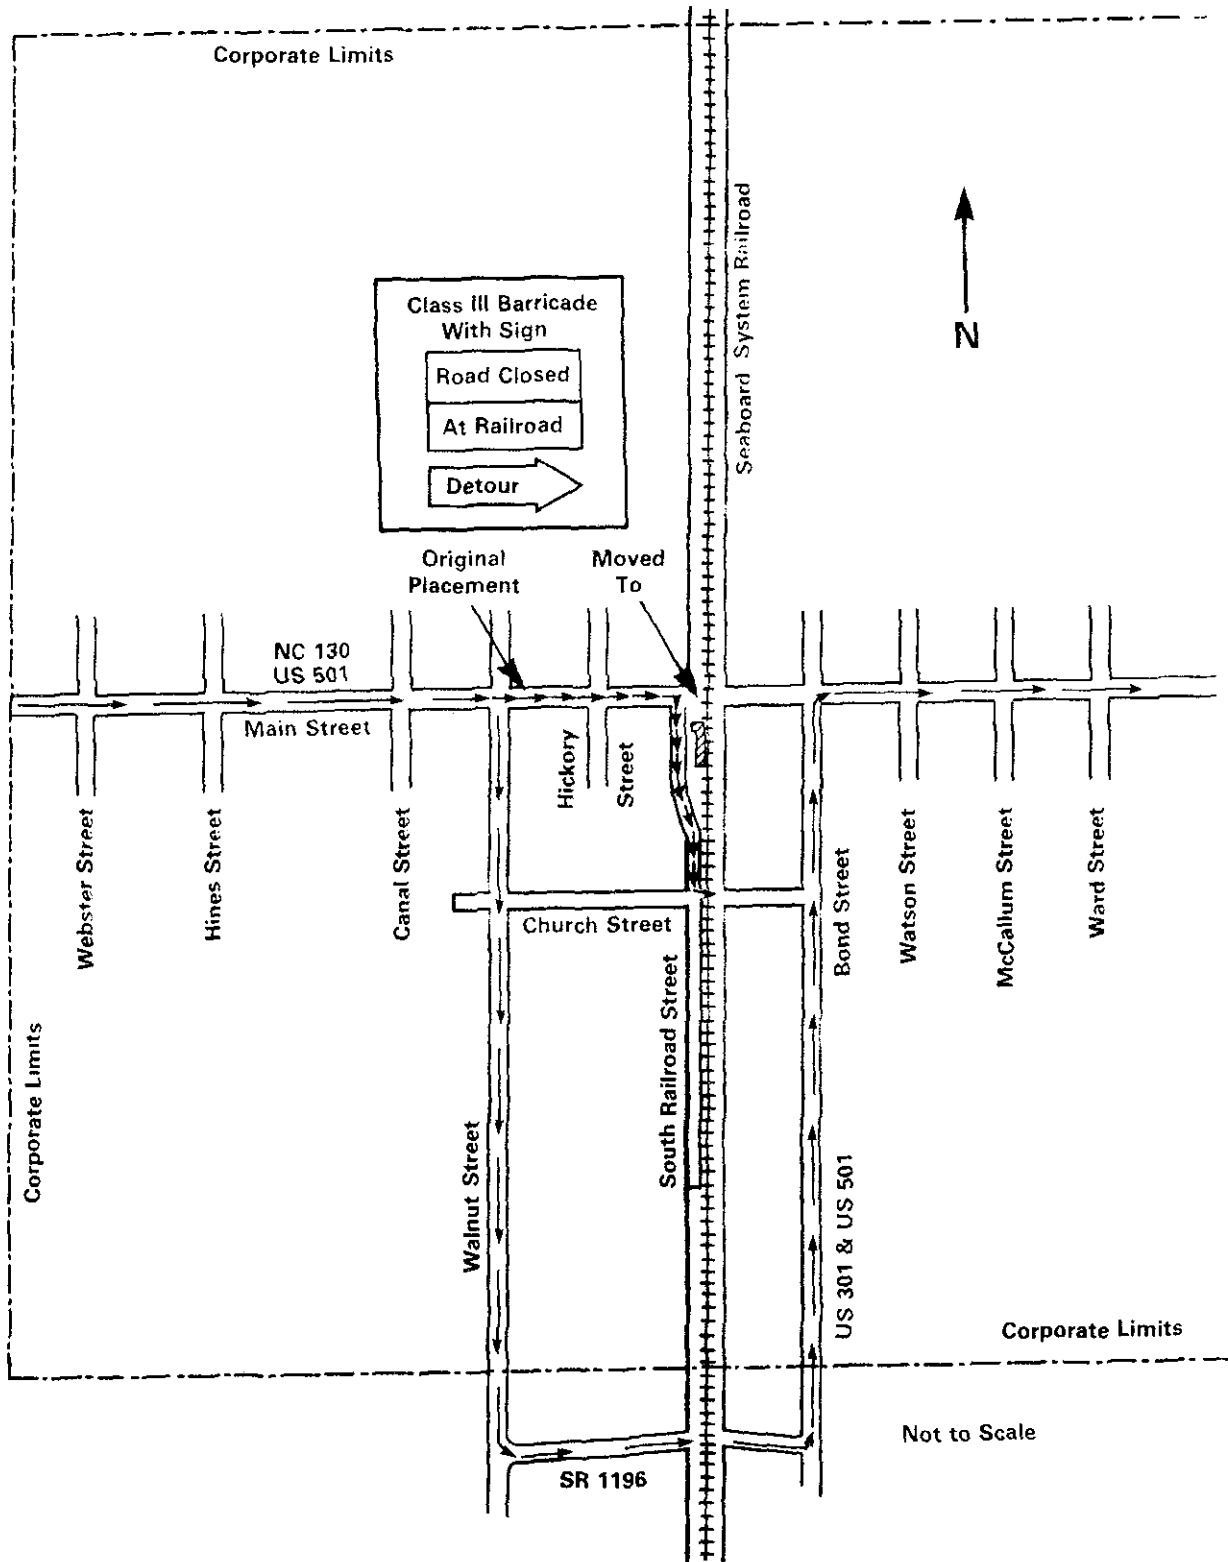
Figure 3.--Plan view of detour route.

Street facing eastbound traffic at intersecting Walnut Street (two blocks west of the grade crossing). (See figure 3.) A series of signs with arrows diverted eastbound traffic southerly on Walnut Street to N.C. Route 1196 (just south of the city limits), eastwardly on N.C. Route 1196 across the same Seaboard track, then northerly on Bond Street (1 block east of the track) to Main Street. A similar barricade was placed in the center of Main Street at the intersection of Bond Street to divert westbound traffic over the same route to the west side of the Main Street crossing. All of the roadways on the 1.36-mile-long detour route were State-maintained.

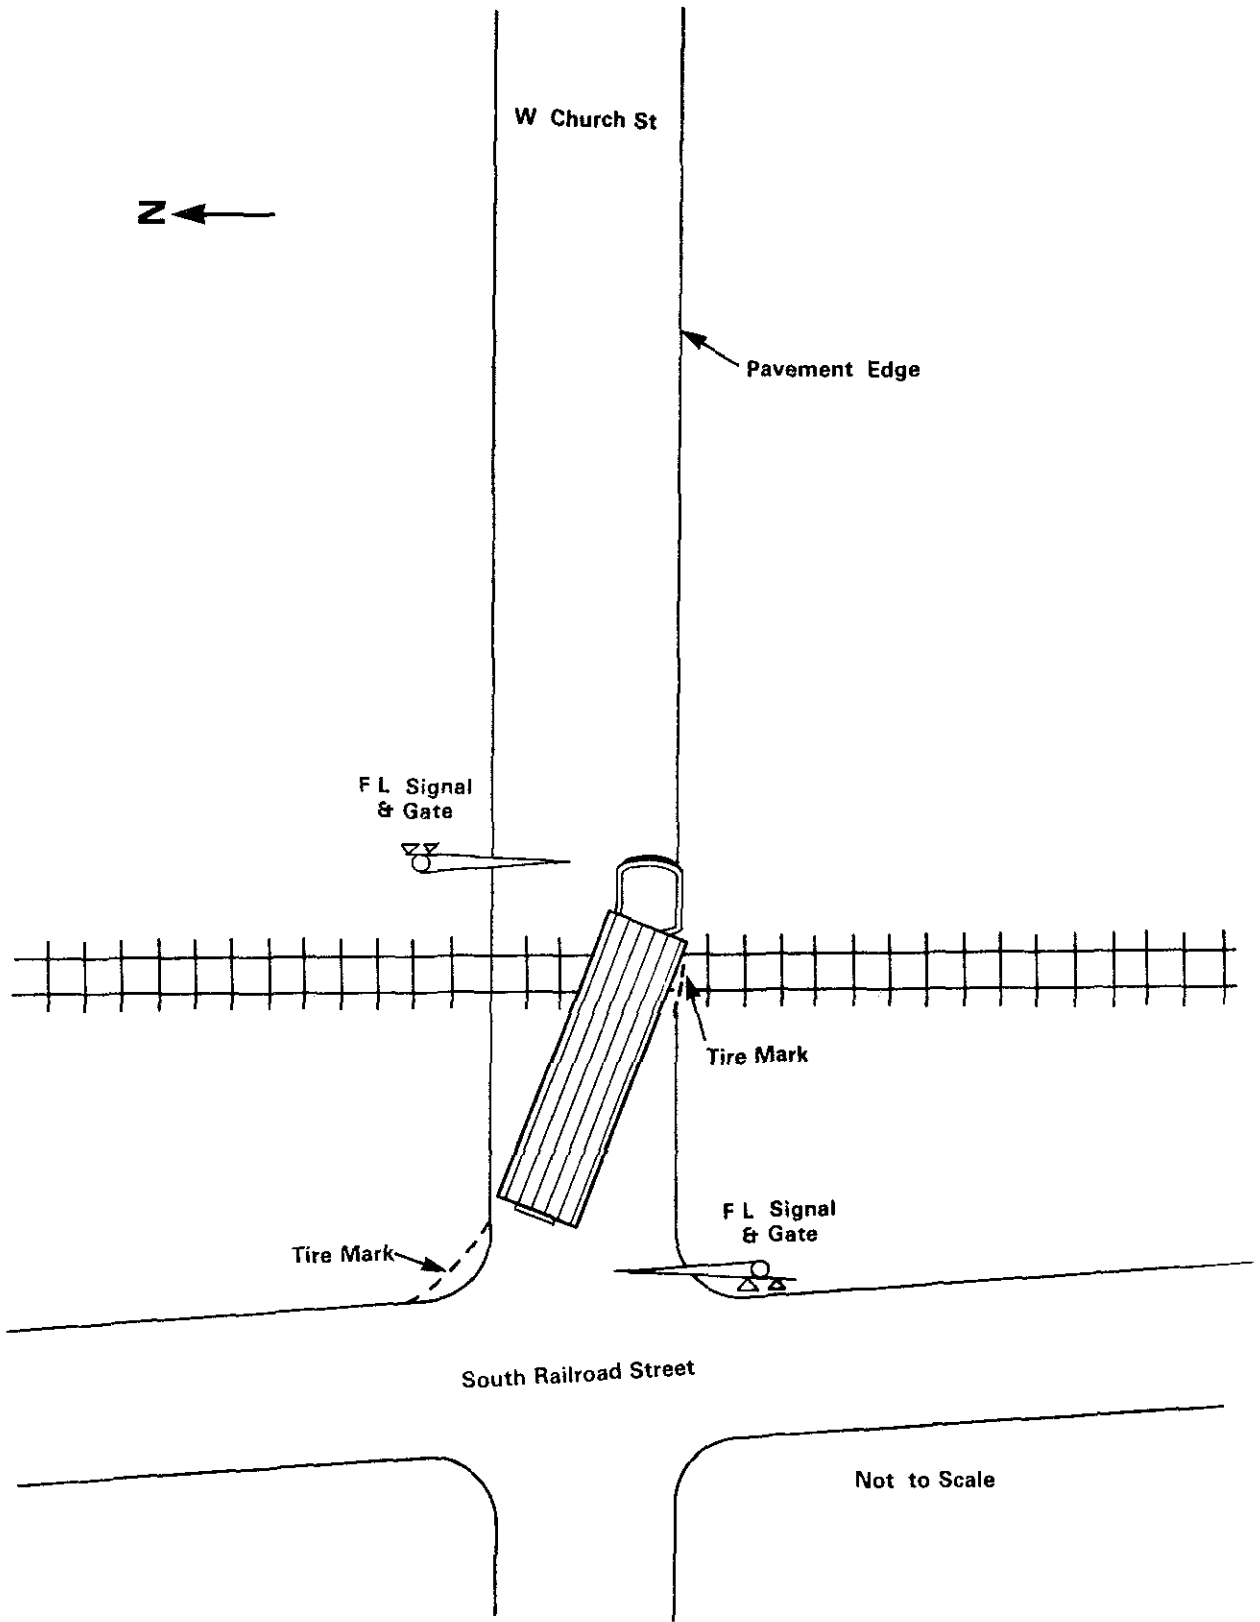
Figure 4.--Truck in lodged position on crossing at accident site.

7. The truck was not being operated in accordance with the requirements of the Federal Motor Carrier Safety Regulations.
8. The low ground clearance of the semitrailer combined with the hump of the grade crossing caused the semitrailer to become lodged on the track.

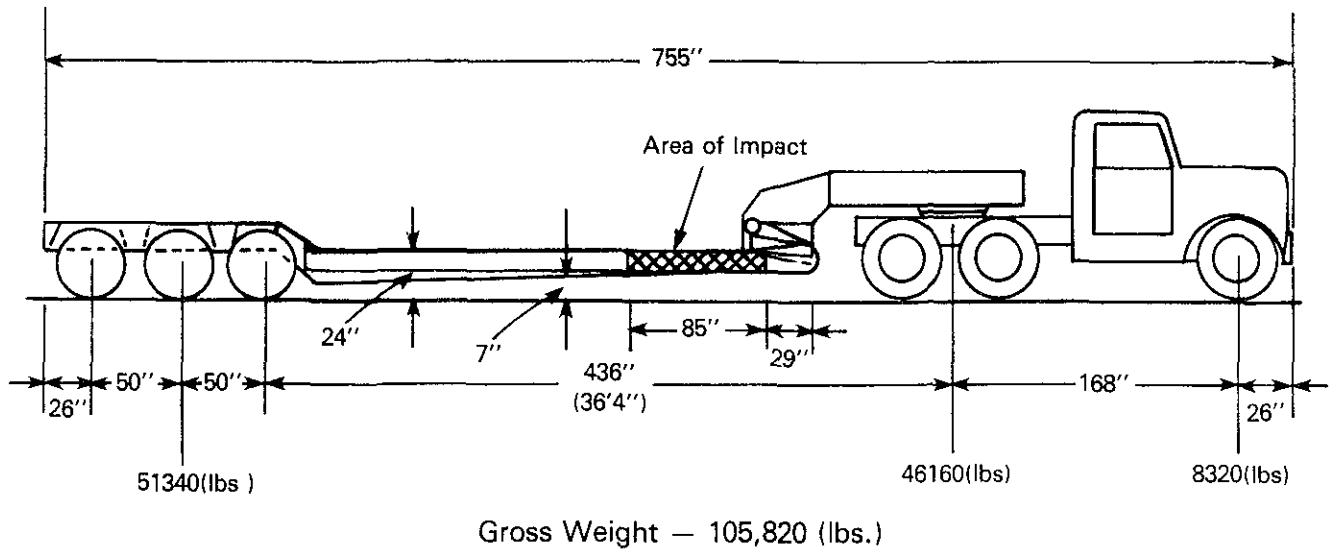
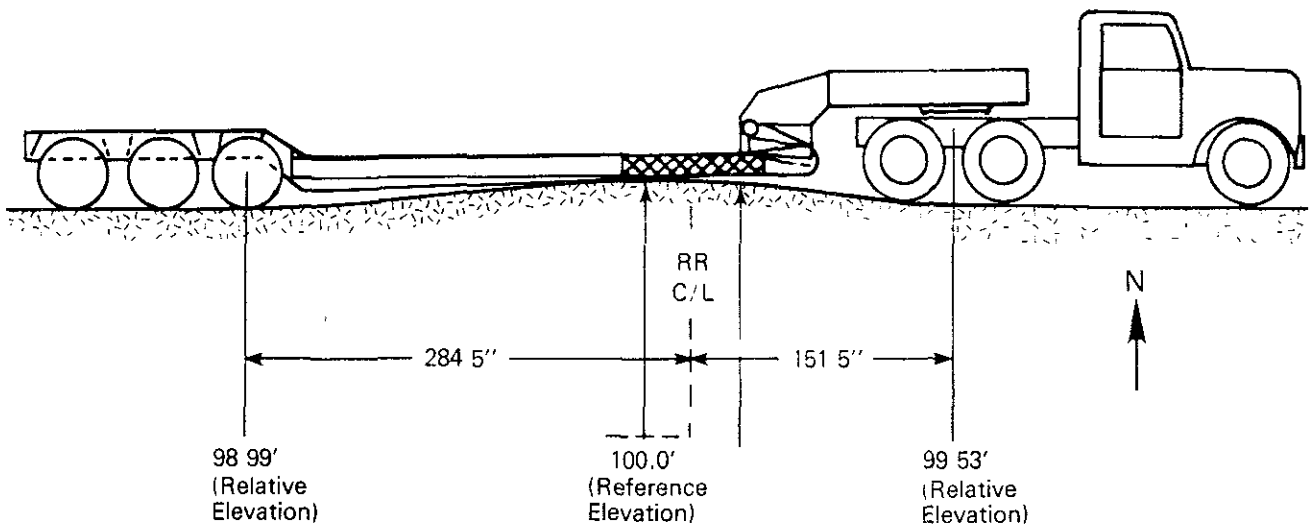
The tractor-lowboy semitrailer combination (see figure 5) was owned and operated by the S.L. Balogh Trucking Company, Inc., of Ft. Lauderdale, Florida. The 63-foot-long unit with its cargo was weighed in Virginia the day before the accident; the gross

Figure 5.--Measurements and weights of tractor and lowboy semitrailer as loaded (top), and measurements of tractor and lowboy semitrailer in relation to grade crossing at the accident site (bottom).

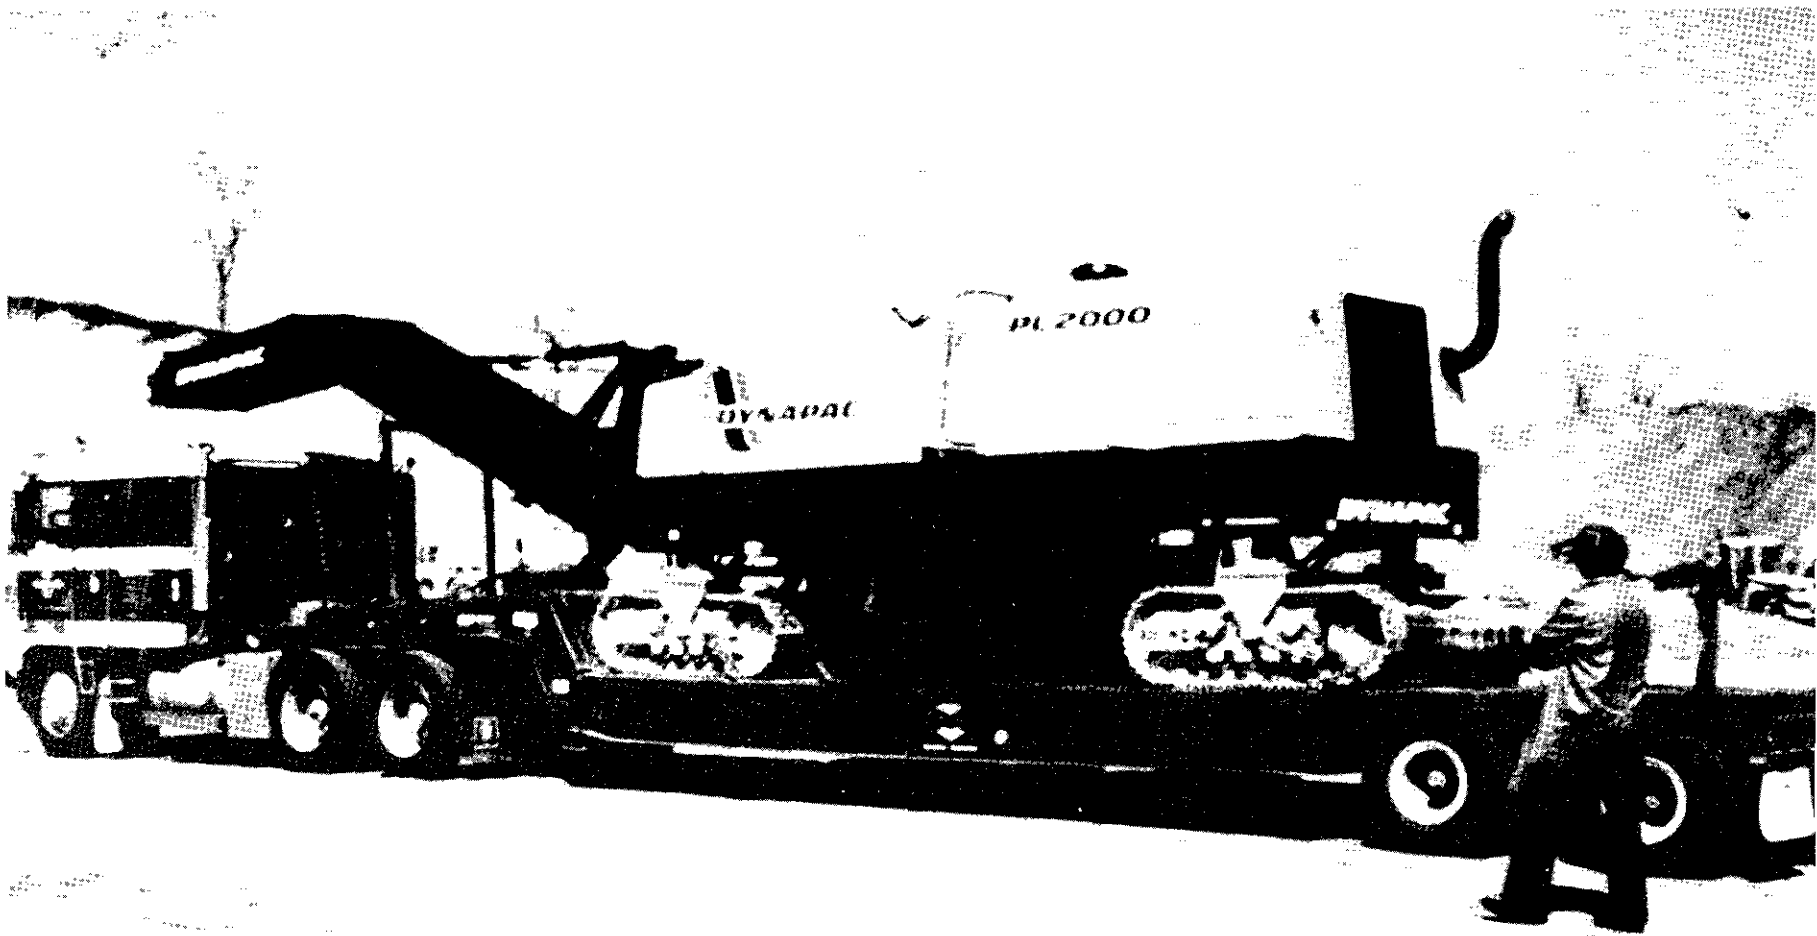
The cargo consisted of a 61,000-pound, 4-wheel-track, Model PL2000 Pavement Profiler (see figure 6). The machine was manufactured by Dynapac Manufacturing, Inc., of Stanhope, New Jersey. The Balogh truck was transporting the equipment from Stanhope to a customer in Hialeah Gardens, Florida. The machine was 98 inches wide, 117 inches high, and measured 22 feet 11 inches long at the wheel tracks. An adjustable boom-type loading conveyor extended 23 feet from the front of the machine.

Figure 6.--Dynapac Pavement Profiler machine, similar to the machine involved in this accident, loaded on a lowboy semitrailer.

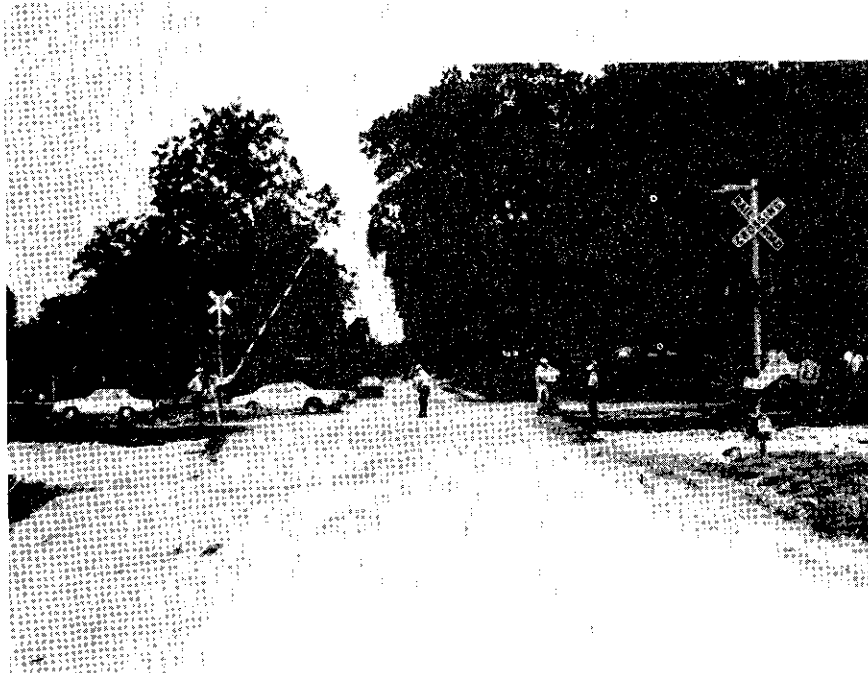
Figure 7.-- West approach to track (above)  
and east approach to track (below).
