RAILROAD ACCIDENT REPORT

DERAILMENT OF AMTRAK TRAIN NO. 1
WHILE OPERATING ON THE
ILLINOIS CENTRAL RAILROAD NEAR
SALEM, ILLINOIS

June 10, 1971

REPORT NUMBER. NTSB-RAR-72-5

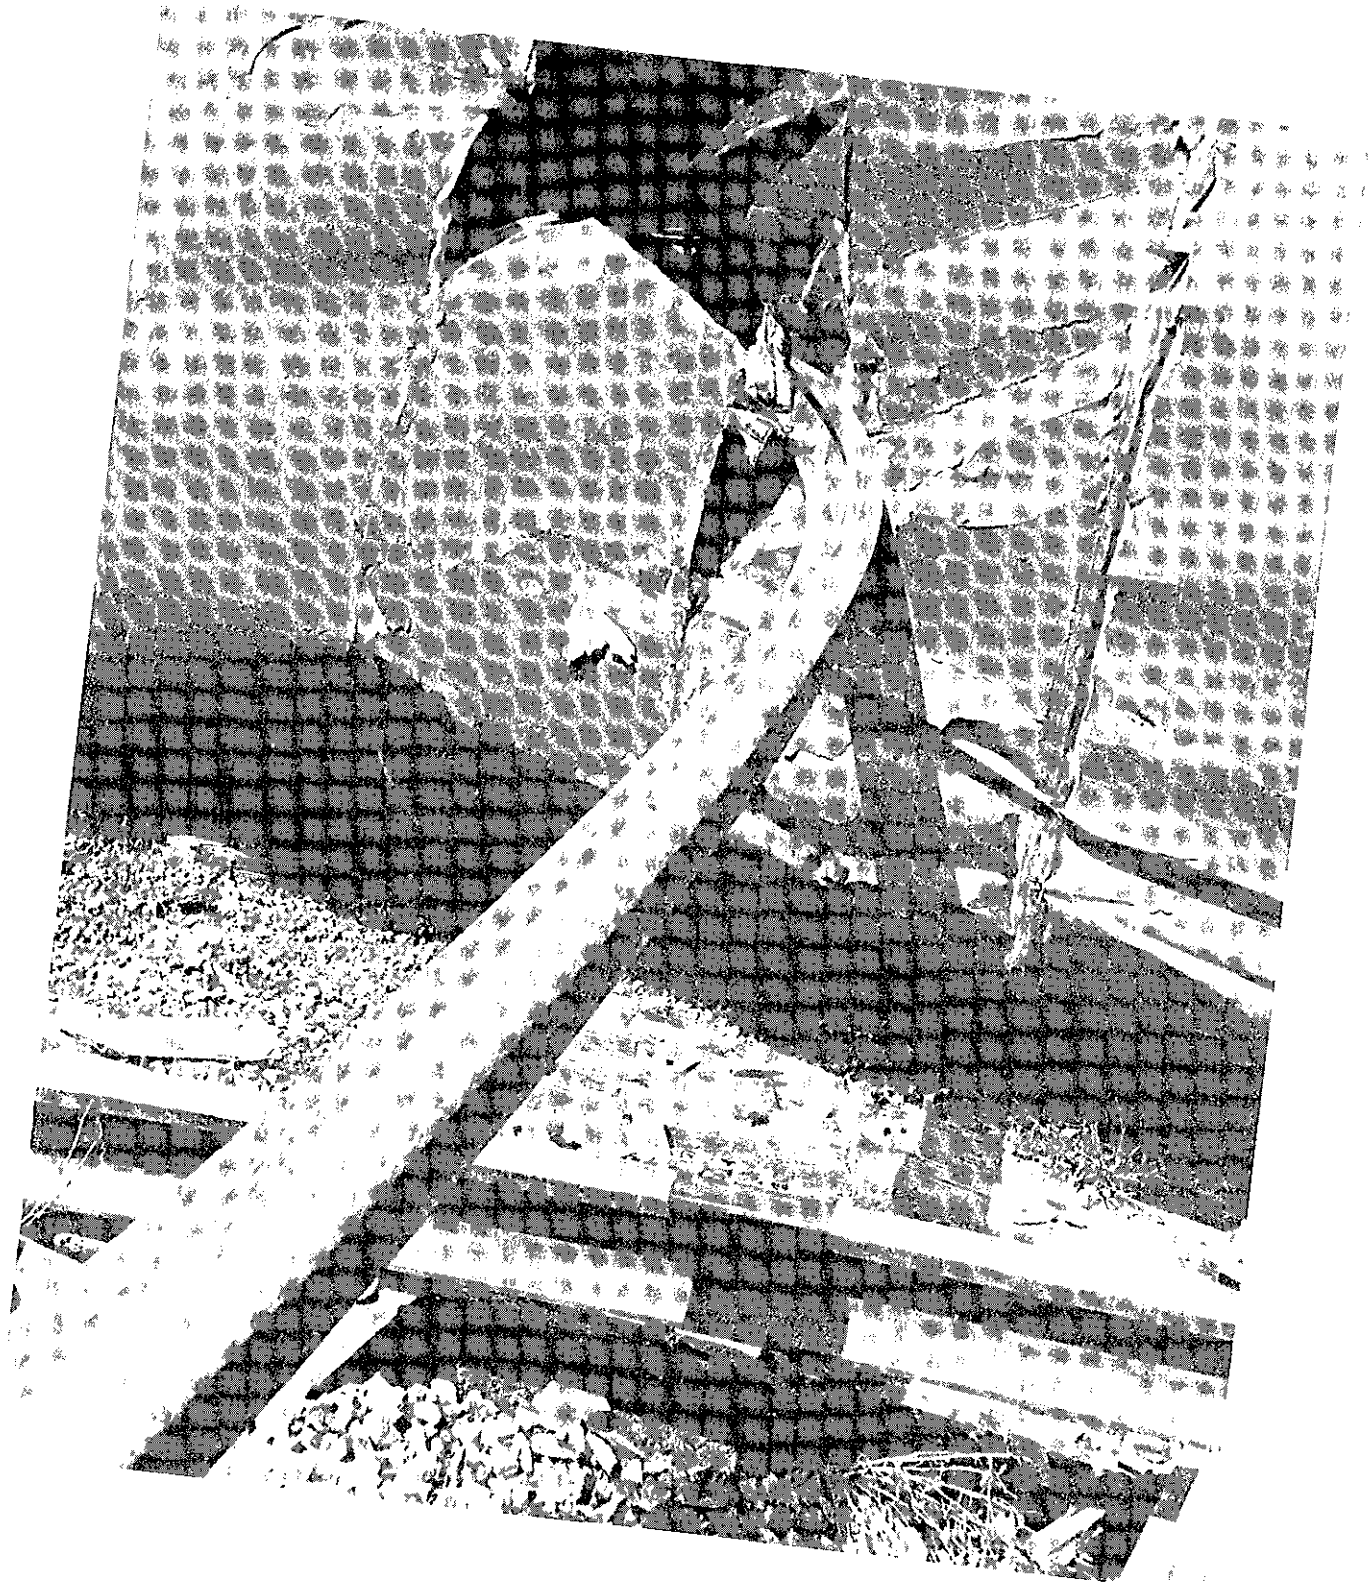
Figure 6 – Rail Penetrated Interior of Car

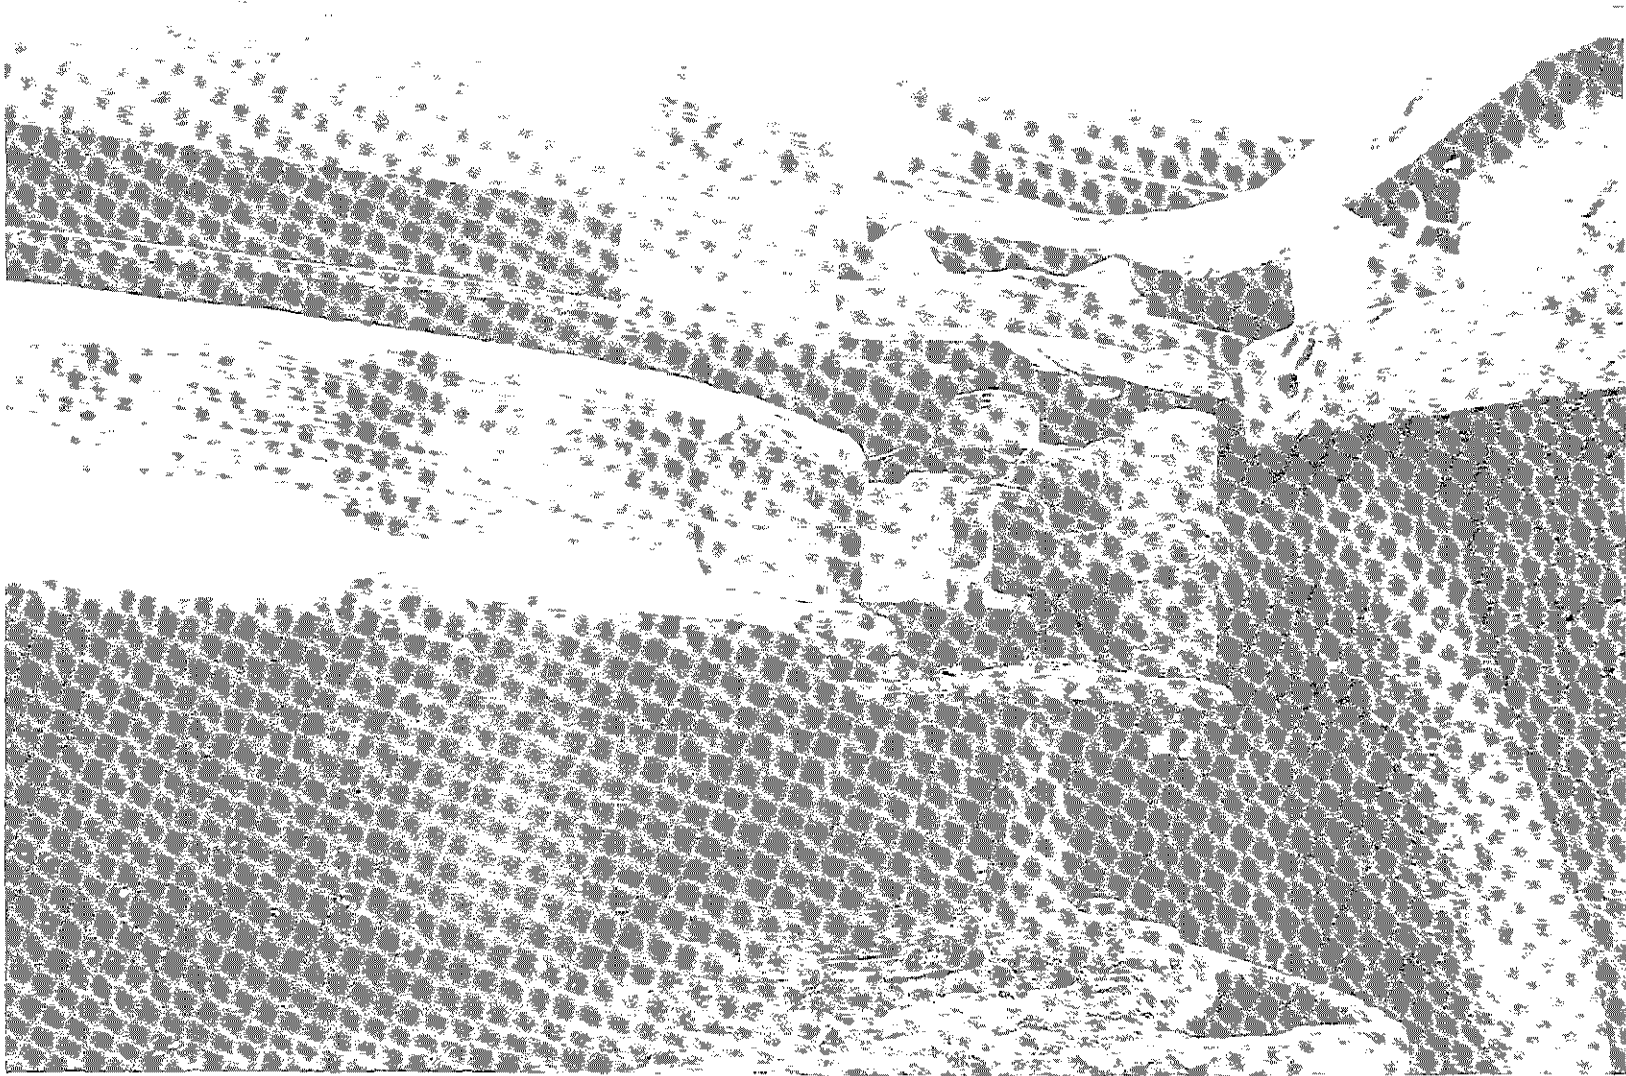
The rear truck of unit 4031 remained attached to the unit when it was turned over on its side. Both of the leading wheels of this truck had flat spots about 10-3/4 inches in length. These flat spots had produced a false flange on the outside edge of the tread. (See Figure 7.) The fact that there were no other flat spots on the wheels indicated that the wheels had not turned after locking. When the gearcase cover was removed, no broken gear teeth or other defects in the gears were found which would have caused the wheels to lock.

**Figure 7 –Slid-Flat Spot on Locomotive Wheel as Observed at Scene of Accident.
Gear Case has been Removed.**

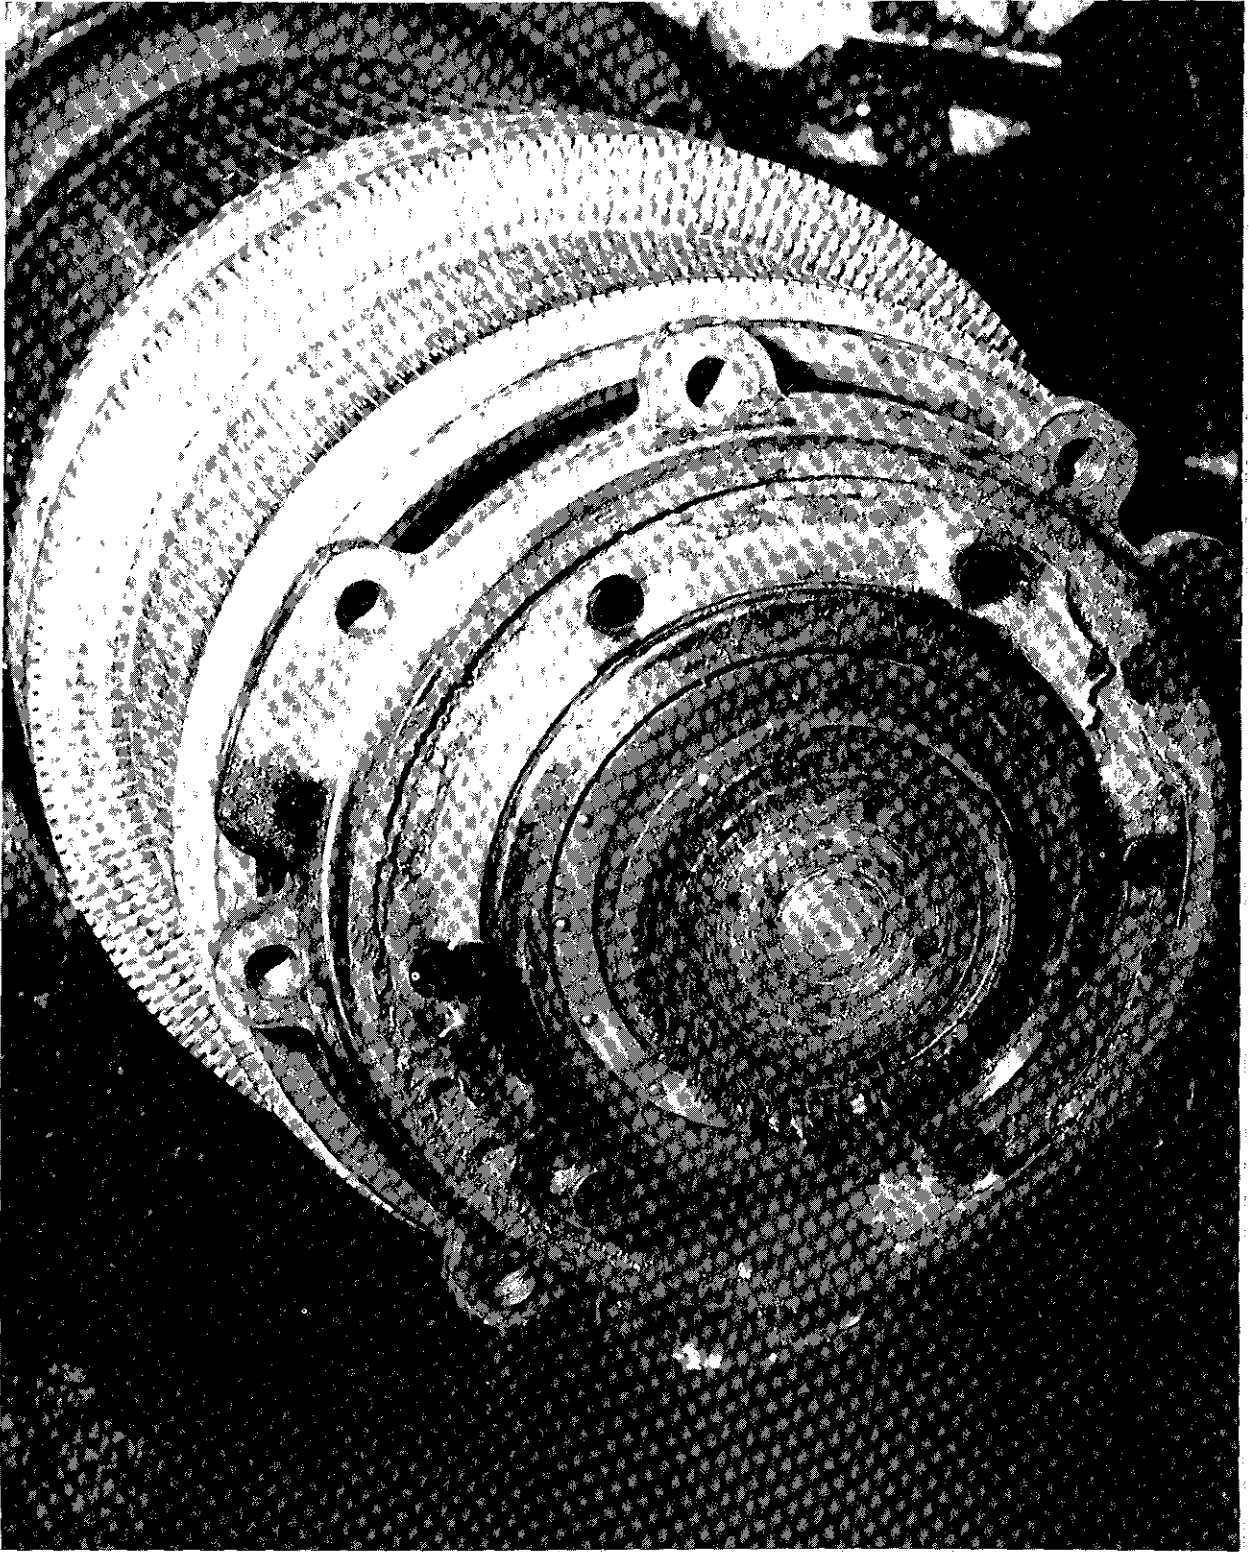
The armature was removed from the motor and disassembled. The commutator end roller bearing was damaged by heat and the grease was charred. (See Figure 9.) The pinion end roller bearing was damaged by heat. The steel rollers were flattened, grooved, and discolored. The inner and outer races were damaged. (See Figure 10.)

Figure 9 – Damaged Commutator End Bearing

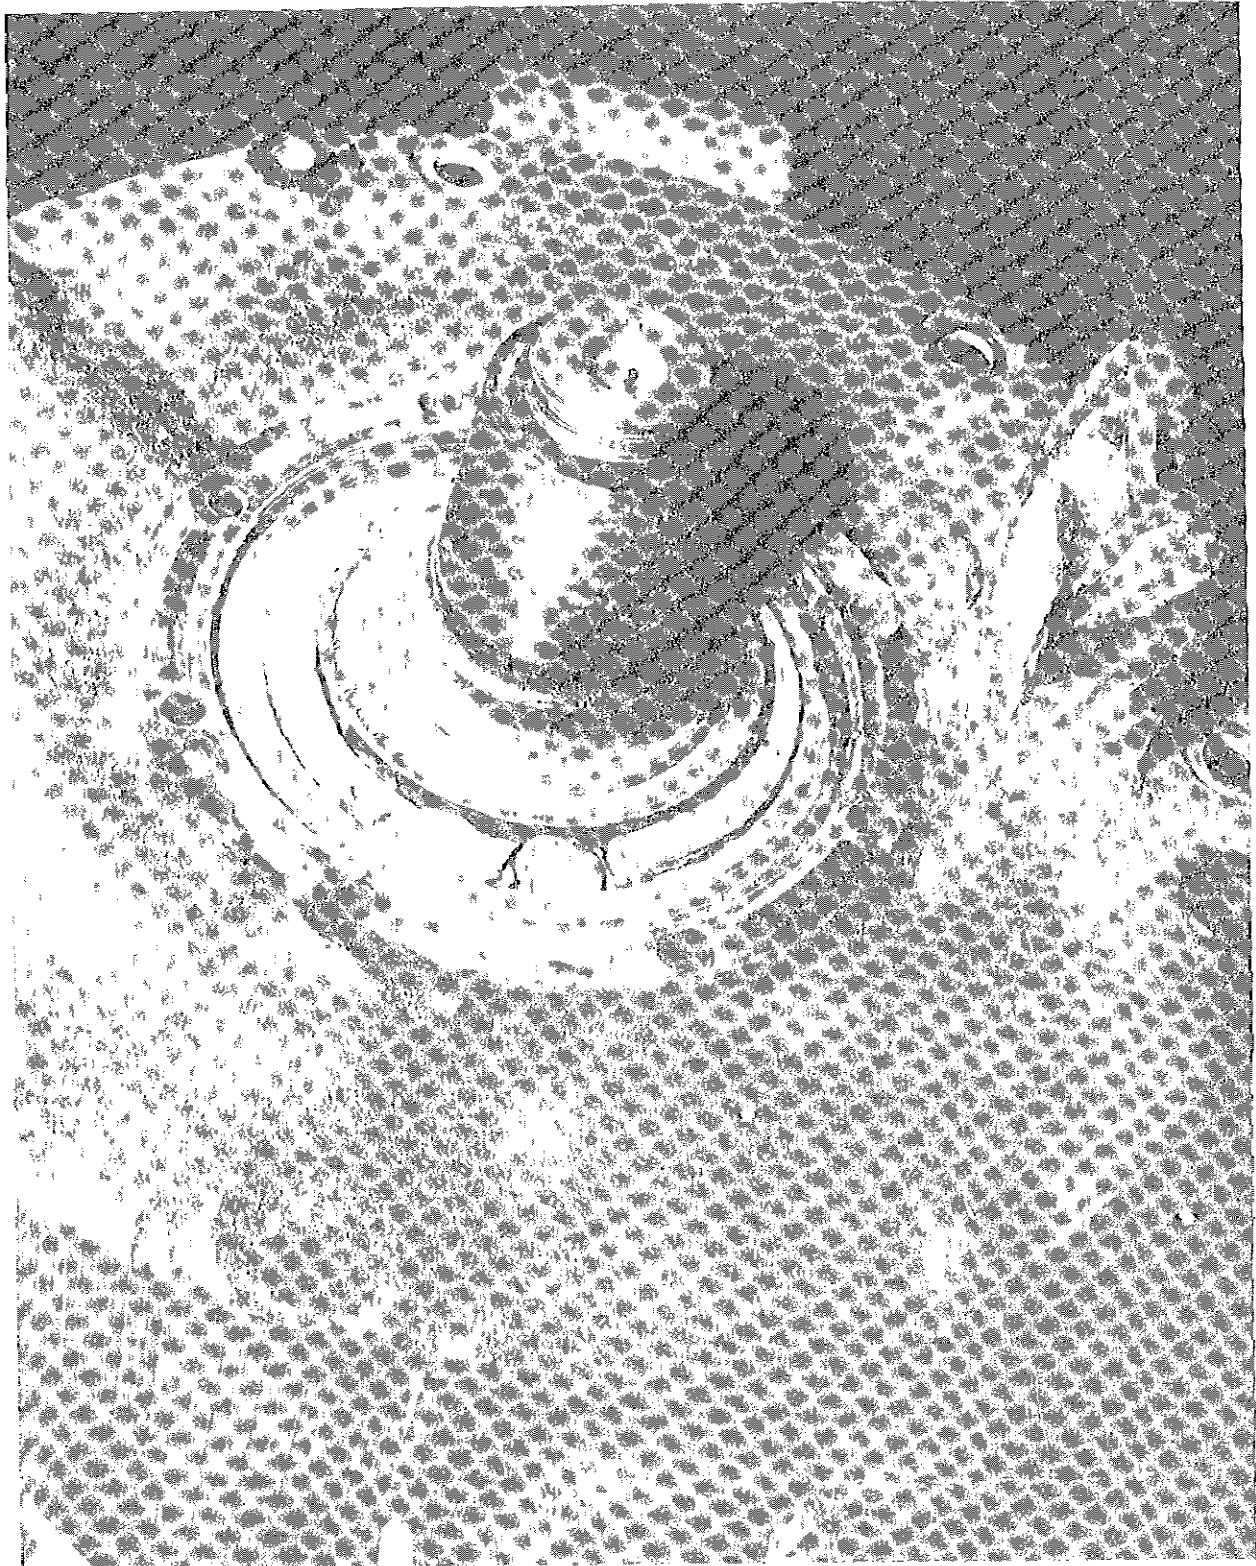
Figure 10 – Damaged Pinion End Bearing

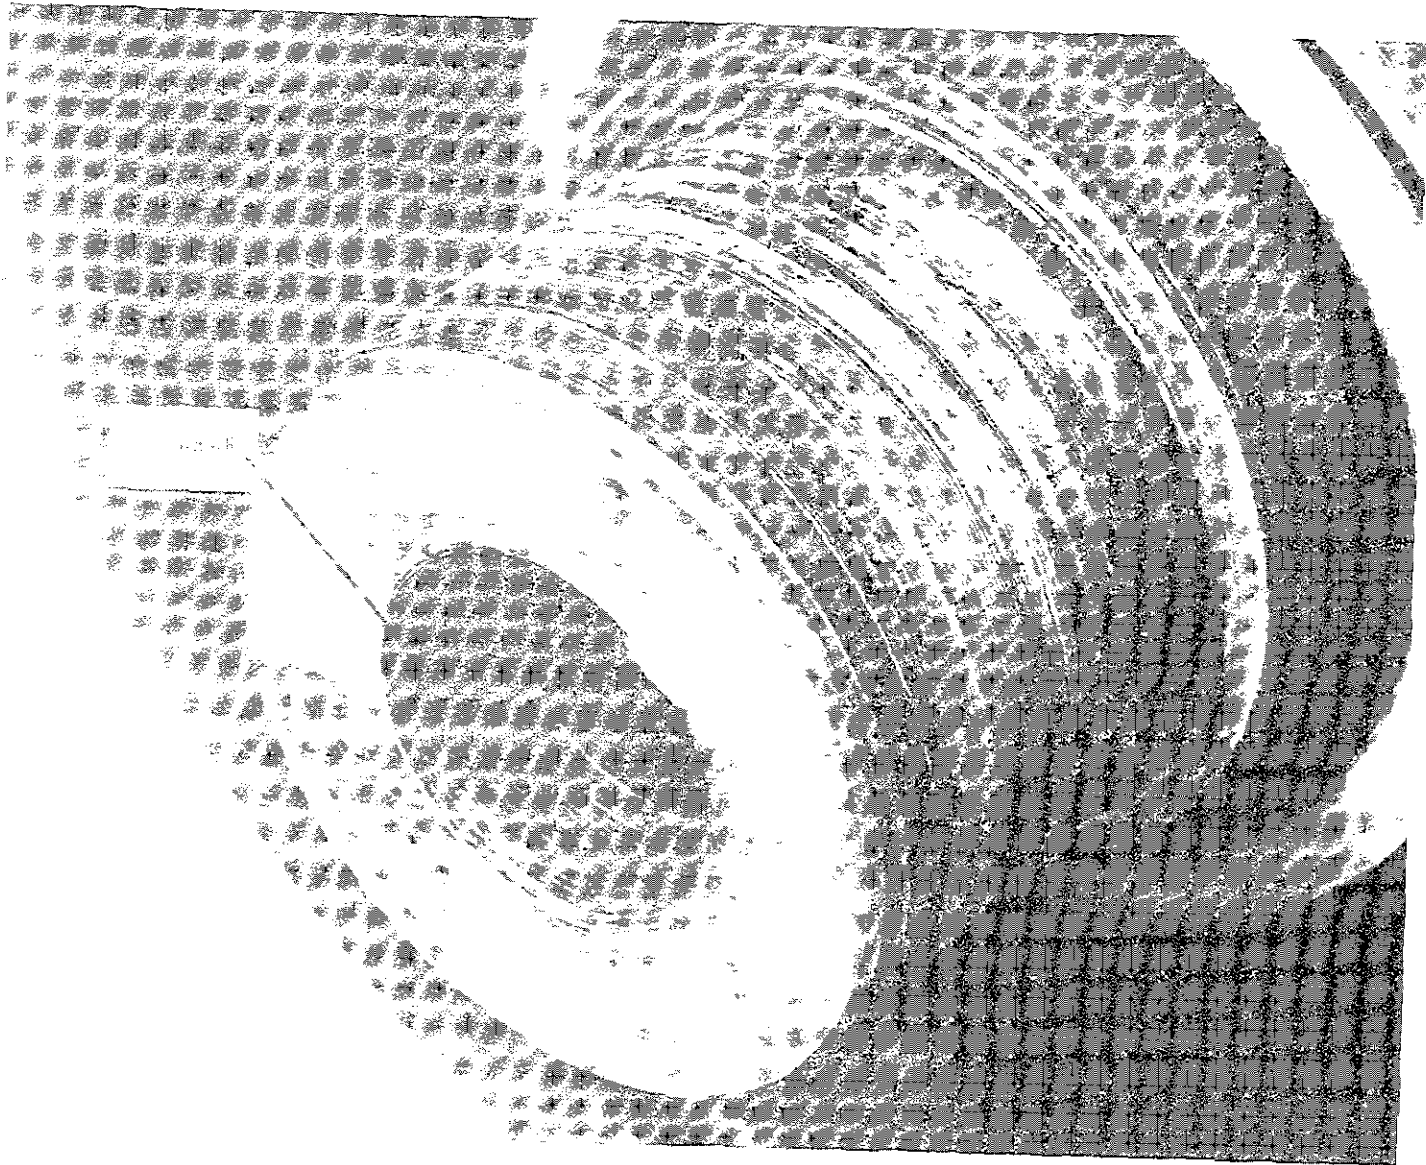
of the armature shaft indicated no distress from movement of the locking screws.⁴

Figure 11.—Commutator End of Armature Shaft showing markings made by set Screws with *no Evidence of Set Screws moving on Face of Shaft.*

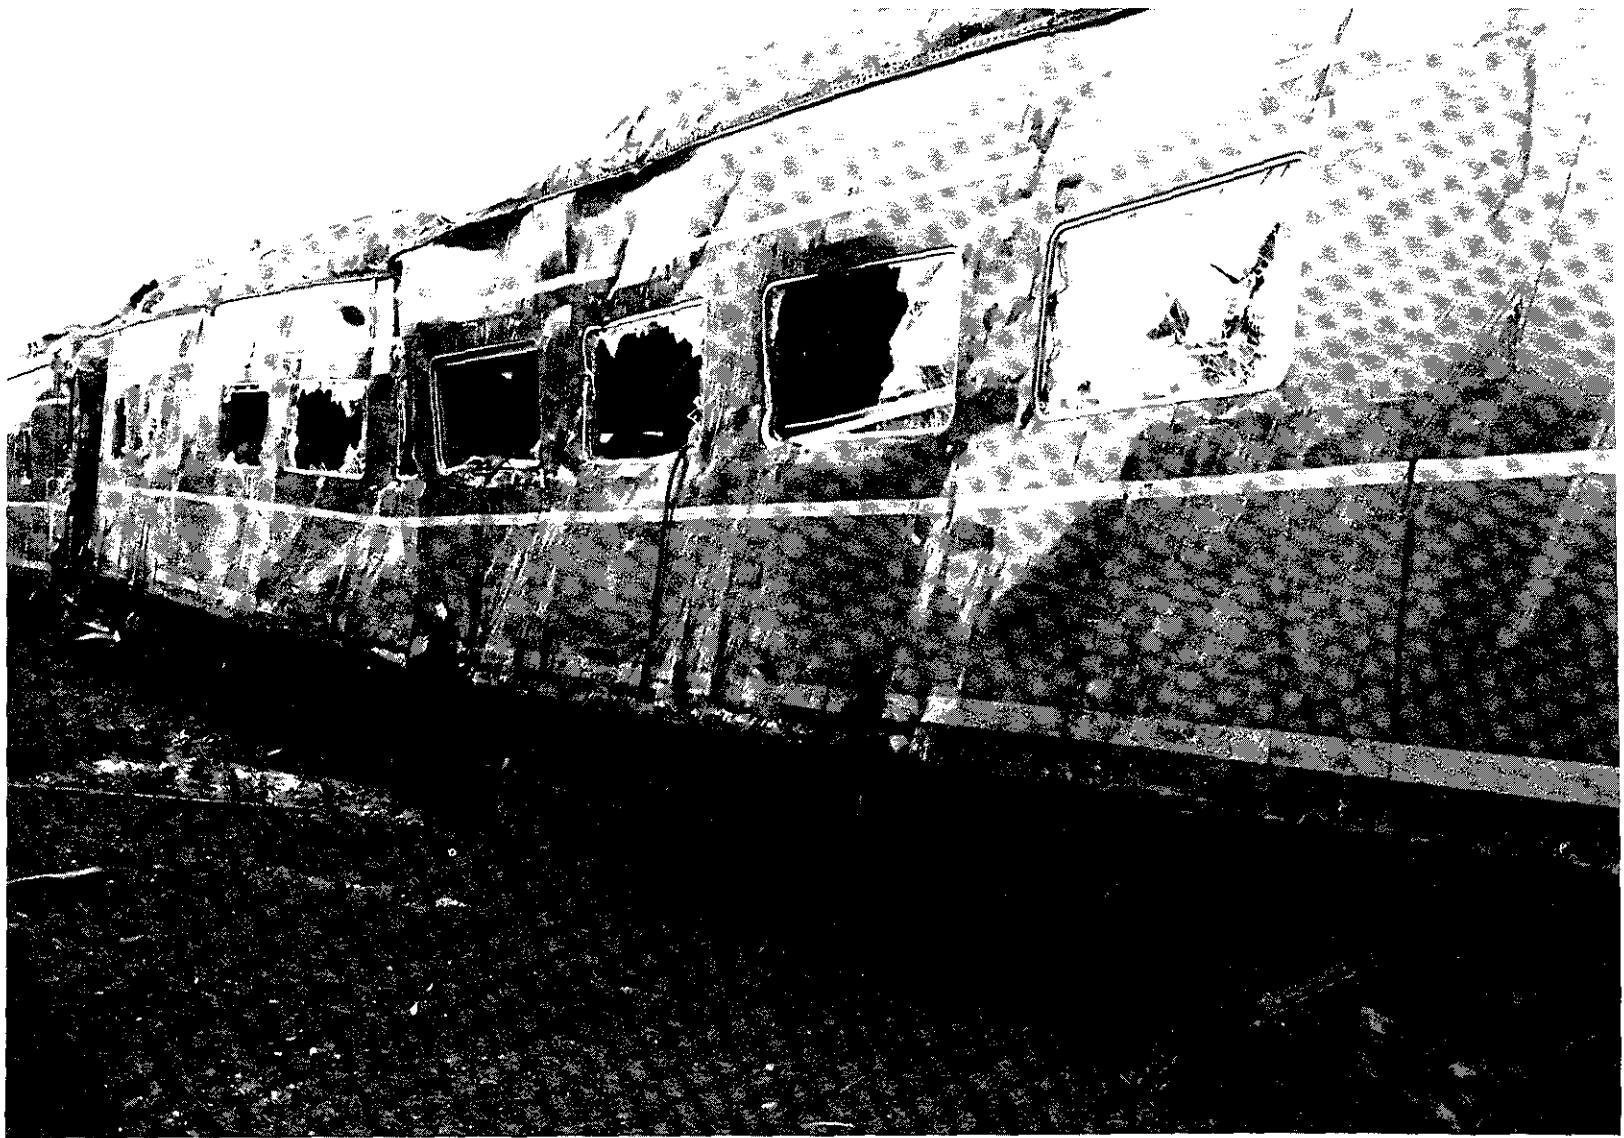
The cause of six of the eleven fatalities was the ejection of passengers through the large side windows which broke when the cars overturned. The other fatalities were caused by passengers being ejected from the end of the car, or being struck by a cross tie, or being hurled against the inside of the car. A total of 163 passengers and employees were injured when impacted against injury-producing surfaces inside the cars.

Figure 12.—Large observation type windows broken out when car 2616 overturned. Note outward distortion of broken glass in two nearest windows. The broken out windows became the floor of the passenger compartment as the car slid to a stop. At least one or as many as three passengers were ejected through these holes and were fatally injured.

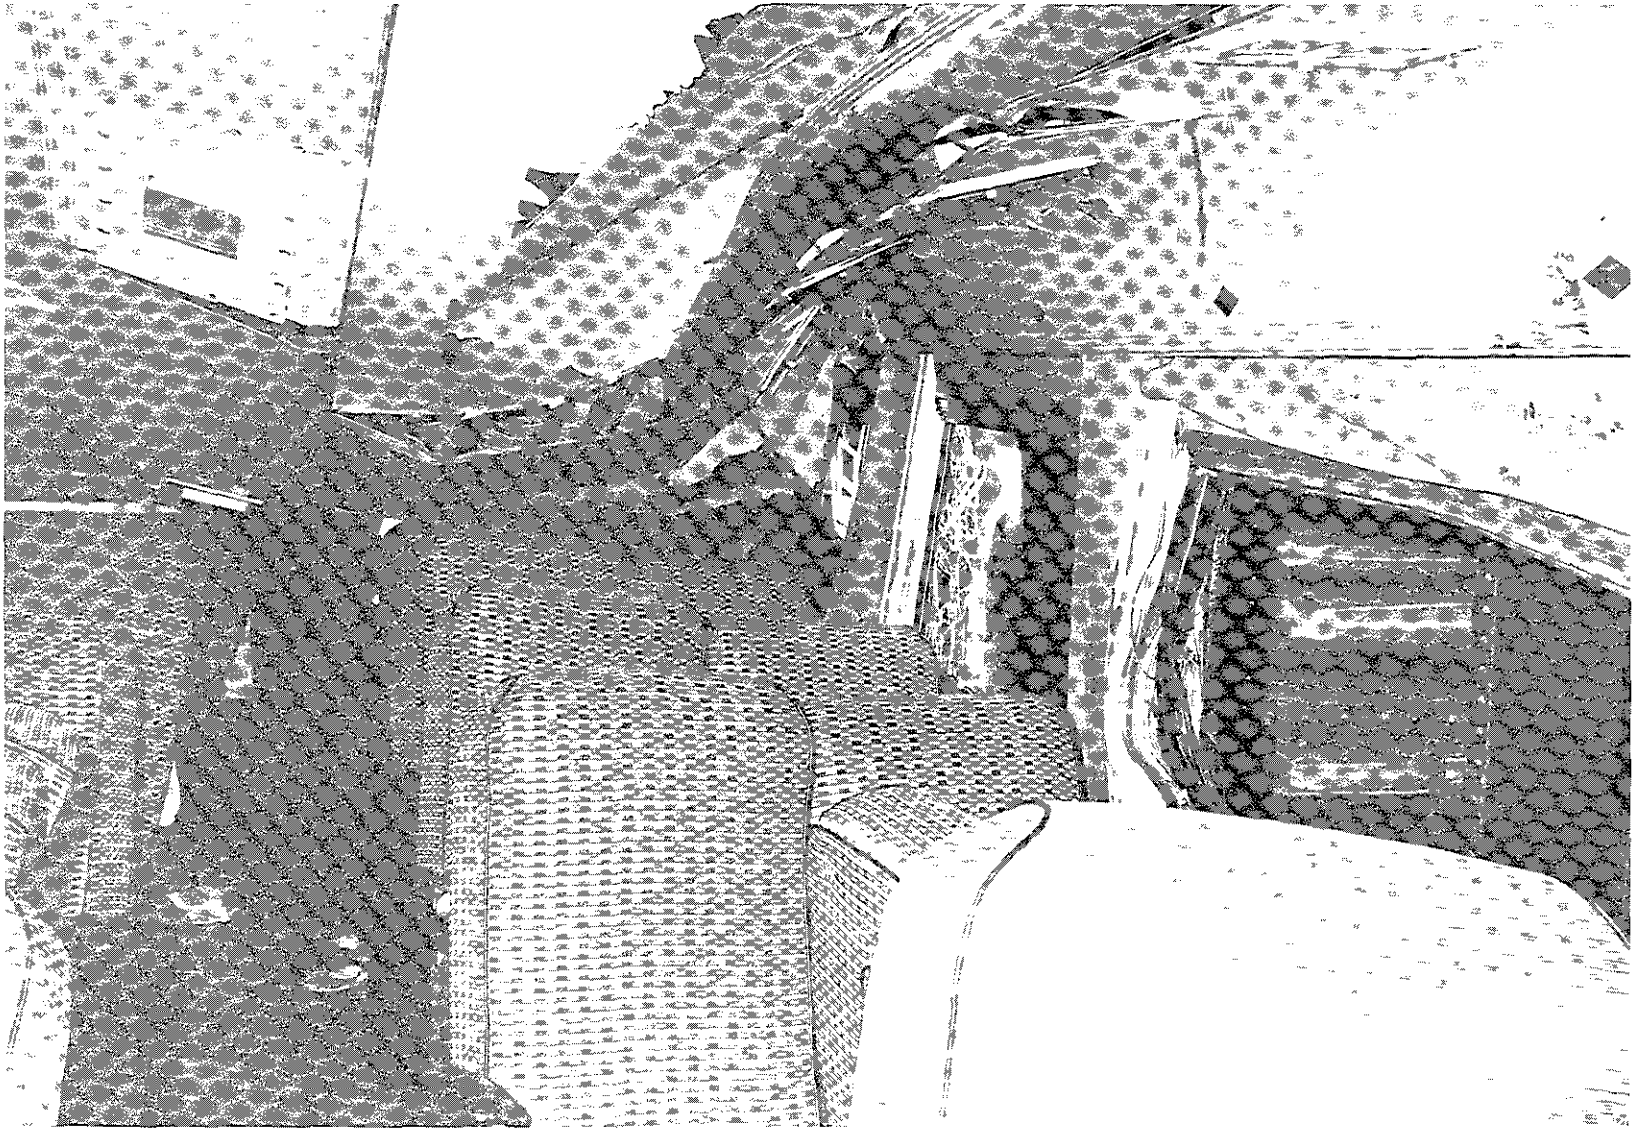
Figure 13.—Separation of metal ceiling which produces sharp edges.

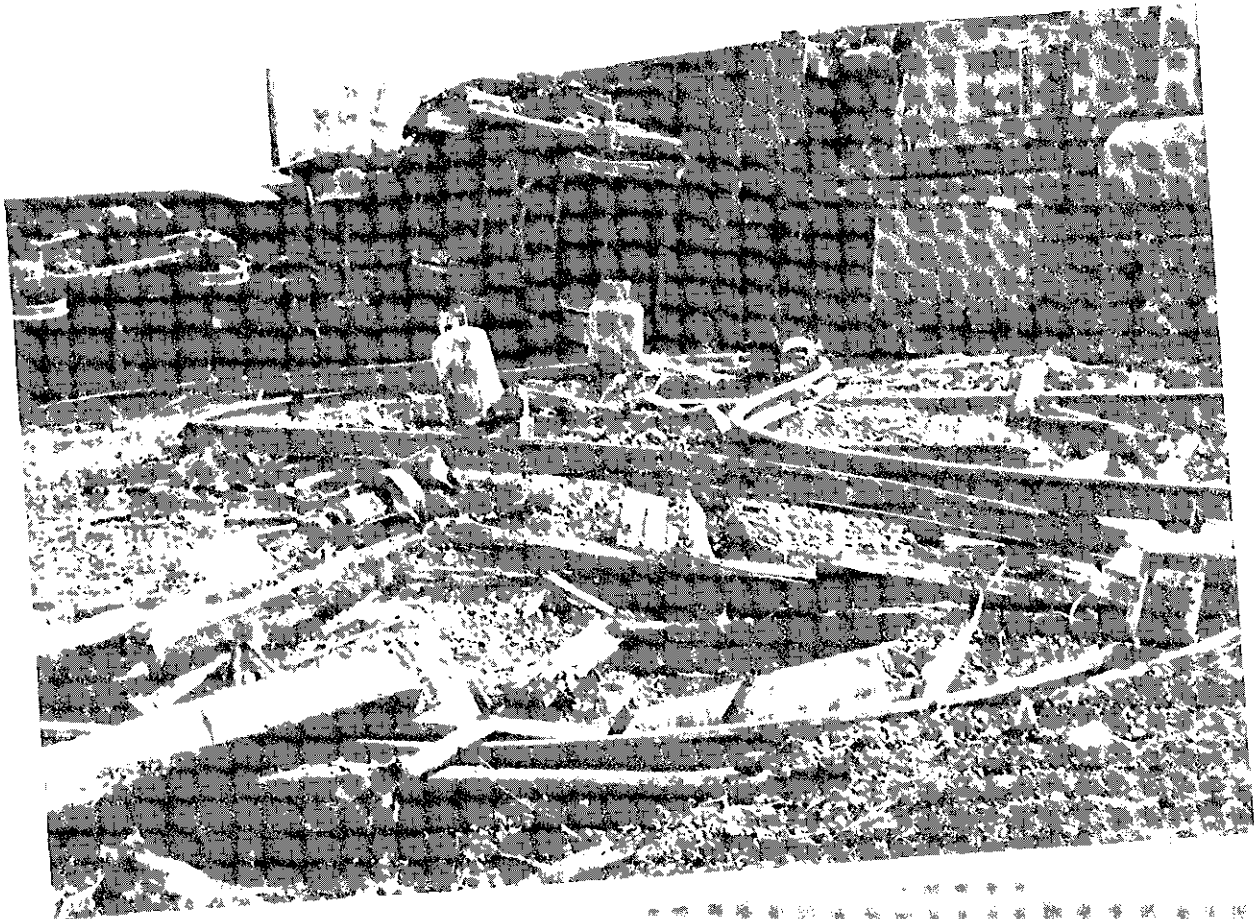
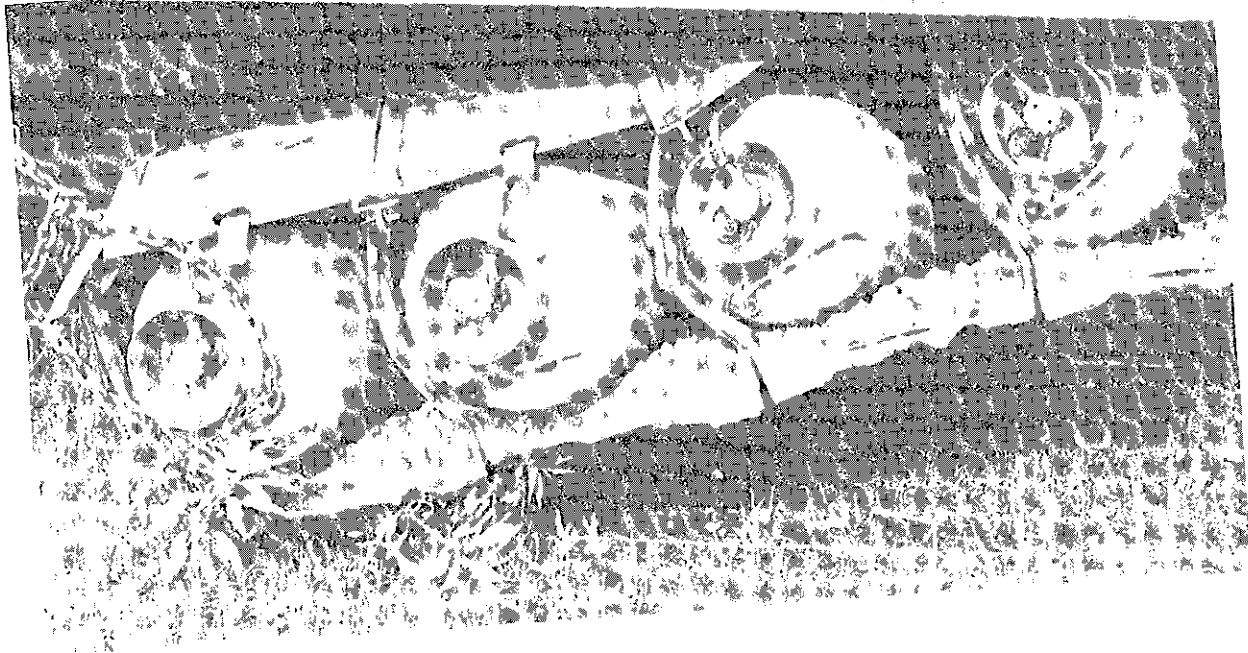
Figure 15 – Views of Damaged Propane Cylinders

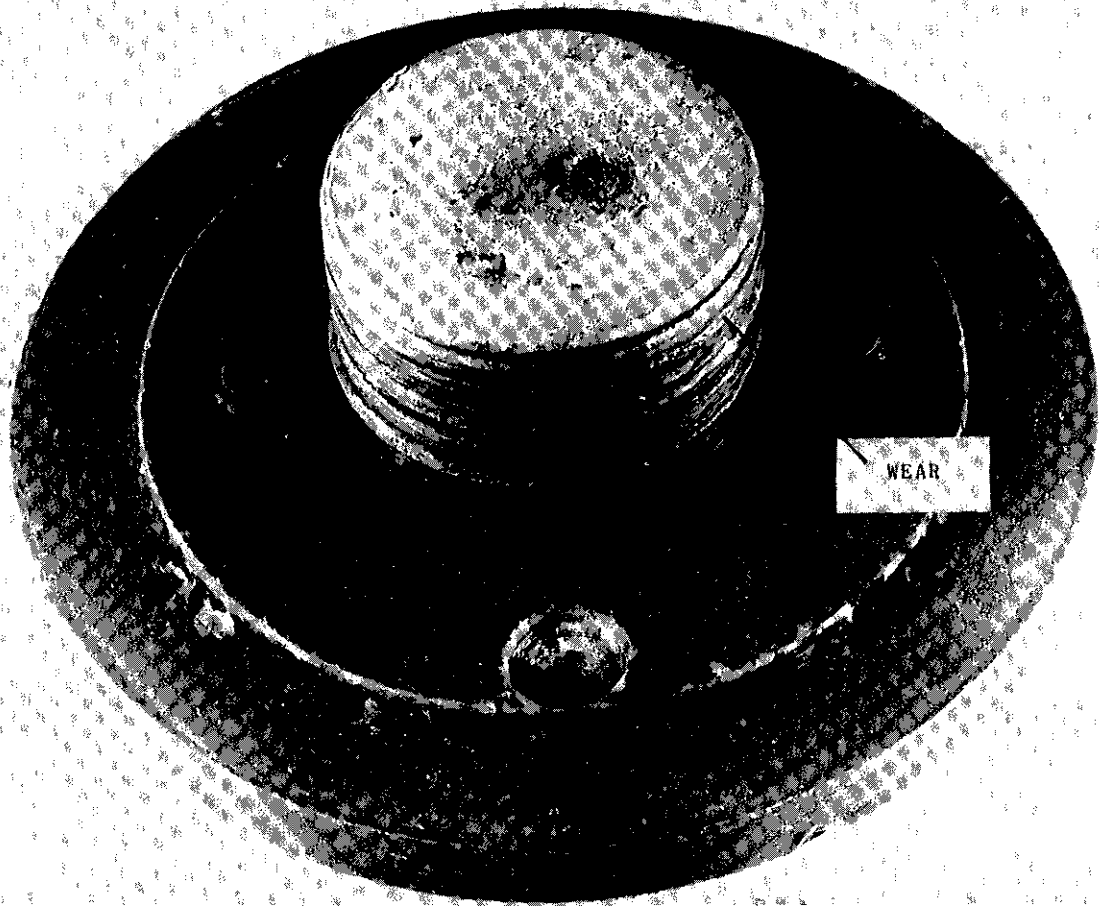
Other parts of the bearing assembly such as the H-ring, the locking plate, and the oil seals and throwers on both bearings showed excessive wear on the parts which would have been affected by excessive lateral movement of the armature toward the pinion end. The H-ring on the commutator end bearing displayed no excessive wear. The end plate which bore against the H-ring indicated evidence of excessive wear where it contacted the end cover only. The end

**Photograph 1D –Inner Face of Locking Plate Showing worn threads and
Lack of wear on outer edge where Plate should Contact H-Ring.**

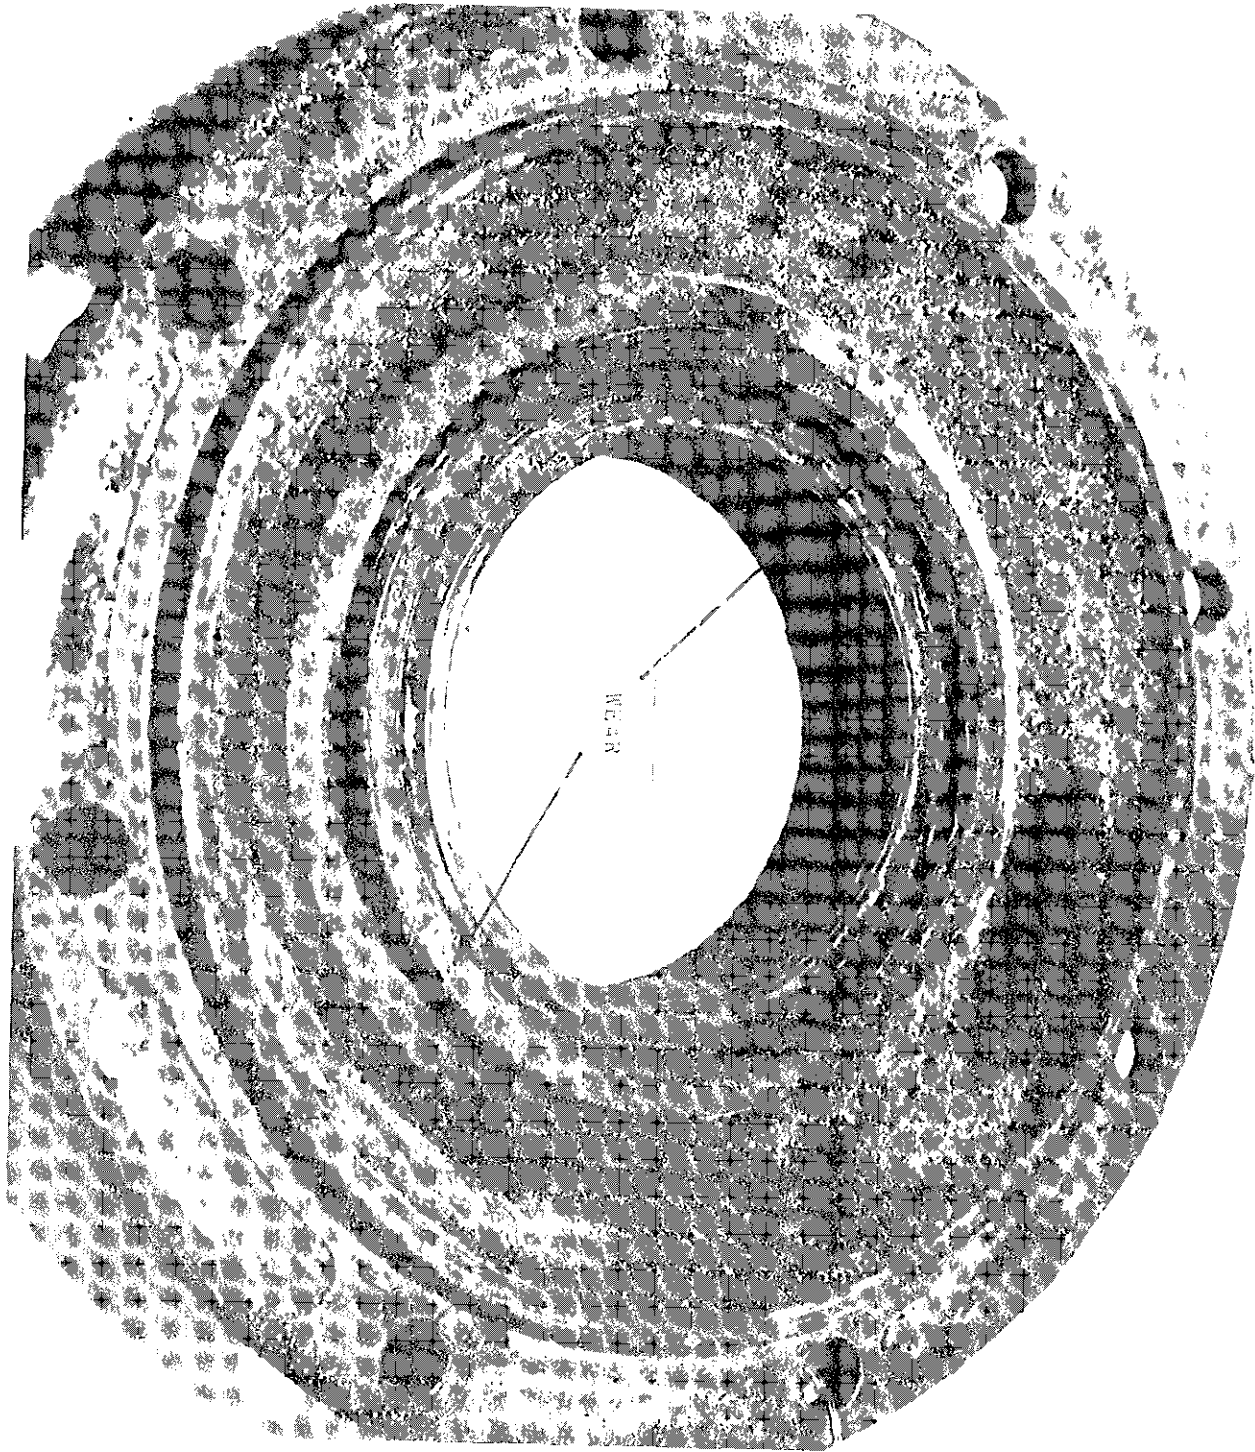
Photograph 2D.—Pinion Bearing End Cover Showing Excessive Wear from Contacting Outer Oil Thrower

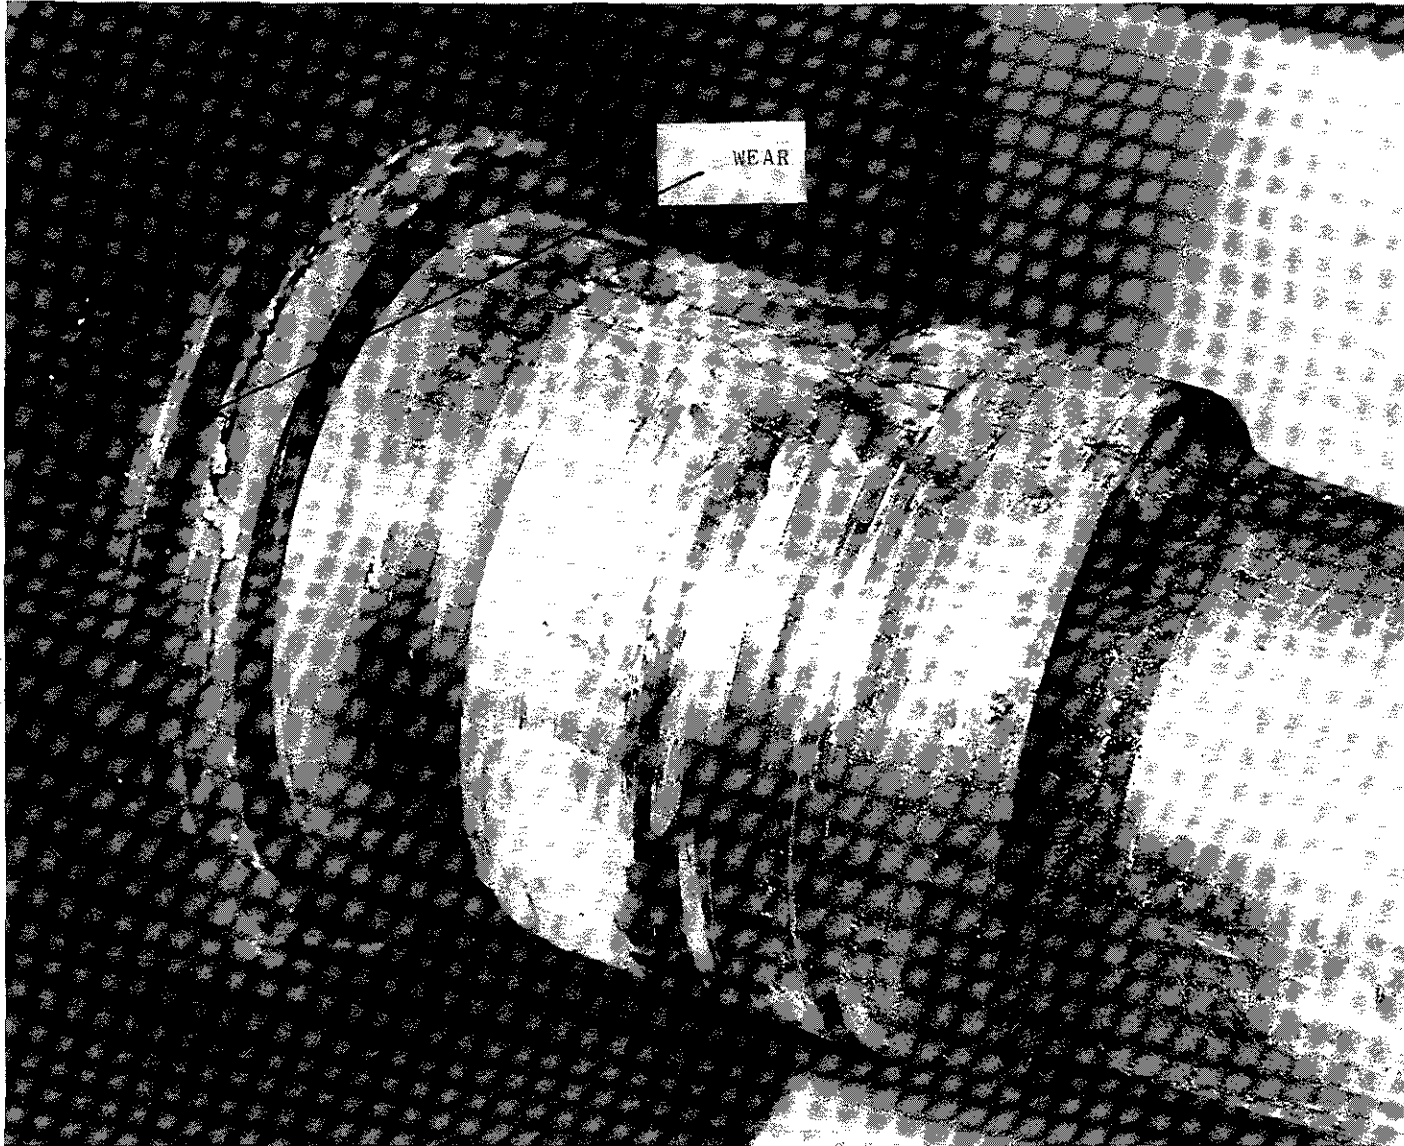
Photograph 3D.—Pinion End of Armature with Bearing Removed, Note Excessive Wear on Oil Thrower

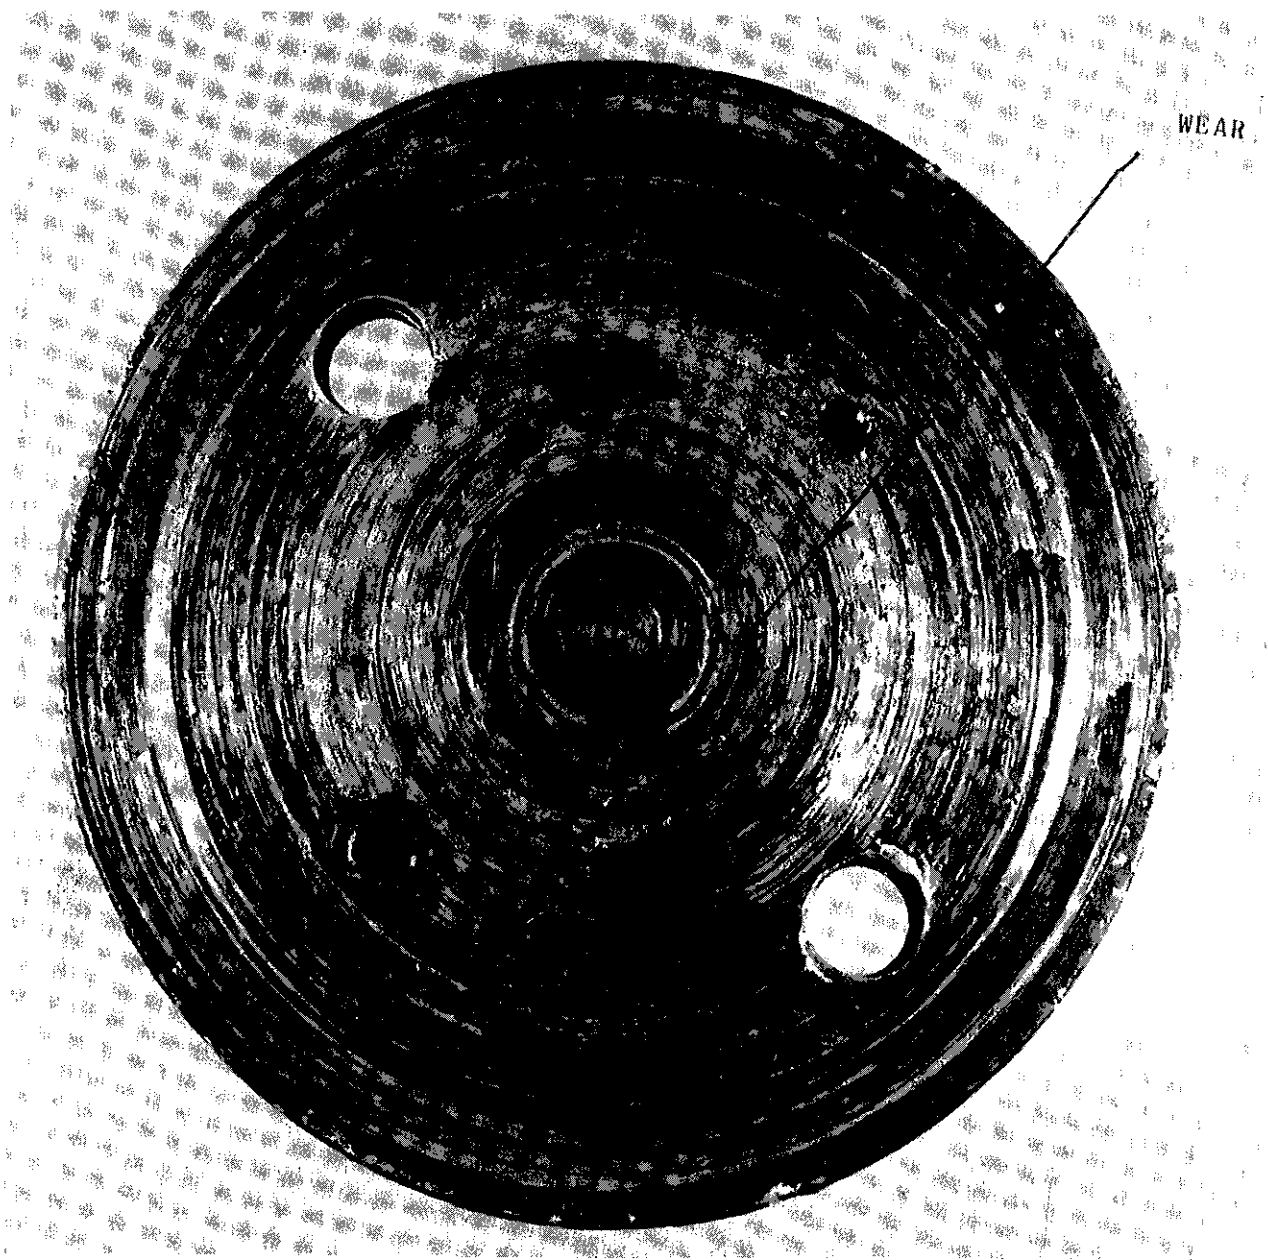
Photograph 5D.—Outside Surface of Locking Plate showing Wear due to Plate Contacting the Commutator Bearing End Cap.
