NATIONAL
TRANSPORTATION
SAFETY
BOARD

RAILROAD ACCIDENT REPORT

AMTRAK TRAIN 87 DERAILMENT
AFTER COLLIDING WITH INTERMODAL TRAILER
FROM CSXT TRAIN 176
SELMA, NORTH CAROLINA
MAY 16, 1994

Adopted: March 21, 1995
Notation 6420A

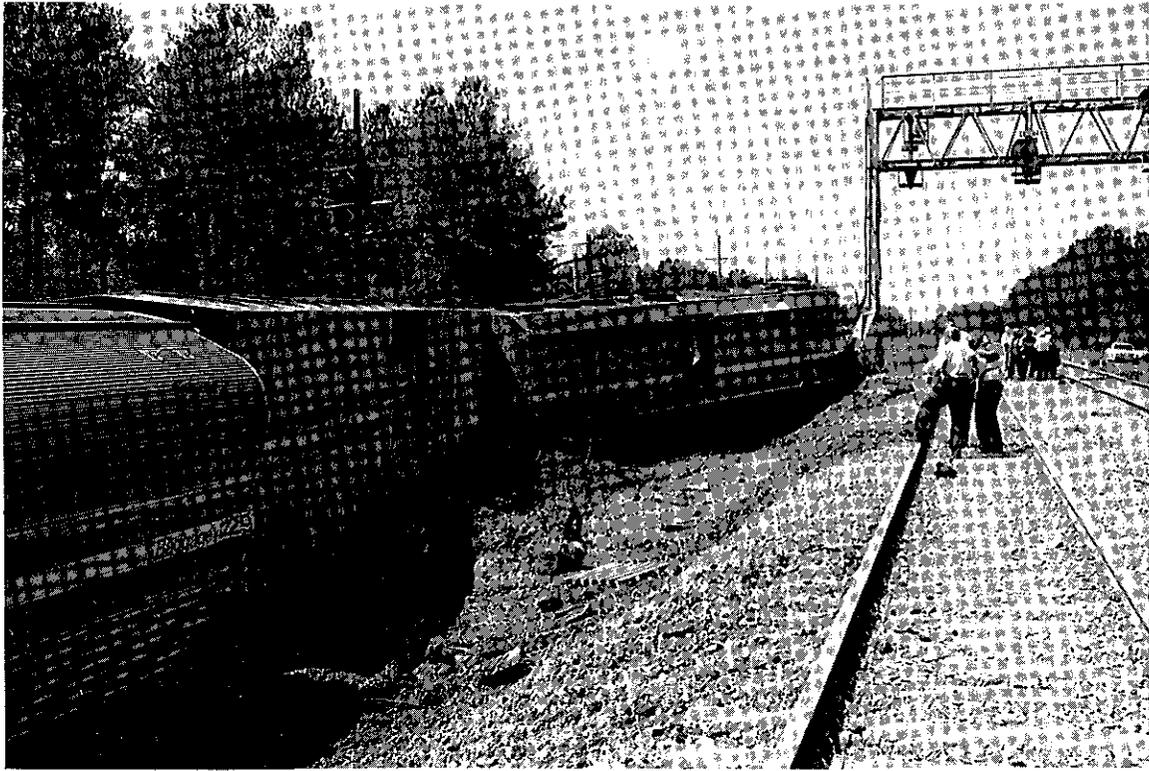
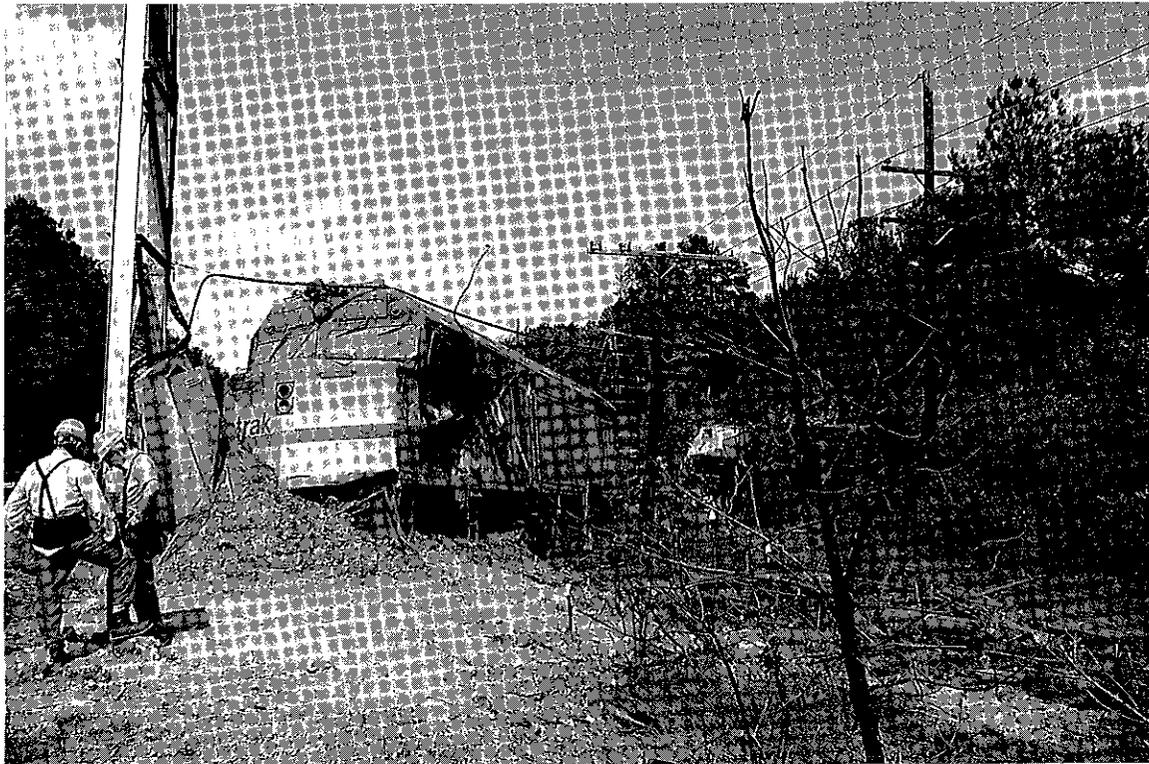
Figure 3. -- View of accident scene.

locomotive fuel tank ruptured during the accident sequence, and fire ignited outside the cab compartment from the spilled diesel fuel. The second unit came to rest east of track 2 against the signal cabinet at the base of a signal bridge. The derailed train had followed the second unit, and most of the derailed cars came to rest in a bog-like area east of track 2. The conductor attempted to call the engineer, received no response, and then contacted the CSXT 176 crew, using a hand-held radio, to summon help. At the same time, an assistant conductor exited the train and used a cellular telephone to contact emergency services.

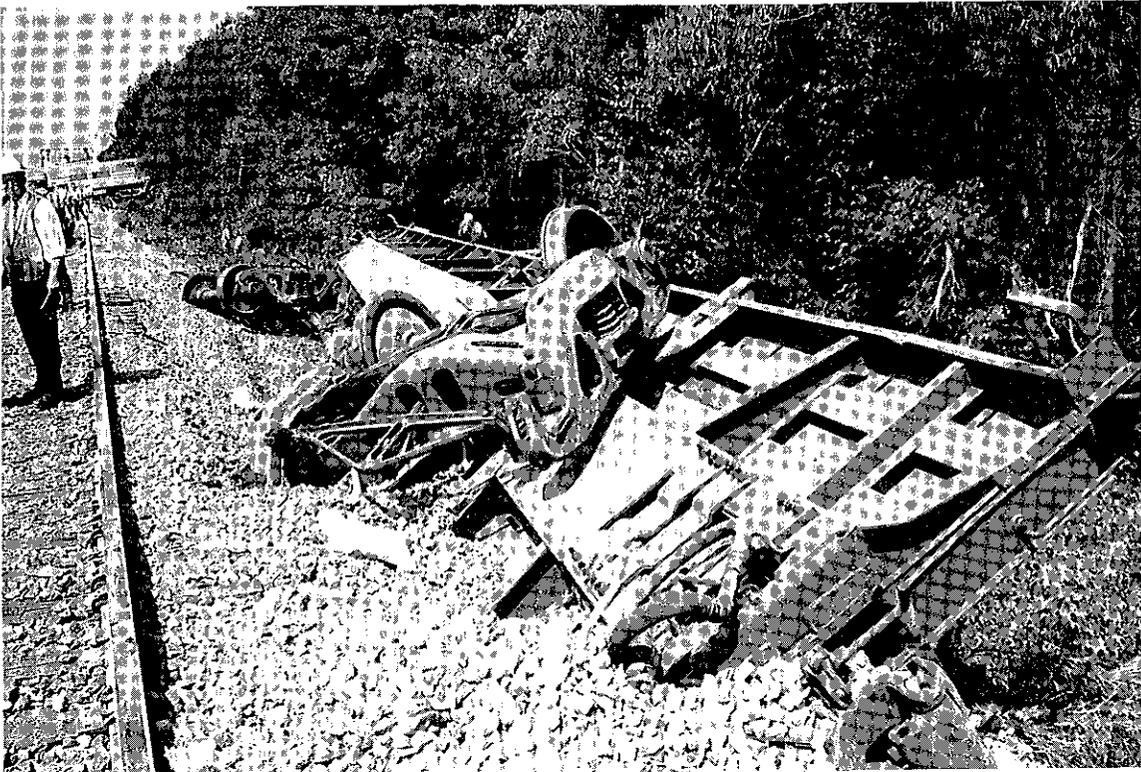
Figure 6. -- Fifty-first car KTTX 251988 of CSXT 176.

Flat car KTTX 251988 was found 40 feet north of the point of impact on its side and angled to the west side of track 1. (See figure 6.) Its A- and B-end were 4 and 24 feet, respectively, from the track. The flat car was righted and examined on-scene. The A-end hitch locking indicator pin was in the open position, and the remains of the second trailer, CSXZ 238848, was still attached to the B-end hitch. On May 17, 1994, Safety Board investigators examined the A-end hitch of KTTX 251988, on which the intermodal trailer REAZ 232980 had been mounted. Shiny marks were found on the front of the "vee notch" of the hitch throat, no other unusual signs of wear were noted. The jaws were closed, and the handle was in the full unlocked position (indicator pin extended about 1 1/4 inches). The hitch, which was laying in the road bed, was completely packed with rock, mud, and debris. The jaws were found in the locked position after the debris and mud were removed, and the hitch handle indicator pin was in the full unlocked position.

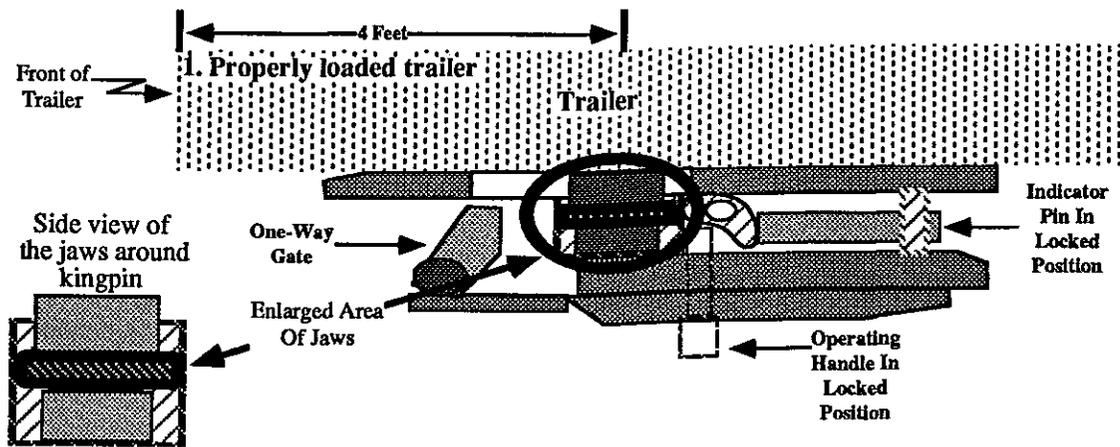
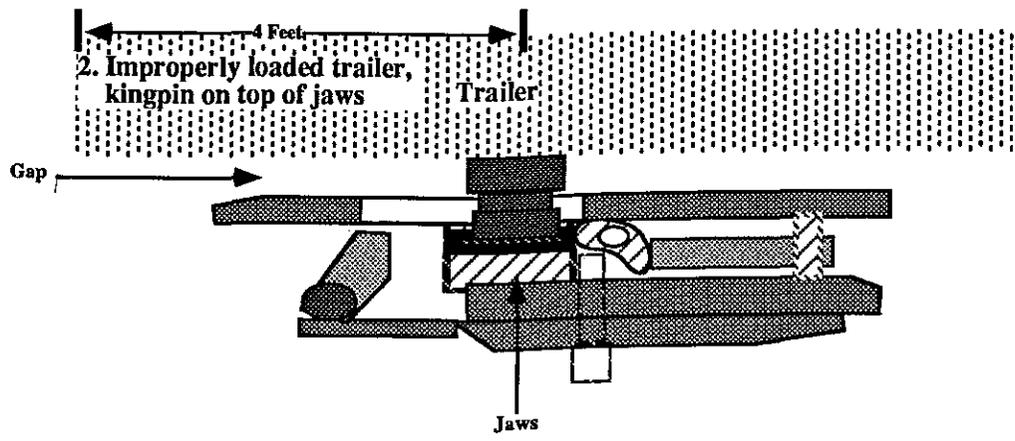
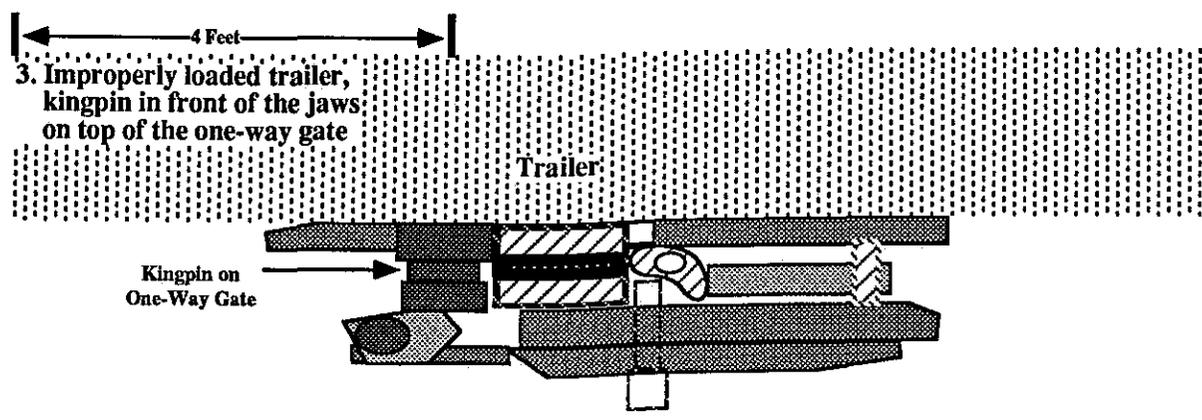
To determine why the kingpin was not locked and properly secured within the locking jaws and its retaining ring when the trailer was loaded, the Safety Board considered three possibilities first, the locking jaws were already closed when the trailer was loaded, second, a mislock could have occurred, and finally, a combination of the previous two possibilities. (See figure 9)

Figure 9. -- Side views of trailer locked and mislocked on an intermodal hitch.

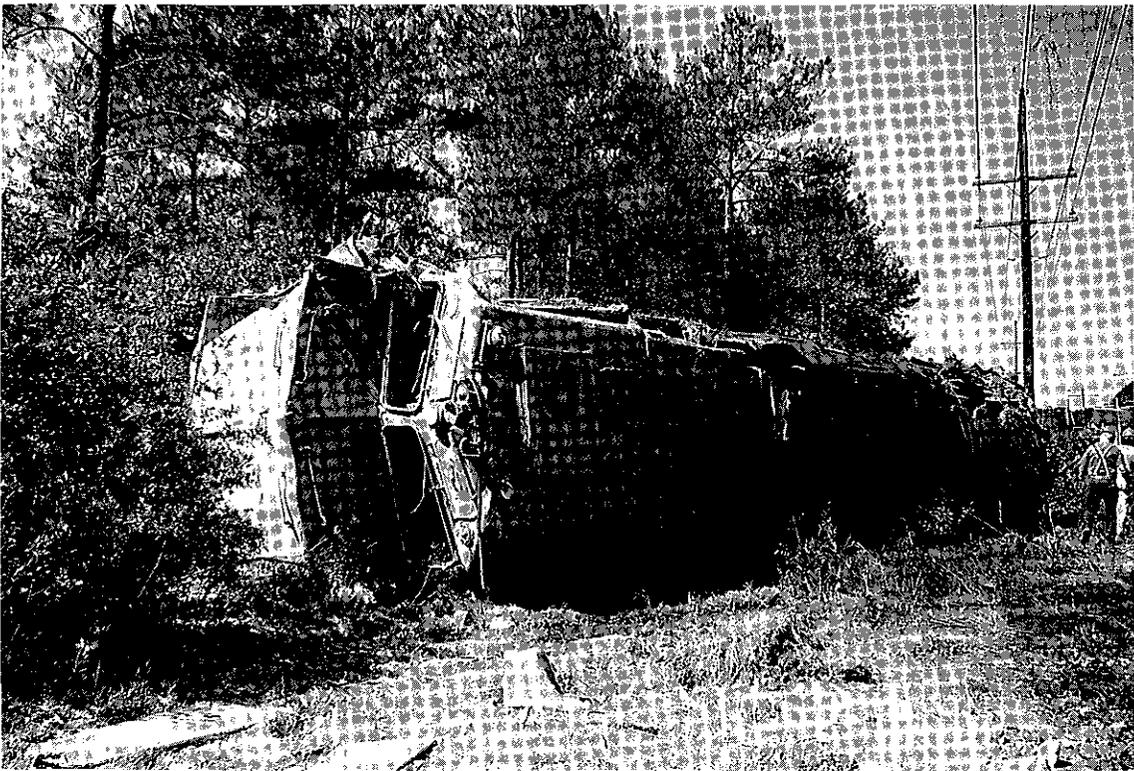
The lead unit front hood showed contact damage from the right front corner extending inward toward the center line for 9 inches. The sheet metal that covered the right side of the front hood and the control compartment was torn and collapsed inward 1.5 feet. All windows, except on the left side of the control compartment, and both windshields were missing. The seats for the engineer and the assistant engineer had separated from their attachment points. The automatic brake and the emergency valve levers were found in the emergency position.

In the Selma accident, the Amtrak train 87 assistant engineer was killed and the engineer was severely injured within the locomotive operating compartment as the unit derailed and overturned (See figure 10.) The Safety Board could not conclude whether the death and the severe injury were caused by impact with the trailer, striking or being struck by objects within the operating compartment, or a combination of both. However, after examination of the control compartment interior, Safety Board investigators noted that the radio bracket, as positioned, was a potential contact-injury producing mechanism. Amtrak is removing, as a precaution, all radio brackets from its locomotive control compartments.

Figure 10. -- Lead unit of Amtrak train 87 locomotive at accident scene.
