RAILROAD ACCIDENT REPORT

DERAILMENT OF
AMTRAK PASSENGER TRAIN NO. 21
ON THE ILLINOIS CENTRAL GULF RAILROAD
SPRINGFIELD, ILLINOIS
OCTOBER 30, 1980

NTSB-RAR-81-5

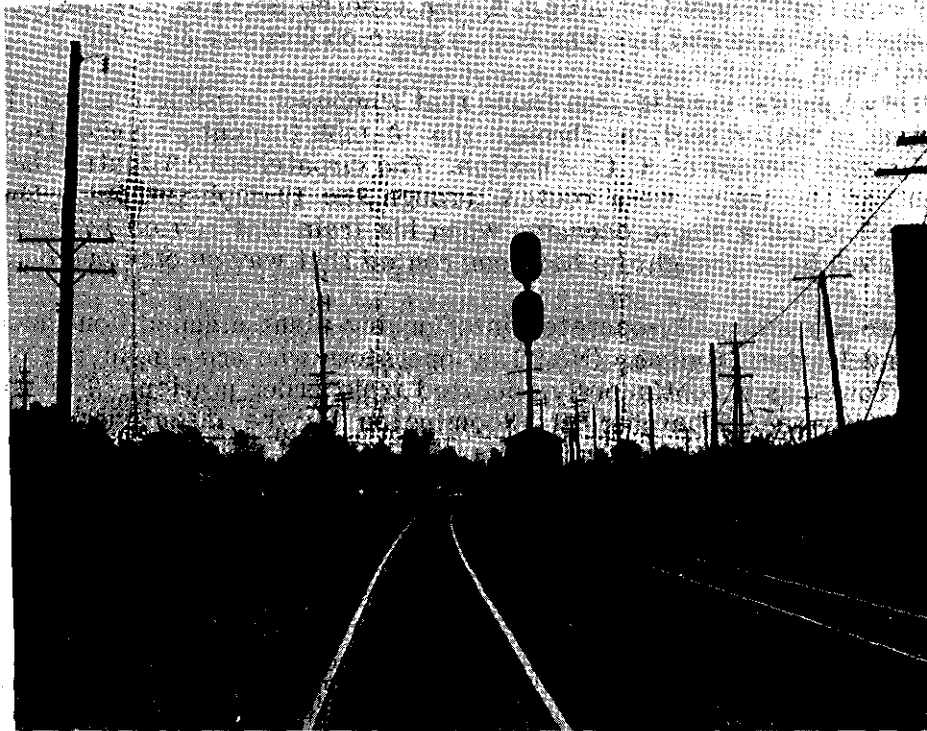
Figure 1.--View from southbound train approaching the home signal and tower at Iles. Iles Avenue crossing is beyond the tower.

The most critical event that preceded the accident was the failure of No. 21's engineer and fireman to observe and comprehend the aspect displayed by the home signal at Iles Tower. This aspect should have indicated to them the route their train was to take at K. C. Junction. Had the signal displayed a green-over-red "clear" aspect to take the straight route, as they supposed, they could pass through K. C. Junction as fast as 79 mph. However, if the signal displayed a yellow-over-green "approach limited" aspect, the train's speed would have to be reduced to 10 mph to permit entering the turnout to track No. 2.

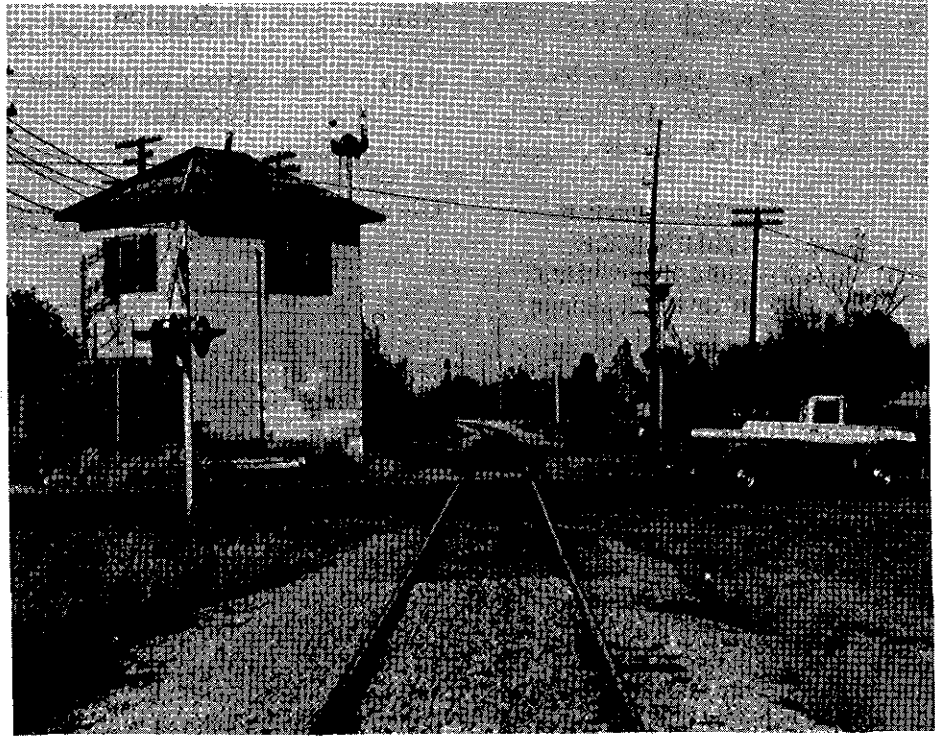
On October 31, 1980, Safety Board investigators observed traffic over the Iles Avenue crossing between 8:00 p.m. and 9:00 p.m. During this period, the flow of vehicles was virtually constant in both directions with traffic frequently stopping on the crossing due to congestion at intersections east and west of the crossing. Subsequent observations revealed that many motorists ignored the flashers and bell as well as the warning whistles of trains approaching the crossing. (See figure 2.)

Figure 2.—Alton Division main track viewed facing north, showing southbound approach to N&W crossing and Iles Tower. Iles Avenue crossing is in the foreground.

Ultimately, ICG retired the northward main track from Iles to Ridgely Yard. Had the southward main track between the same points been retired instead, southbound engineers would have had the ability to see from a greater distance the home signals at Iles and K. C. Junction, the train order signal at Iles, and the Iles Avenue crossing. Realigning Iles Avenue to the south only made the engineers' view of the crossing more restricted than before. Removal of the crossing gates also contributed to the hazardous nature of the Iles Avenue crossing.

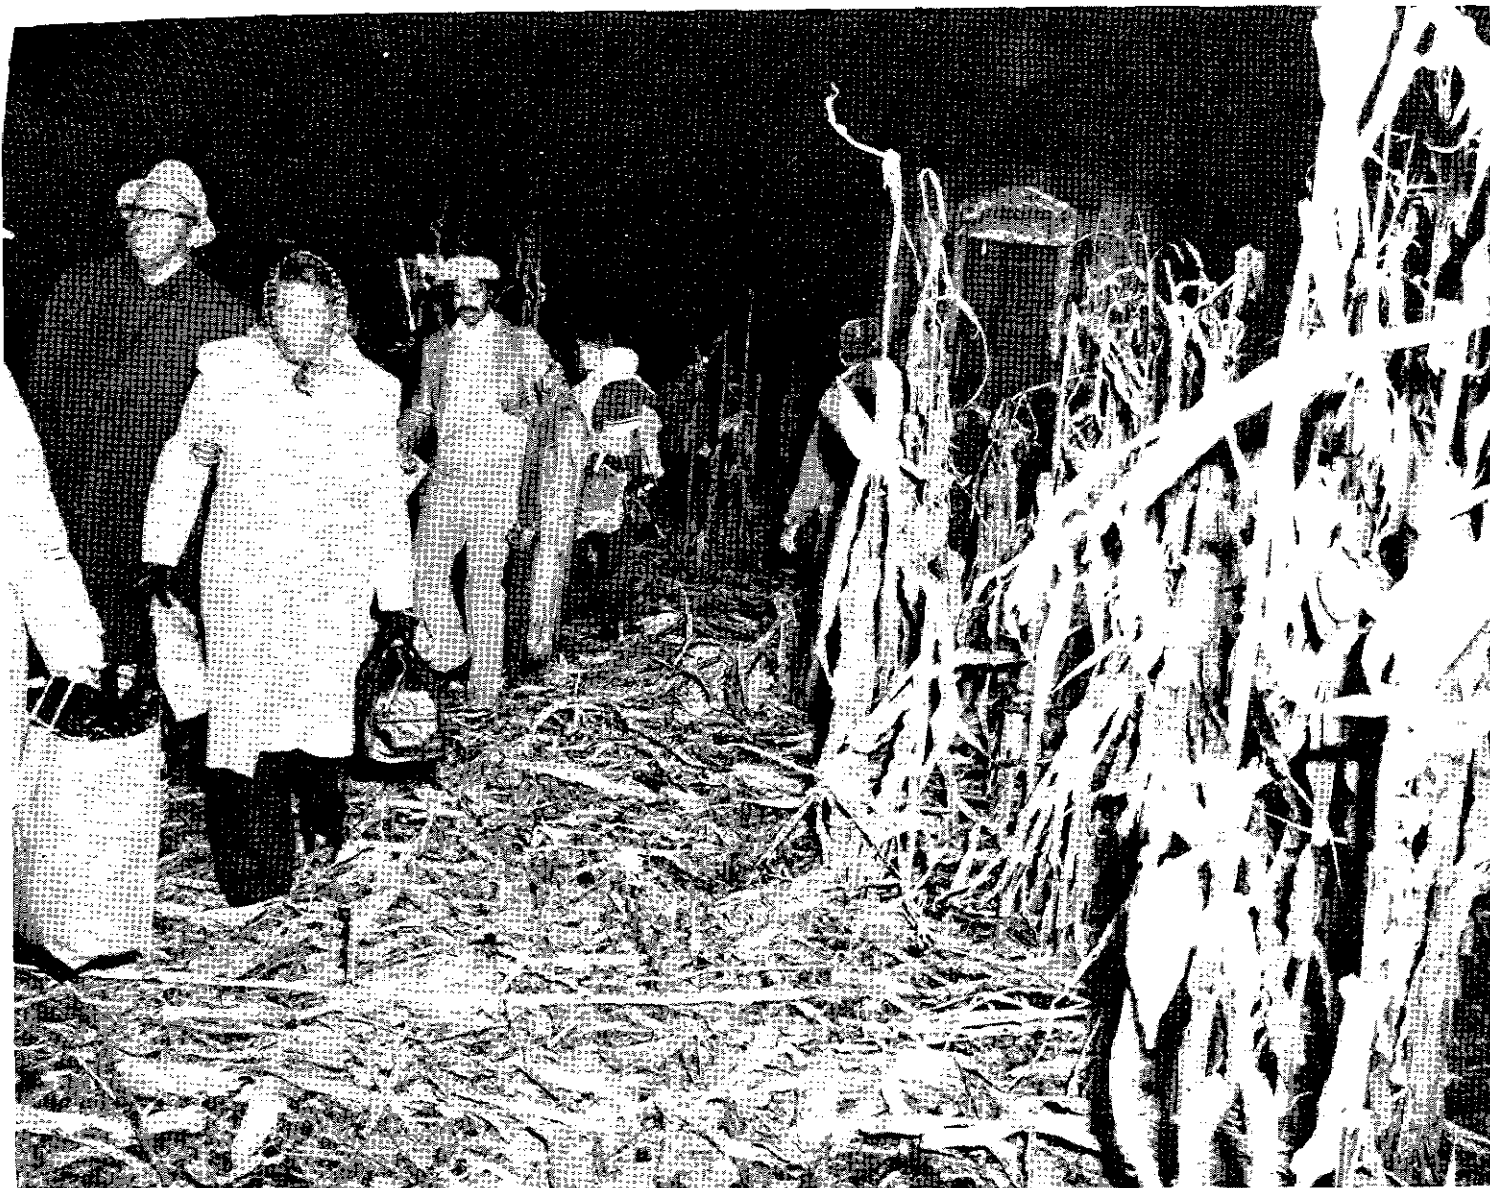
Figure 4.—Passengers of Amtrak No. 21 during the evacuation from the derailment area.

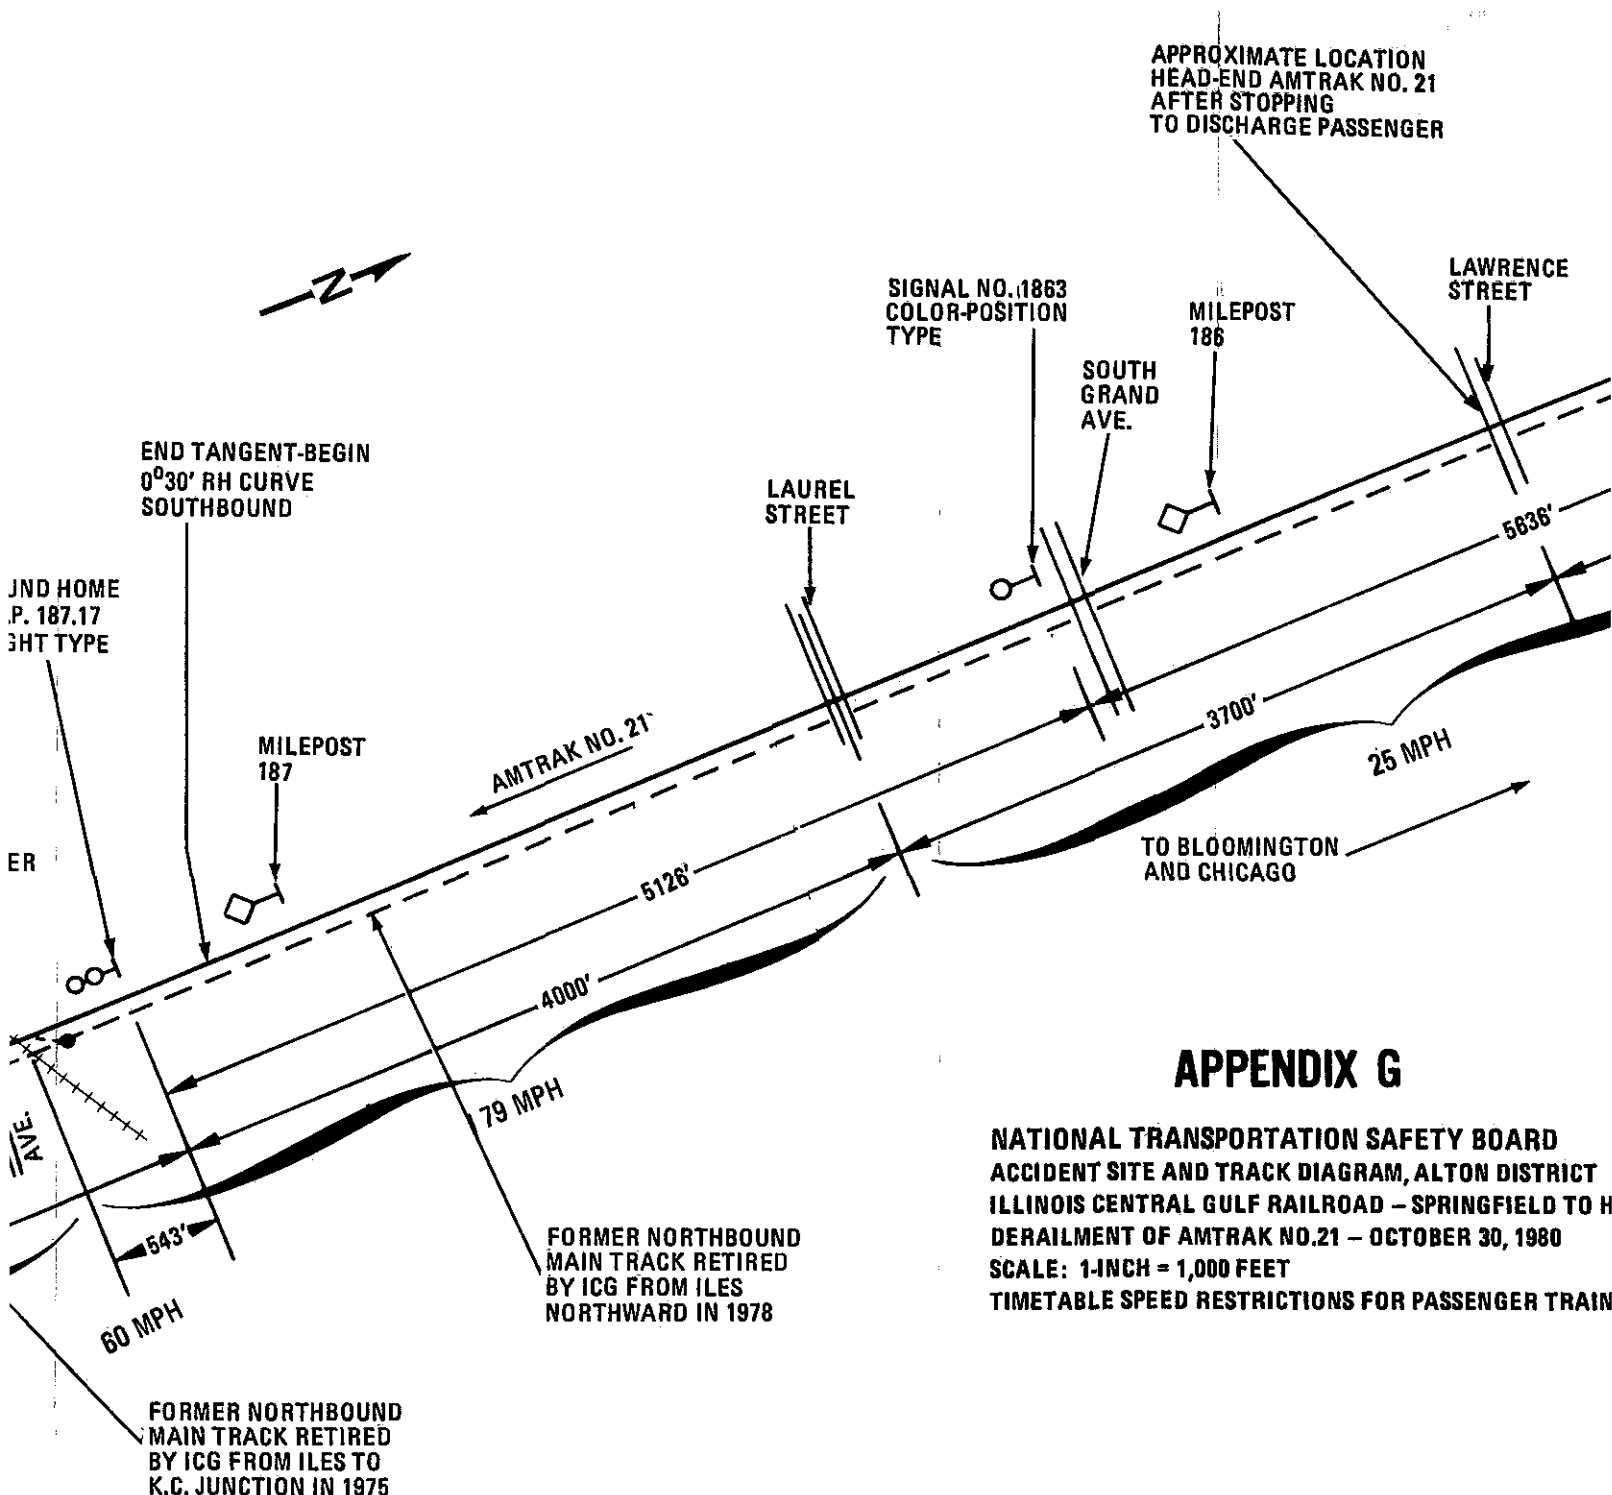
APPENDIX G

NATIONAL TRANSPORTATION SAFETY BOARD
 ACCIDENT SITE AND TRACK DIAGRAM, ALTON DISTRICT
 ILLINOIS CENTRAL GULF RAILROAD - SPRINGFIELD TO H
 DERAILMENT OF AMTRAK NO.21 - OCTOBER 30, 1980
 SCALE: 1-INCH = 1,000 FEET
 TIMETABLE SPEED RESTRICTIONS FOR PASSENGER TRAIN

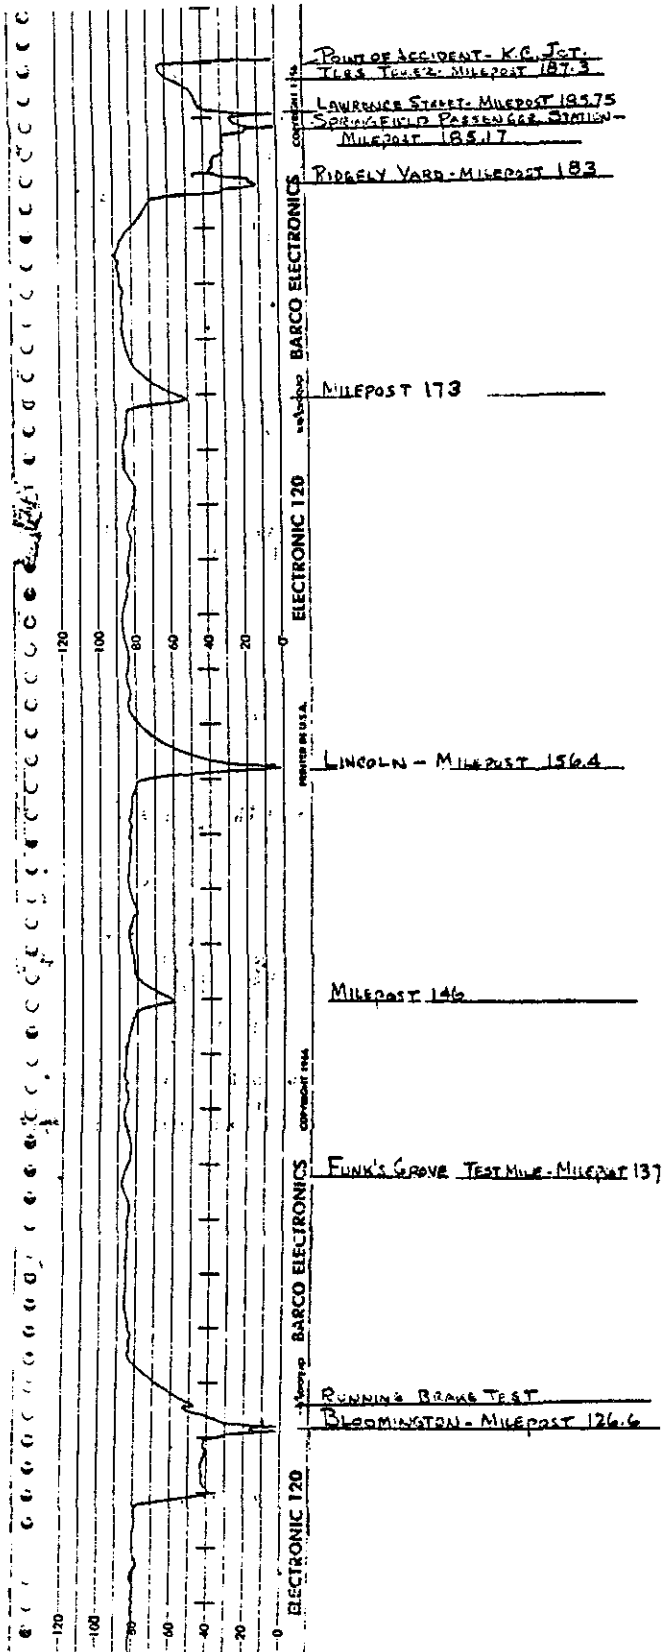
LOCOMOTIVE SPEED RECORDER TAPE
REMOVED FROM AMTRAK NO. 21

Following the accident, the speed recorder and speed indicator were calibrated on the basis of an actual wheel diameter of 39.31 inches. It was disclosed that speed was recorded at a rate 2 mph greater than actual speed up to 70 mph; 1 mph greater than actual speed from 80 to 95 mph; and at the correct rate at 100 mph. It was also found that speed was indicated at a rate of 1 to 1 1/2 mph slower than actual speed at virtually all speeds. When the train was traveling at an actual speed of 80 mph, the needle of the speed indicator would be at 79 mph and the speed being recorded on the tape would be 81 mph.
