NATIONAL TRANSPORTATION SAFETY BOARD

RAILROAD ACCIDENT REPORT

DERAILMENT OF
AMTRAK TRAIN NO. 21 (THE EAGLE)
ON THE MISSOURI PACIFIC RAILROAD
WOODLAWN, TEXAS
NOVEMBER 12, 1983

NTSB/RAR-85/01.

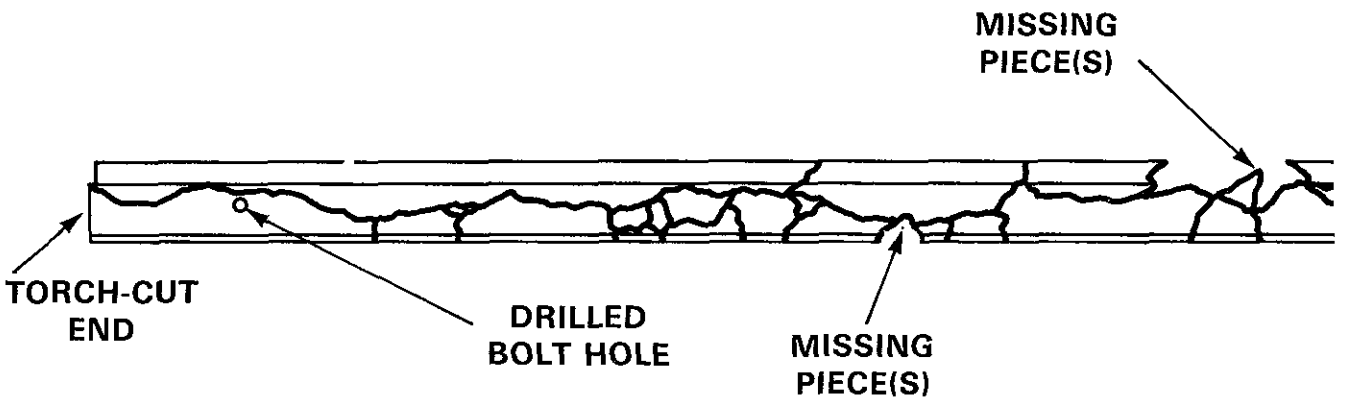
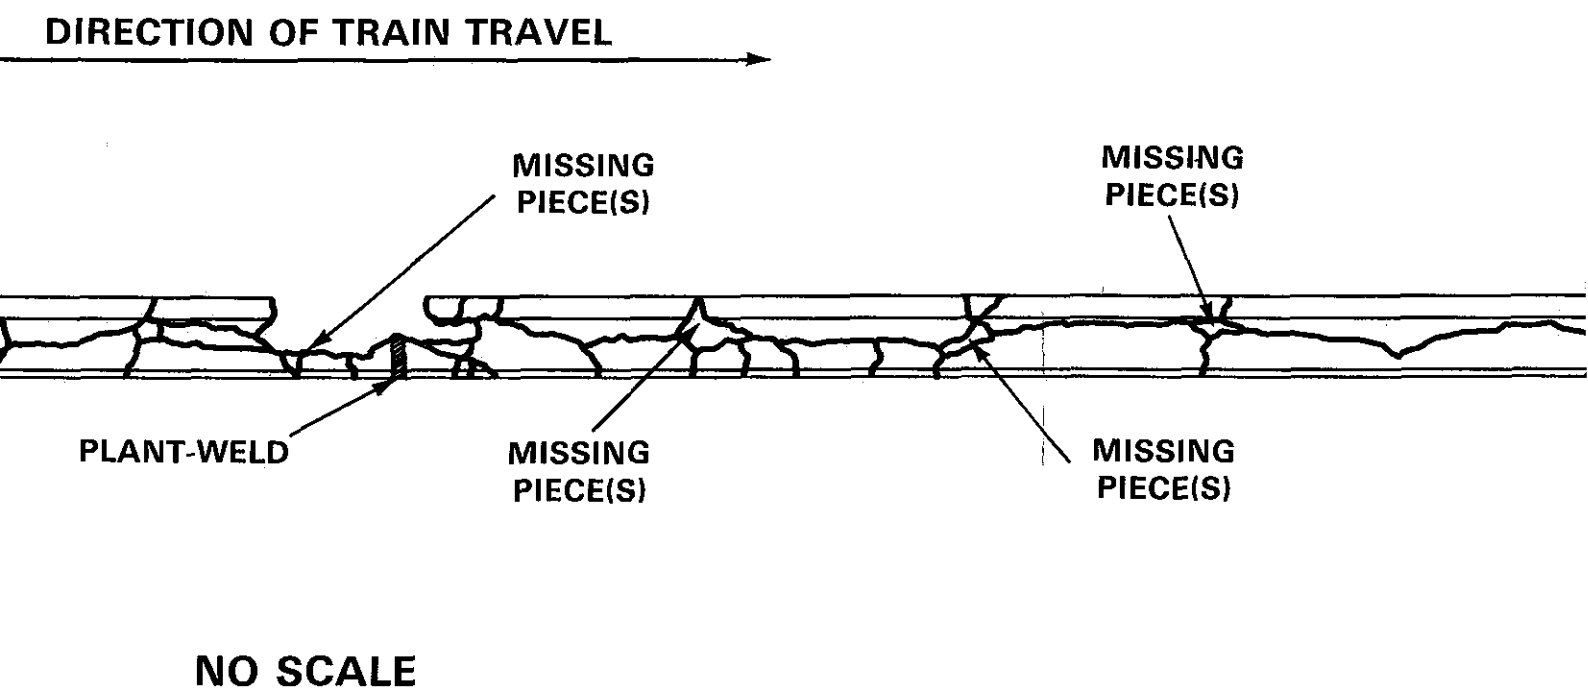
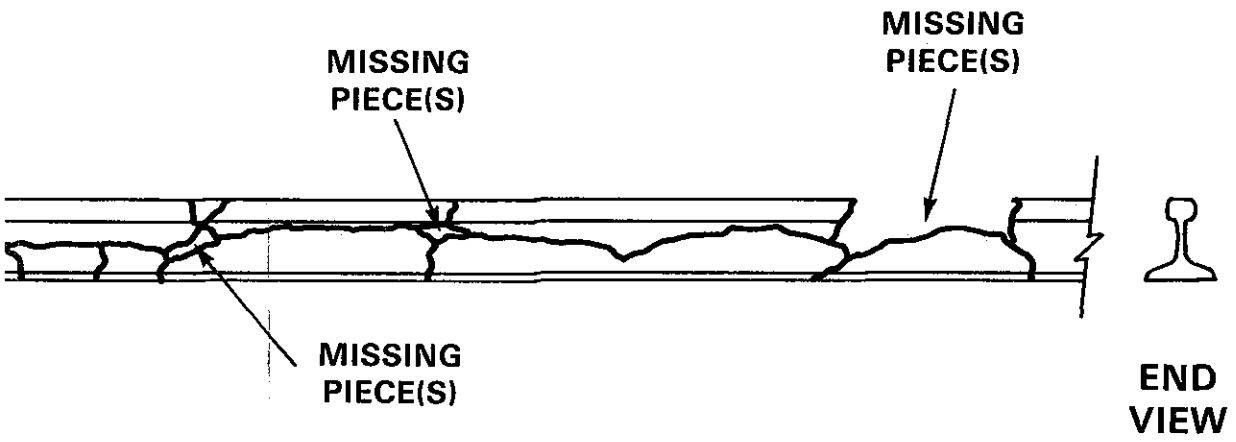
4.- Rail fracture diagram.

Initial onsite examination of the chrome-vanadium alloy rail indicated the presence of a small crack in the web of the rail at a discontinuity in the torch-cut face near where the alloy rail was bolted to the south end of the standard-carbon insert. The break appeared to extend from that discontinuity through the web a distance of about 6 feet. Within the next 34 feet approximately, the rail was broken into between 50 and 100 pieces of various size.

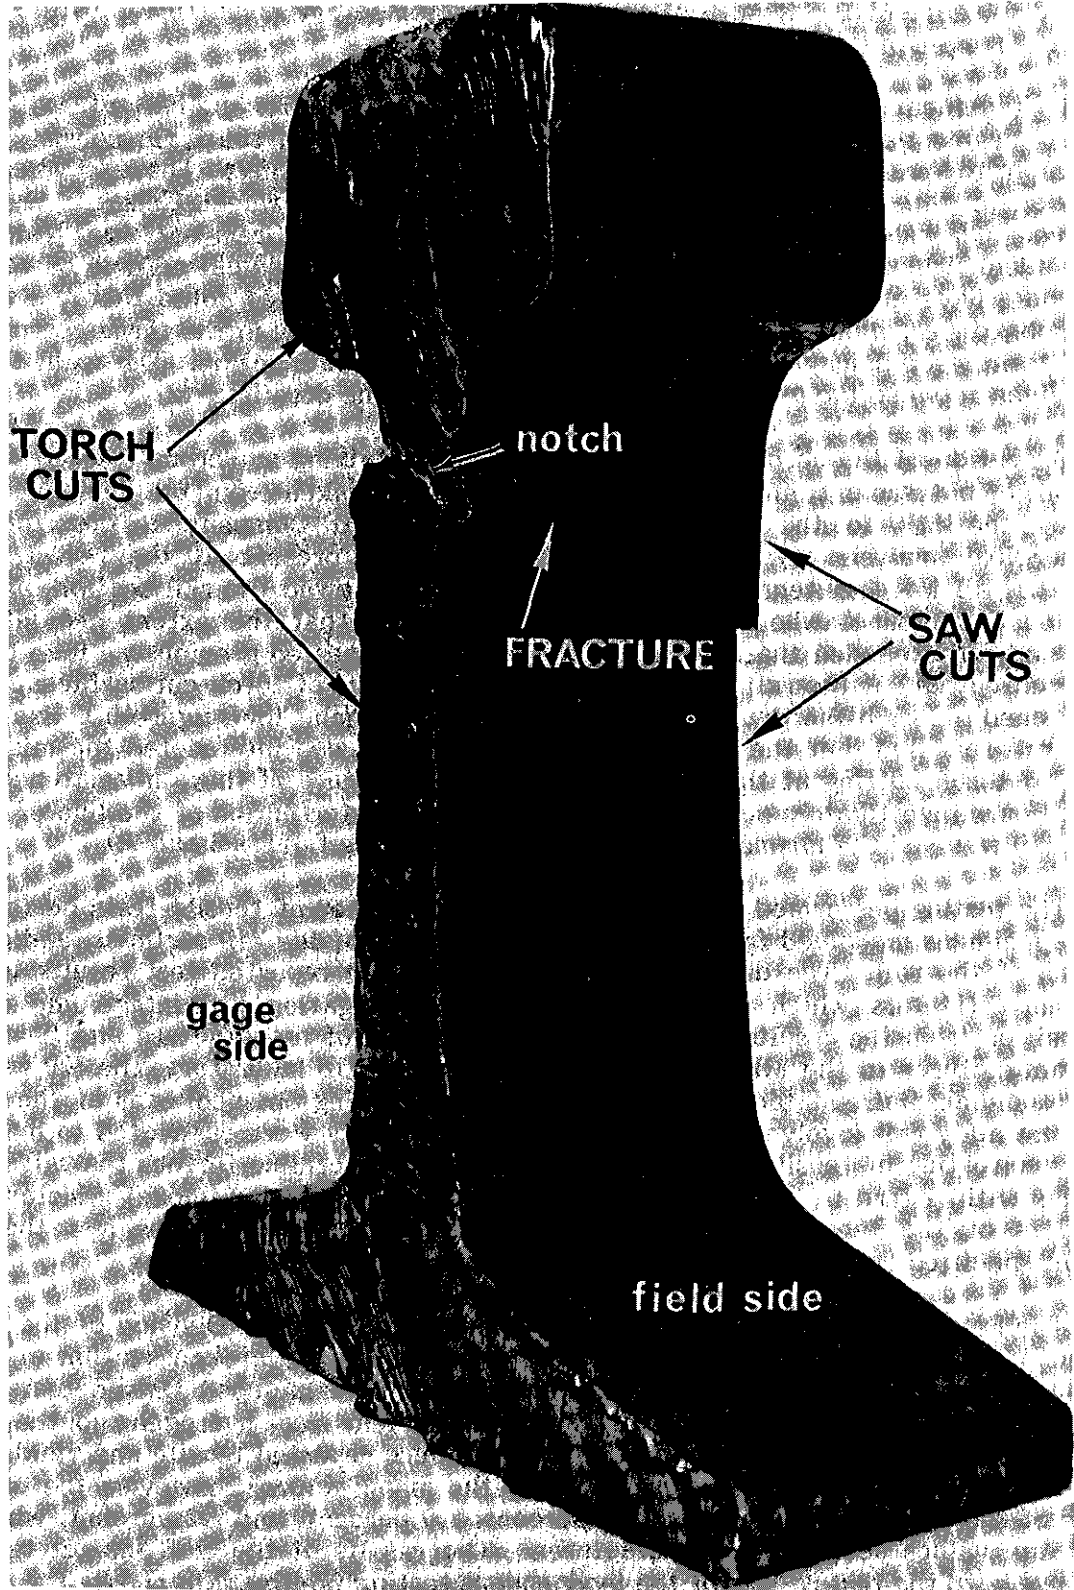
A section of the chrome-vanadium alloy rail containing numerous fractures, several locations of batterment, and the torch-cut rail end was taken from the accident site and sent by the MP to the Union Pacific (UP) Railroad Company testing facility for metallurgical analysis. ^{11/} Safety Board investigators present at the testing facility noted that all MP maintenance-of-way personnel who viewed the rail section, as well as the UP lab personnel who viewed the section, stated that the extent and manner of fracturing far exceeded that which any of them had witnessed previously. (See figure 4.) The torch-cut end of the rail displayed mismatched planes of torch-cut surfaces, with the mismatched planes offset by approximately one-eighth inch. (See figure 5.) Examination of the rail revealed that the line of fracture in the rail web intersected the mismatched planes of torch-cutting at the notch located at the juncture of those mismatched planes. Safety Board investigators noted thermal cracks at the intersection of the line of fracture in the rail web and the mismatched torch-cut planes. (See figures 6 and 7.)

Figure 5.--View of torch-cut rail end of chrome-vanadium alloy rail after the accident. The transverse saw cuts were made after the accident to separate the rail end pieces from the remainder of the rail.

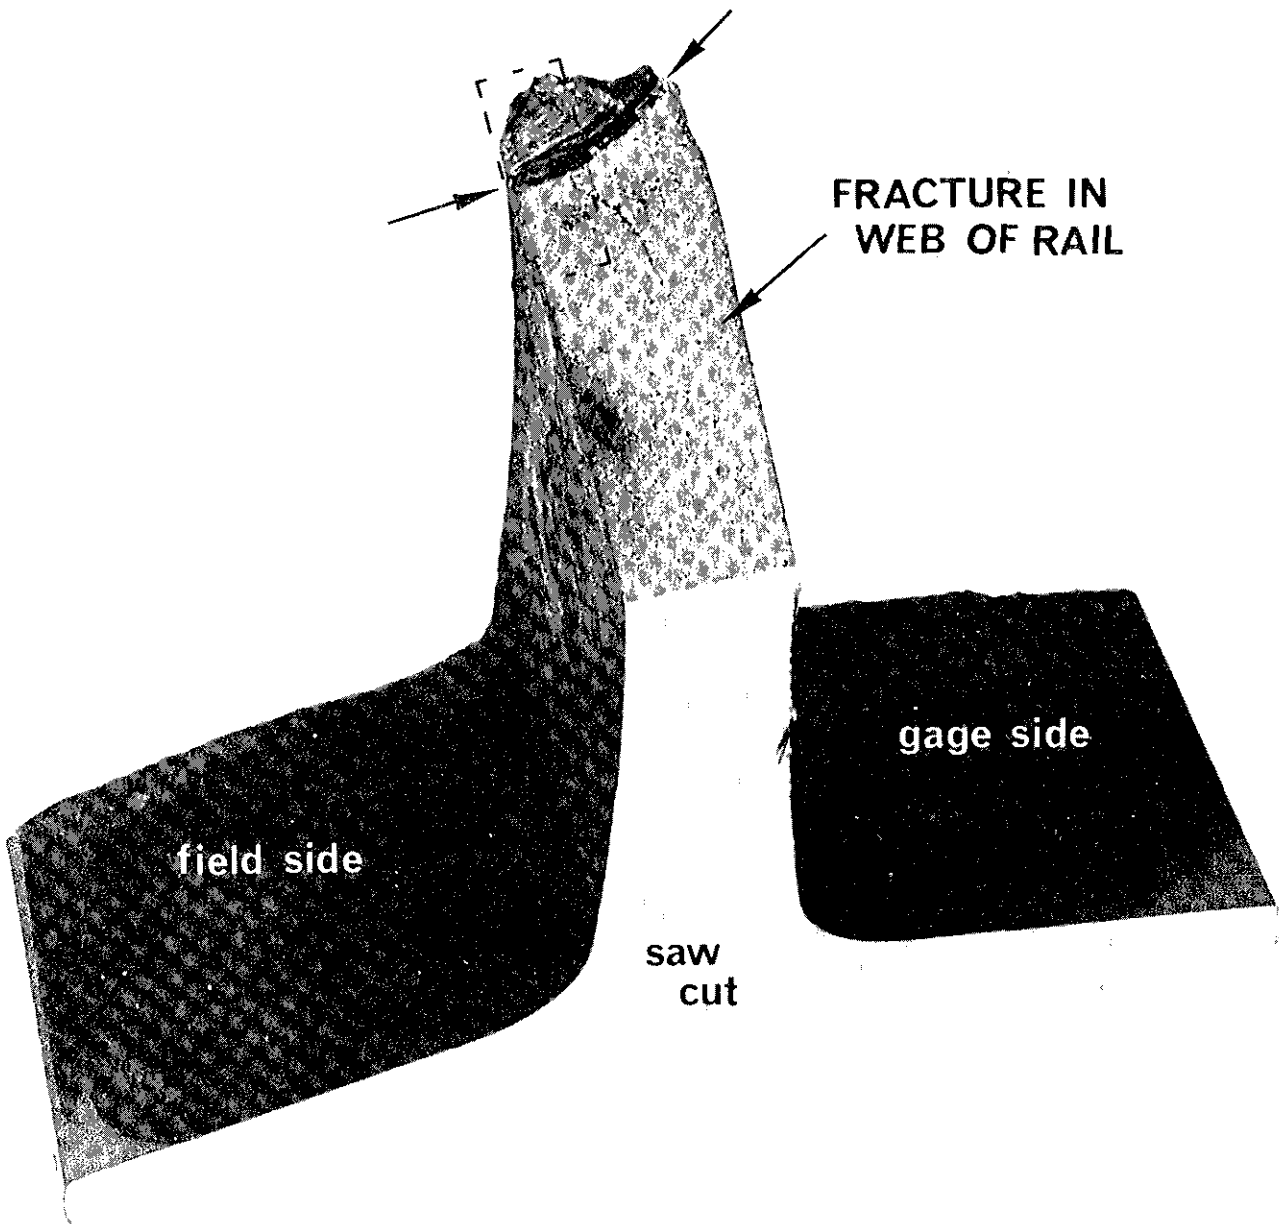
Figure 6.--View looking down on web fracture in lower portion of torch-cut rail end shown in figure 5. The arrows indicate the bottom of the notch created by the torch-cutting. The outlined area is shown in figure 7.

the rail web; the thermal crack at the torch-cut rail end probably served as the crack origin. The freight train which passed at 9:30 a.m. probably negotiated the temporary track repair successfully only because of its slower speed and resultant lower impact forces imposed on the rail joint. Further, recent tests performed by the AAR at its metallurgical testing facility indicate that the crack arrest characteristics of chrome-vanadium alloy rail are such that cracks travel four to eight times farther before arrest occurs, compared to standard carbon rail. It is therefore extremely unlikely that a crack which had initiated under the freight train could have existed without the rail fracturing severely until the passing of the passenger train.

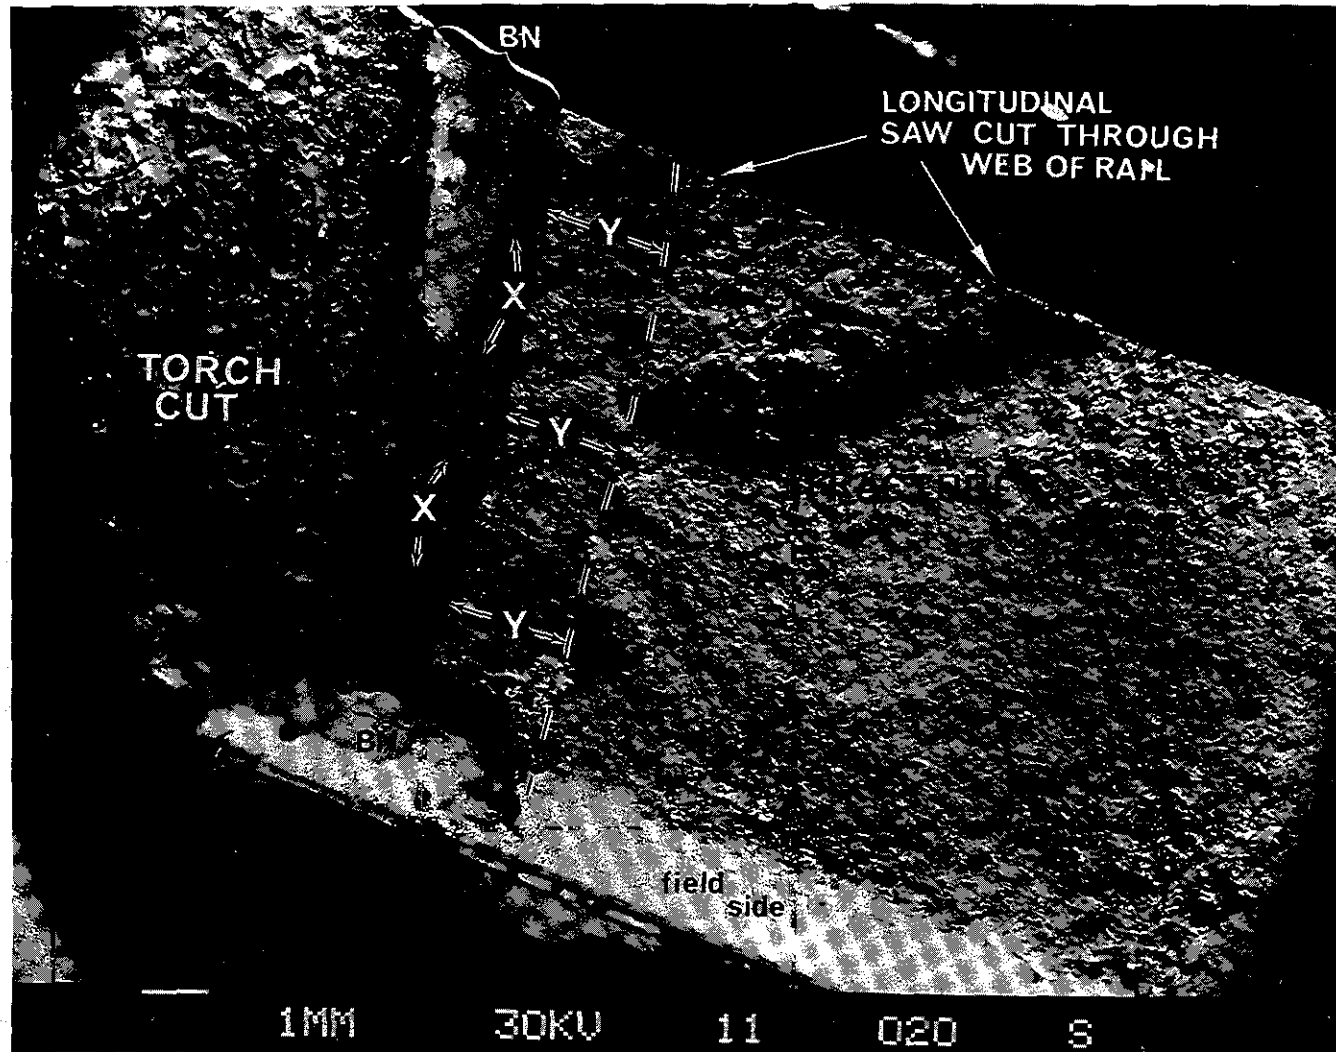
Figure 7.--Scanning electron microscope photograph of the area within dashed line box in figure 6. The bottom of the torch-cut notch is between brackets "BN". Also, two series of thermal cracks are visible in this photograph. One series was unopened and was found in the bottom of the notch, and is indicated by arrows "X". A second series was opened during the fracture process and was found on the side of the notch. The surface of this opened series of thermal cracks was darkly discolored and is indicated by arrows "Y".

The Safety Board believes that the thermal cracks found in the chrome-vanadium alloy rail were precipitated by the use of the torch to cut the rail. Metallographic examination of the subject rail did not reveal any other internal defects that could have served as the origin of the rail fracture. Torch-cutting of rail often may introduce flaws at or near the torch-cut surface. The inherently uneven surface of a torch-cut rail has numerous surface discontinuities. These surface discontinuities, in a rail subject to the imposition of dynamic loads from wheels passing over the rail, serve as stress raisers. Stresses most often will occur in their highest intensities at such surface discontinuities. Further, there is a natural propensity for the heat-affected layer of metal adjacent to a torch-cut surface to form thermal cracks upon the cooling of the metal. These thermal cracks probably initiated the severe fracturing of the subject rail as Amtrak train No. 21 passed over it, 45 minutes to 1 hour after the torch cuts were made in the chrome-vanadium alloy rail.
