RAILROAD/HIGHWAY ACCIDENT REPORT

**COLLISION OF
AN AMTRAK/ATCHISON, TOPEKA AND SANTA FE
RAILWAY TRAIN AND A
TRACTOR-CARGO TANK SEMITRAILER**

MARLAND, OKLAHOMA

REPORT NUMBER: NTSB-RHR-77-3

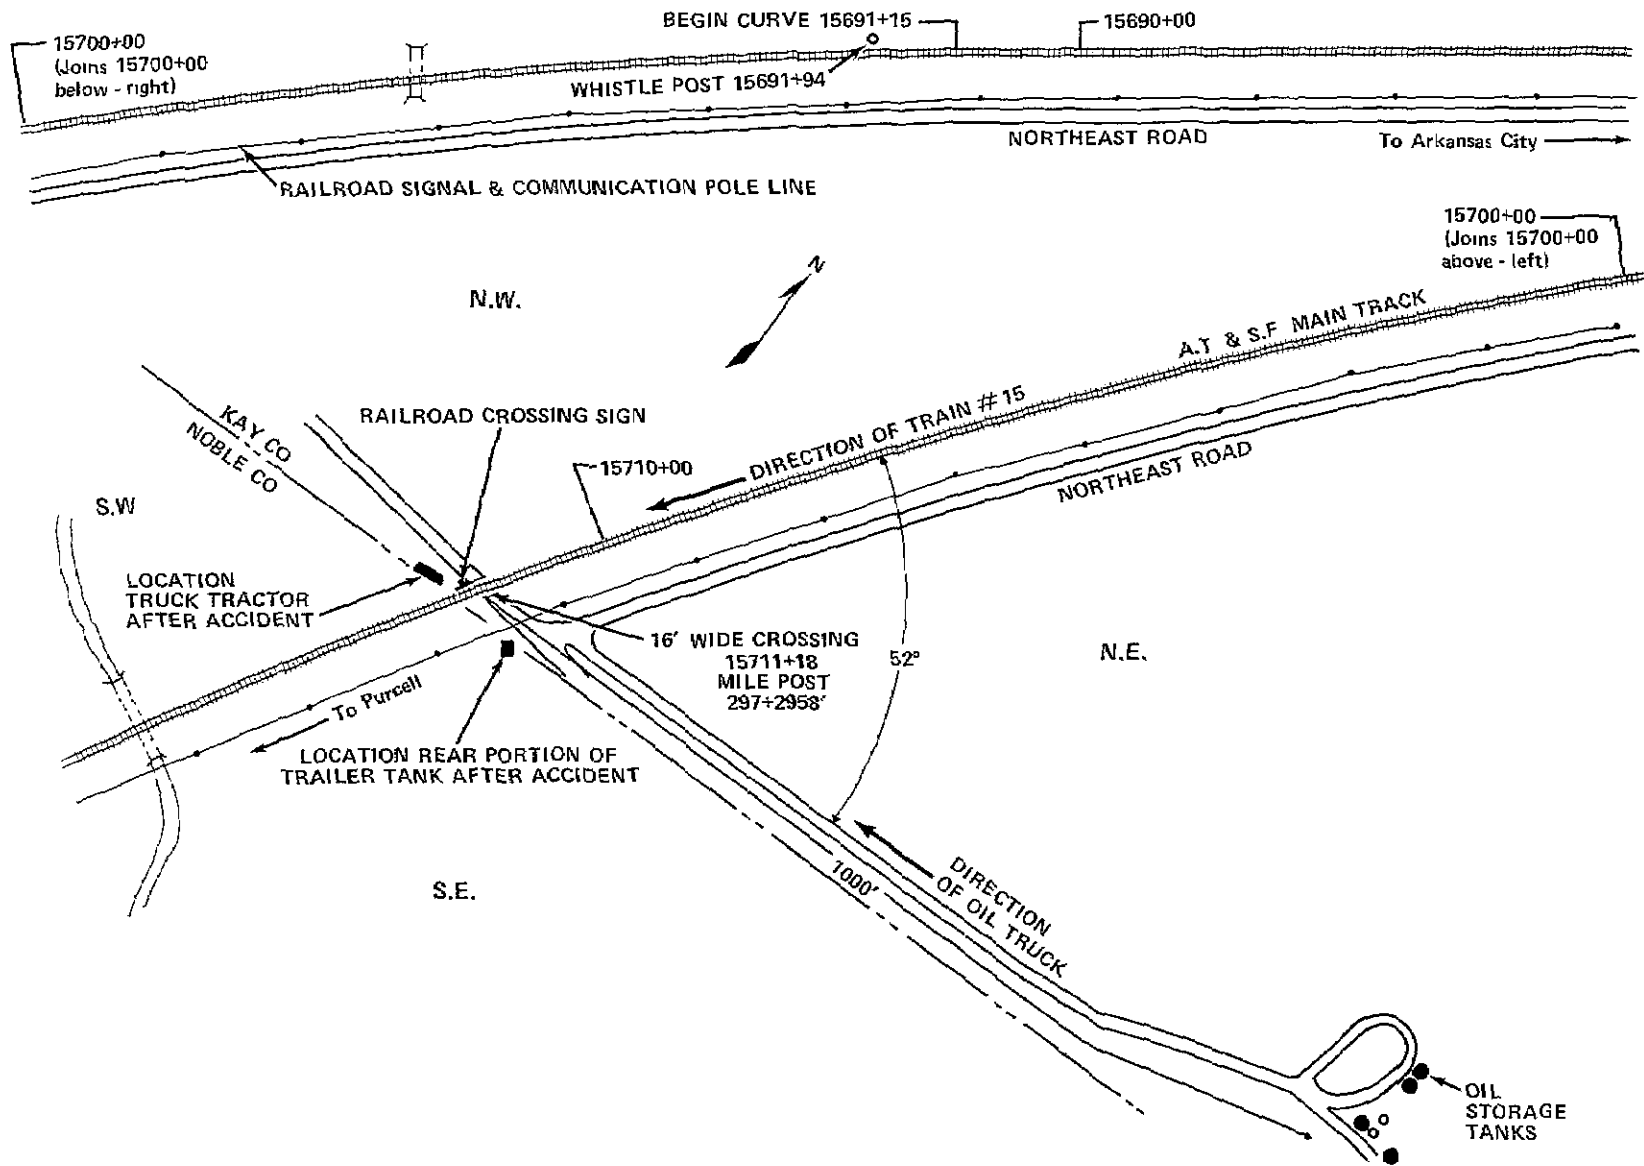
Figure 1. Plan view of accident site.

Approaching the crossing, a southbound train moves from a long tangent into a 1°00' curve to the left which begins 2,005 feet north of the crossing and ends 1,077 feet beyond the crossing. Over this distance there is an ascending southbound grade of 0.15 percent. The single main track is elevated about 3 to 4 feet above the surrounding terrain. With unlimited visibility, a train approaching from the north is first visible

when it reaches a point 2,300 feet from the crossing. An average of 15 trains are operated daily over this line, including 2 passenger trains. The passenger trains, one in each direction, pass the crossing about 12 hours apart. (See figure 1.)

The county-maintained road runs east-west, averages 18 feet in width, and is surfaced with gravel. This road begins at State Route 156, about .4 mile west of the crossing, and ends about 65 feet east of the crossing. The angle of intersection in the northeast quadrant of the crossing is about 52°. A westbound vehicle on the road ascends a grade of about 5 percent over the 65 feet immediately east of the crossing. The west approach to the crossing is almost level. A single standard crossbuck railroad crossing sign is located in the southwest quadrant.
