RAILROAD ACCIDENT REPORT

REAR-END COLLISION OF
AMTRAK/MASSACHUSETTS BAY
TRANSPORTATION AUTHORITY COMMUTER TRAINS,
BOSTON, MASSACHUSETTS,
NOVEMBER 12, 1987

NTSB/RAR-88/05

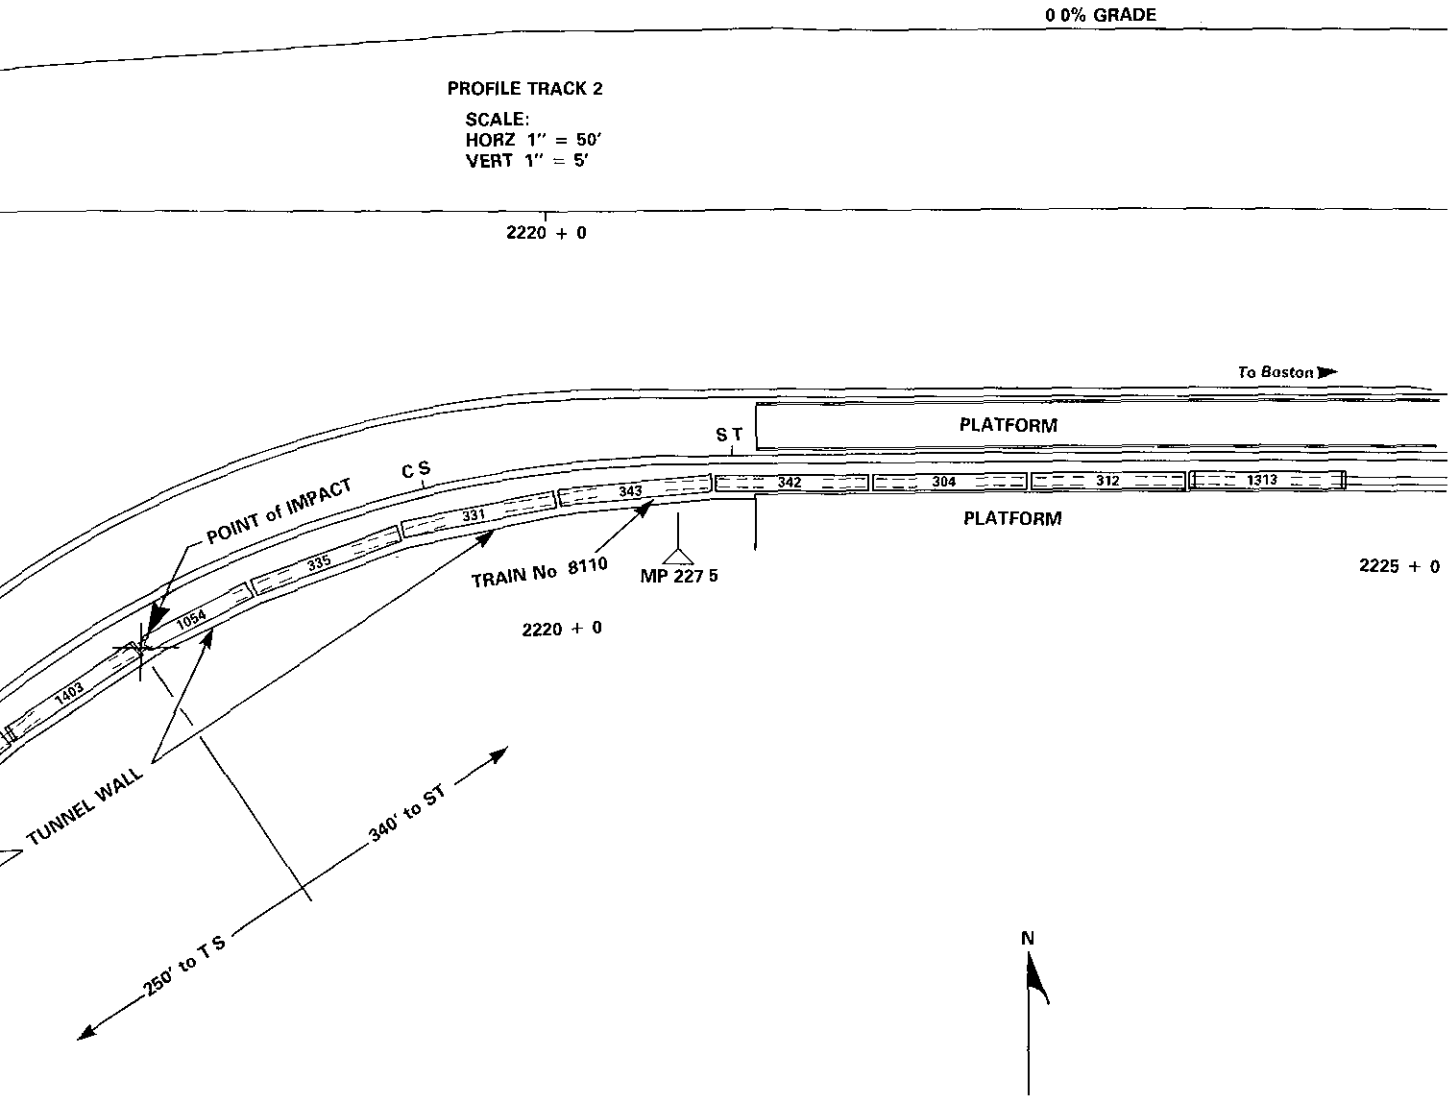
Figure 2.--Plan view of accident site.

The engineer said that as train 8110 rounded the curve approaching the Back Bay station platform, he observed train 8910 stopped at the platform. (See figure 2.) Because only about two car lengths of platform space remained behind train 8910, the engineer of train 8110 stopped his train short of the platform to prevent any passengers from detraining. Train 8110's engineer then radioed train 8910's engineer to request that train 8910 pull forward. After train 8910's engineer complied with that request, train 8110's engineer pulled his train forward so that the head 3 1/2 cars were stopped adjacent to the station platform.

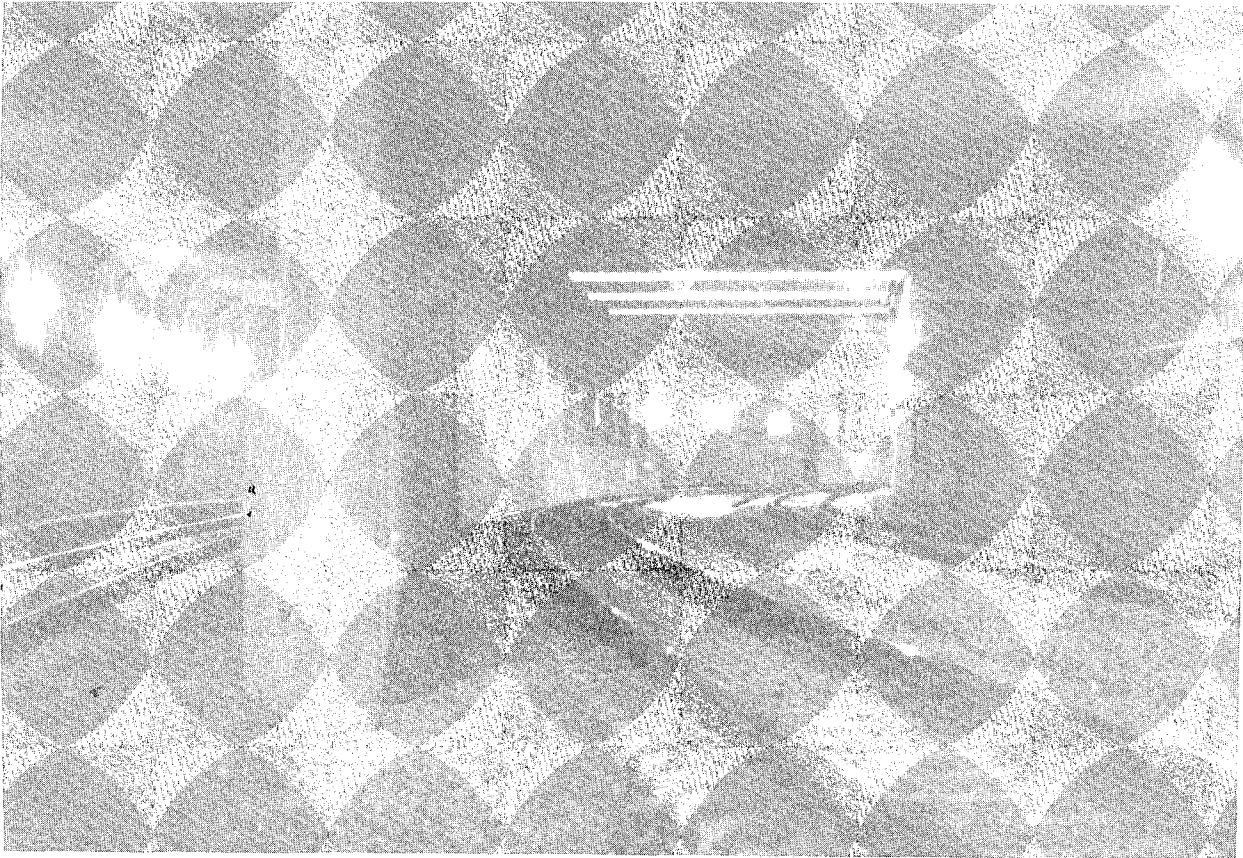
Figure 3 --Accident location.

At 8:05, train 8114 collided with the rear end of train 8110 340 feet west of the Back Bay station platform near the apex of a 9° 30' curve to the right. (See figure 3.)

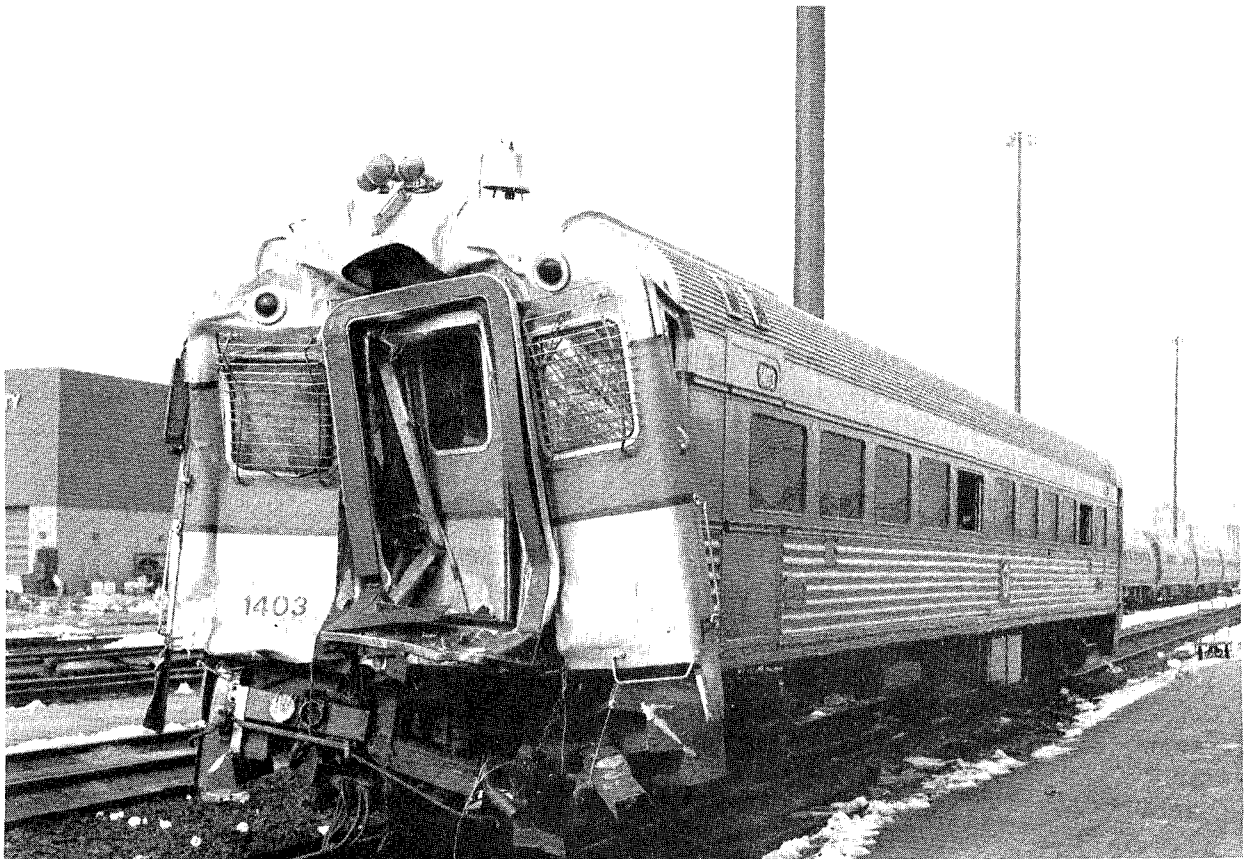
Figure 4.--Damage to the control car (1403) of train 8114.

There was major crush damage to control car 1403 of train 8114. (See figure 4.) At the engineer's control position the cab was displaced 4.5 feet rearward, the floor was displaced 17 inches upward, and sheet metal displacement extended 25 feet beyond the left outboard side. (See appendix C.)

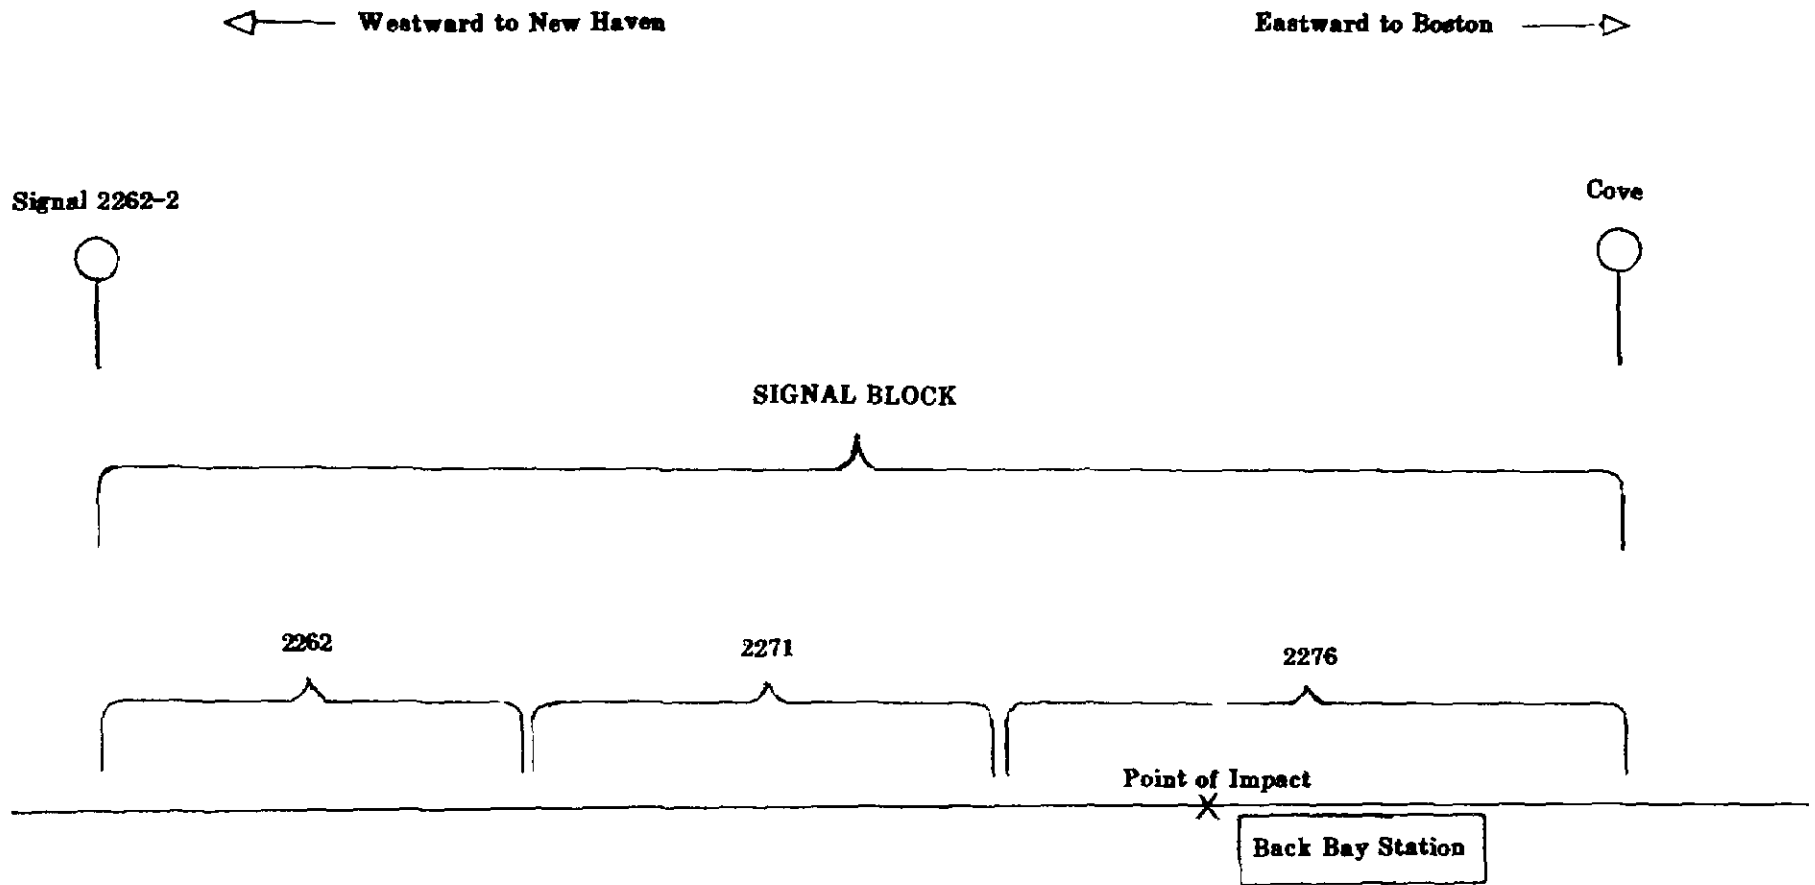
Figure 5.--Signal block section at the accident site.

Train 8110 entered the signal block governed by wayside signal 2262-2 ahead of train 8114. Wayside signal 2262-2 displayed a false proceed indication (approach aspect) to train 8110 because with train 8910 in the signal block, wayside signal 2262-2 should have displayed a stop and proceed aspect (train 8110's cab signal went to restricting). Further, field tests conducted after the accident established that wayside signal 2262-2 displayed false proceed indications with a train in the signal block. The investigation determined that the signal failure resulted from excessive wear on the contacts of the 2TBPR relay because of a unique design feature of the signal systems.

The track circuits misinterpreted the cycling reset feature as a code and improperly displayed an approach aspect on the wayside signal when a stop and proceed aspect was required and intended.

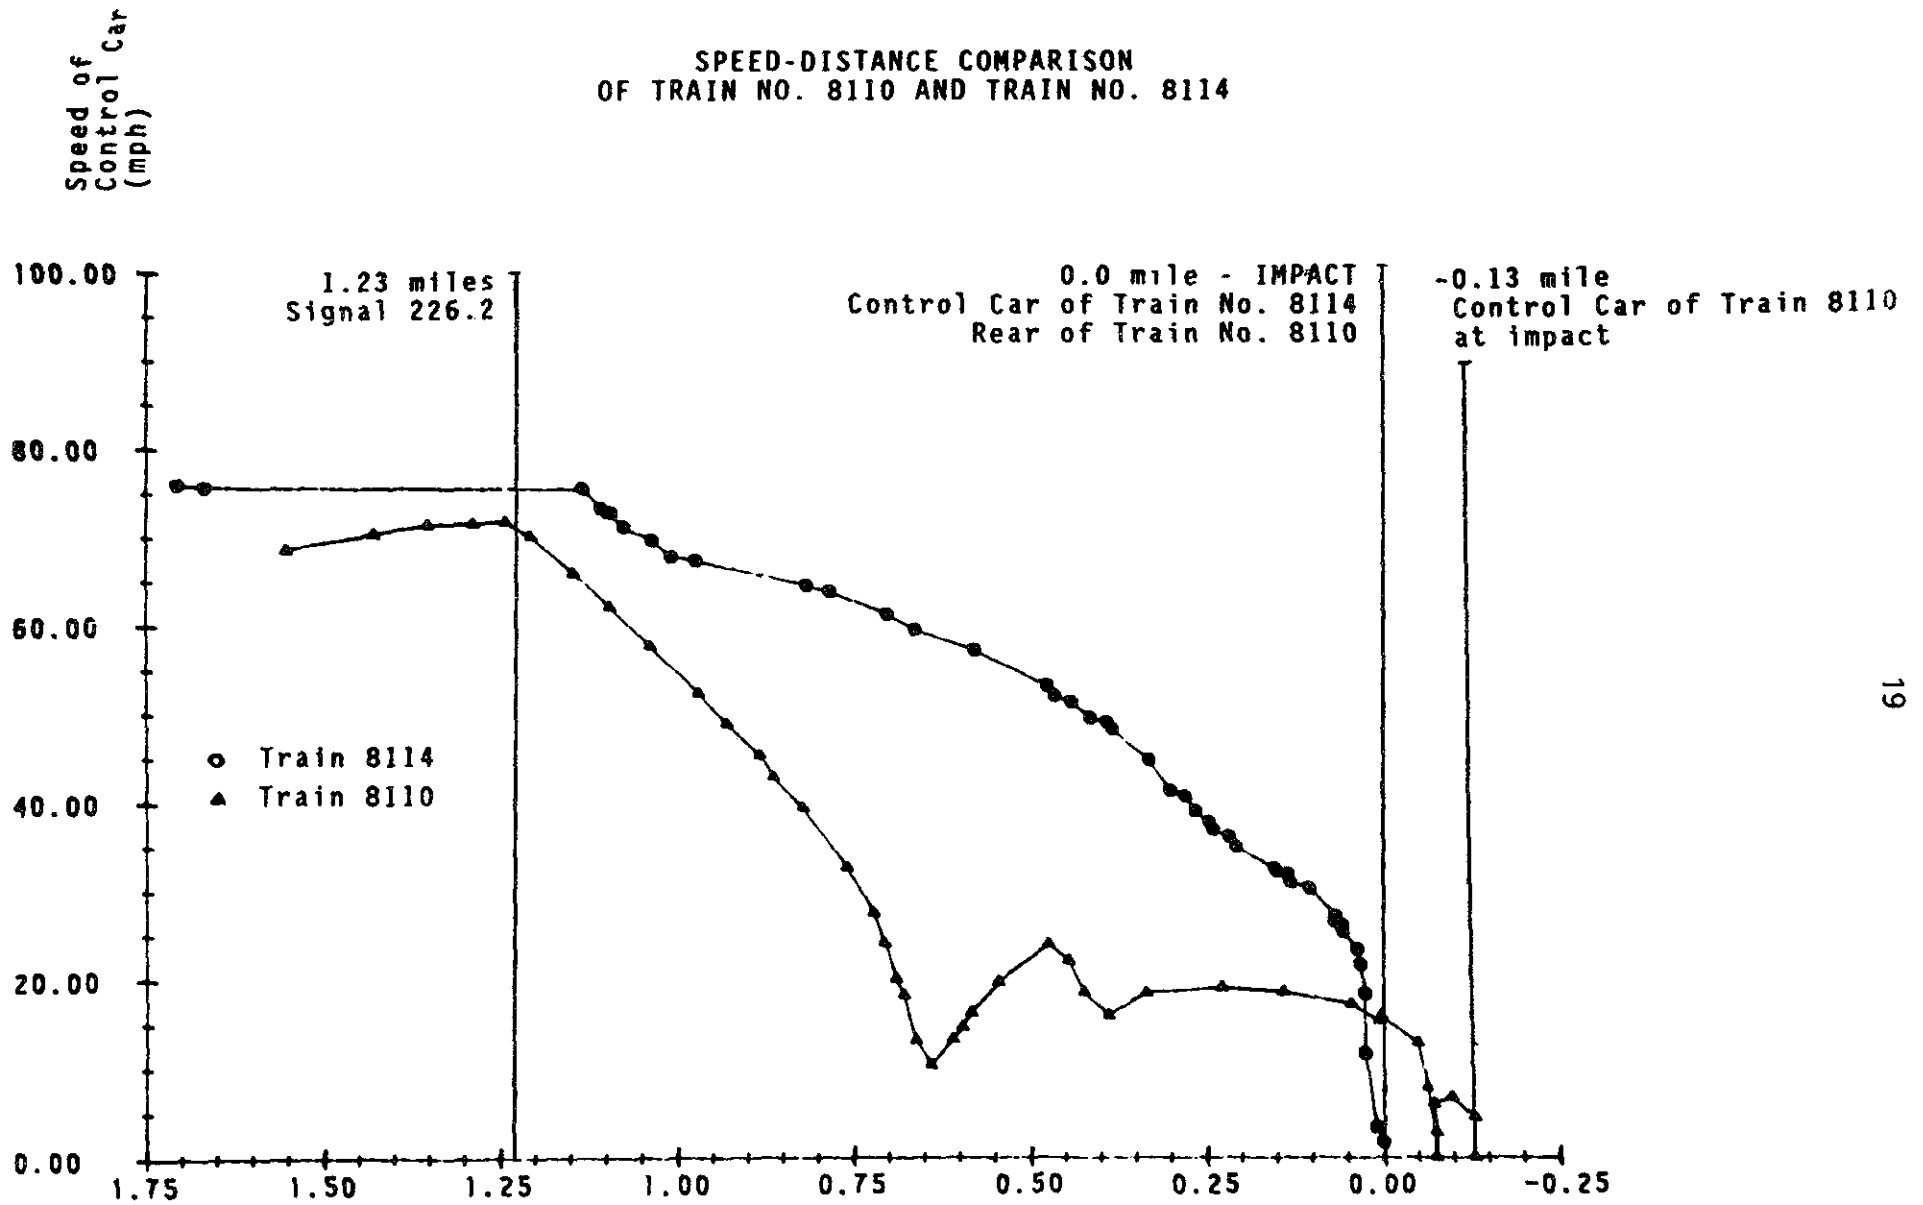
Figure 6.--Speed-distance comparison of train No. 8110 and train No. 8114.

Stopping Distance--Both trains were in push mode with both engineers operating from their control cars. Rail surface conditions were similar. Other than a weight difference, the equipment on the two trains involved in the accident were similar. Both trains had the same braking ratio¹⁵. The striking train had an additional control car in the consist. Both control cars of train 8114 were equipped with devices that apply sand at the wheel/rail interface to improve adhesion. The improved adhesion provides greater tractive and braking ability. Comparisons of the speed tape recordings from both trains were made at the Safety Board's laboratory in Washington D.C., to determine stopping distances. (See figure 6.) Data from the speed tapes were

digitized using an optical readout station, then converted to scale. The speed tape trace from train 8114's control car appeared to cross below the 0 mph mark. The 0 point on the speed curve was determined from the last stop train 8114 made before the collision, and the data was adjusted accordingly. The majority of the information retrieved was read directly from this scaled data, the remainder of the information was extrapolated by approximating a smooth curve over a portion of data. The smooth curve was used to project an available stopping point. From the scaled and extrapolated data it was determined that train 8110 could have made the transition from 75.6 mph to 0.0 mph in 3,850 feet. The distance for train 8114 was an actual distance covered, not a projected distance. Train 8114 decelerated from 75.6 mph to 0.0 mph in 6,020 feet. The collision occurred 6,480 feet from signal 2262-2.

Speed tape comparisons were consistent with the testimony of the engineers and indicated that each engineer had a different method of train handling. The engineer of train 8110 began to apply service braking 53 feet (0.5 seconds) before reaching wayside signal 2262-2. When the engineer of train 8110 observed the cab signal degrade to restricting after the control car passed wayside signal 2262-2, he continued the brake application to the maximum service braking available and simultaneously reduced throttle, which resulted in a sharp deceleration rate and an available stopping point 2,630 feet short of the point of collision. Train 8114 did not begin to decelerate until 480 feet (4.3 seconds) past signal 2262-2. After the engineer of train 8114 applied maximum service braking, the deceleration rate still did not drop as sharply as that of train 8110. Since both trains had the same braking ratio, train 8114 would have had a braking advantage over train 8110 because train 8114 had an extra control car that applied sand to the rail head. The Safety Board concludes that the primary difference in stopping distance was the use of locomotive power by the engineer of 8114 after he had applied the trains' brakes in a manner (in suppression) that satisfied the requirements of the automatic train control system. Using train 8110's braking curve, without any braking advantage factored in, train 8114 could have stopped 2,150 feet short of the point of collision by using train 8110's braking method. The collision occurred at about 11 mph.

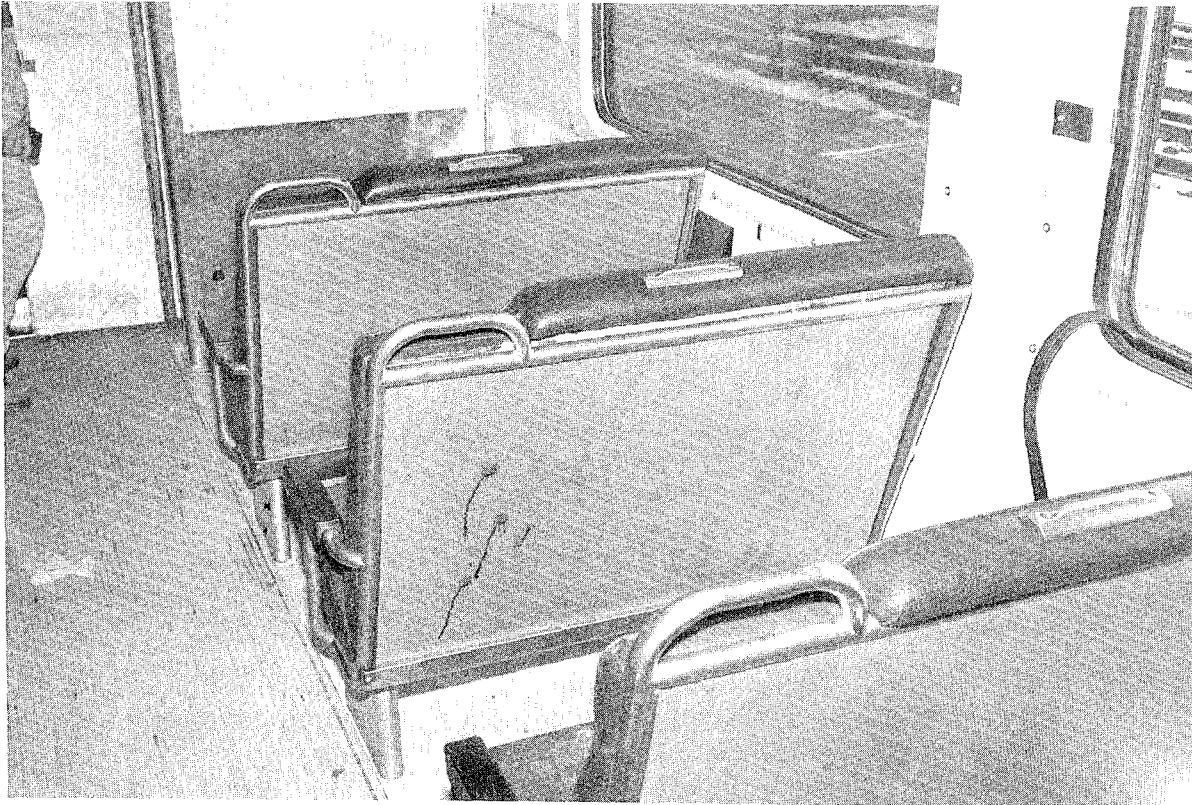
Evidence of emergency triage was found near the rear seats of this car. Bandage material and blood splatters were scattered about the floor.

Figure 1.--Blood on facing seatback.
