INTERSTATE COMMERCE COMMISSION  
WASHINGTON

REPORT OF THE DIRECTOR  
BUREAU OF SAFETY

ACCIDENT ON THE  
ANN ARBOR RAILROAD

INVESTIGATION NO. 2350

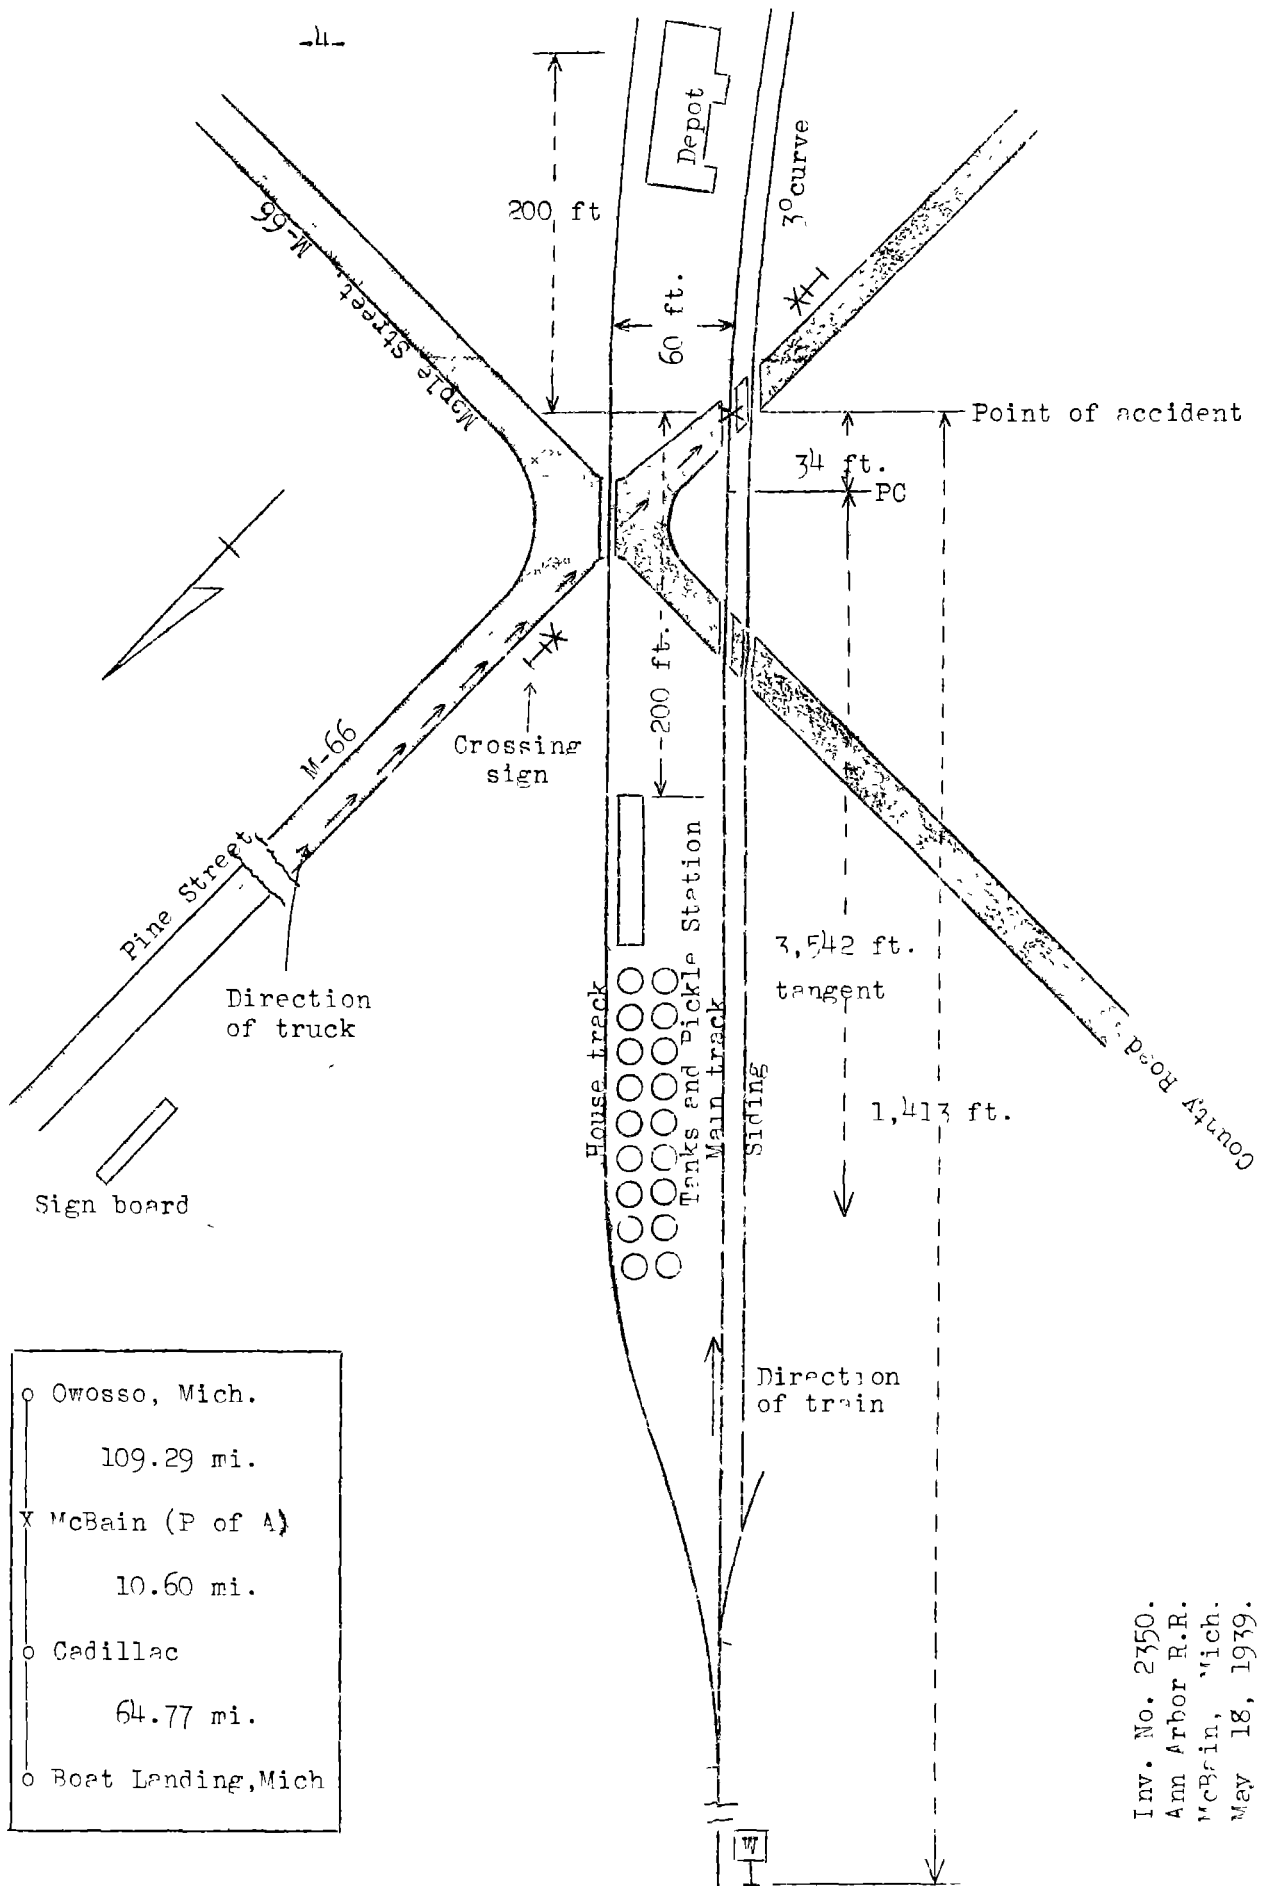
Inv. No. 2350.  
 Ann Arbor R.R.  
 McBain, Mich.  
 May 18, 1939.

The crossing involved is protected by two cross-buck signs, which are furnished by the State Highway Department and bear the words "RAILROAD CROSSING 3 TRACKS" in reflector buttons. One sign is located 25 feet west of the center-line of Pine Street and 168 feet north of the center-line of the main track, or 70 feet north of the center-line of the house

track; the other sign is located south of the siding and east of the street. The tops of these signs are about 11 feet above street level.

At a point 300 feet north of the main track, the driver of a south-bound vehicle could have an unobstructed view of an approaching east-bound train a distance of 950 feet. Between 300 and 210 feet the view is obstructed by a sign-board 15 feet high by 51 feet wide, located 57 feet west of the center-line of the street. From 210 to 100 feet the view is unobstructed a distance of 1,250 to 1,390 feet. A pickle-station building, 30 feet wide, 75 feet long, and 18.5 feet high, located 200 feet west of the crossing and 29 feet north of the main track, obstructs the view from 100 feet to 49 feet north of the main-track crossing. At 49 feet the view is unobstructed a distance of 750 feet; at 33 feet the view is unobstructed a distance of 3,600 feet; between 33 and 25 feet a pole line obscures the view, and from 25 feet to the main track the view is unobstructed a distance of 3,600 feet.
