NATIONAL TRANSPORTATION SAFETY BOARD

RAILROAD ACCIDENT REPORT

ATCHISON, TOPEKA AND
SANTA FE RAILWAY COMPANY (ATSF)
FREIGHT TRAINS ATSF 818 AND ATSF 891
ON THE ATSF RAILWAY
CORONA, CALIFORNIA
NOVEMBER 7, 1990

ADOPTED: July 23, 1991
NOTATION: 5413A

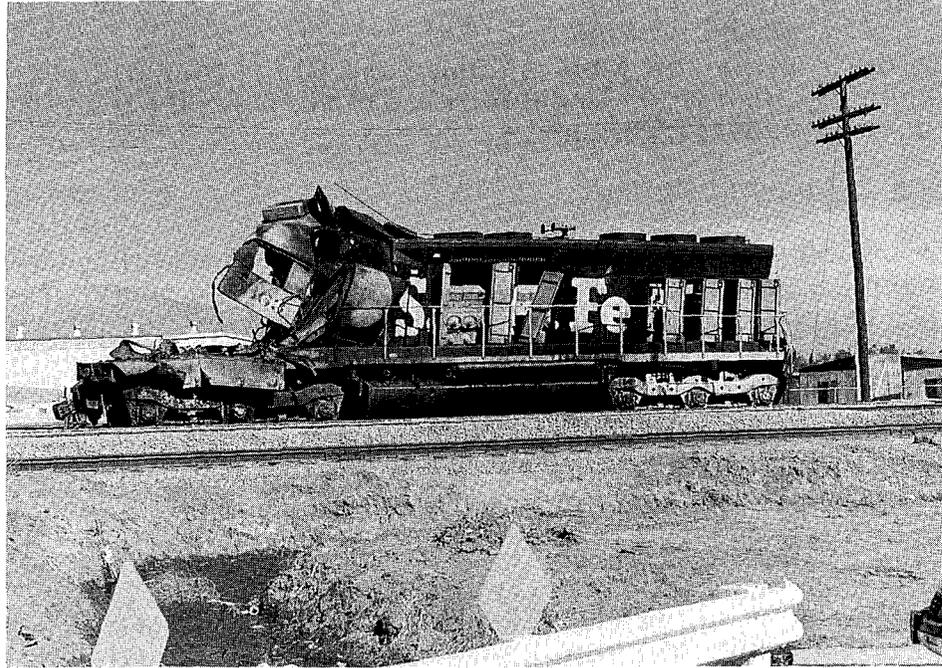
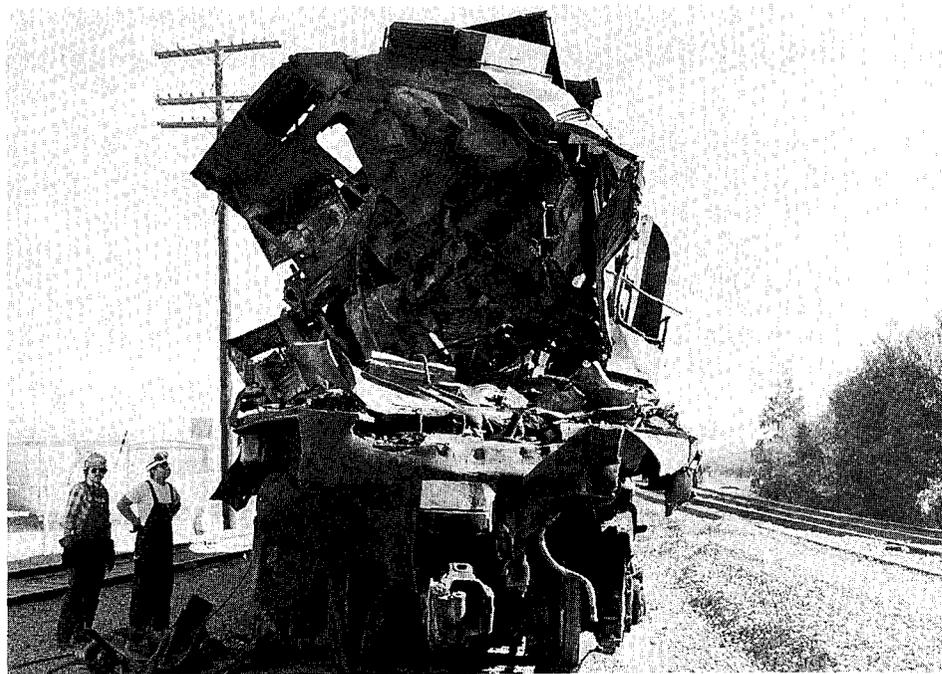
The left front end sill area of the lead locomotive on train 818 collided with the left front end sill area of the lead locomotive on train 891. The lead locomotive of train 818 incurred damage due to the collision and subsequent fire. The superstructure of its control compartment had sustained thermal damage and showed crush damage from the front end sill rearward for approximately 15 feet. The locomotive remained on its trucks in the turnout on the west end of the siding, and its fuel tank was intact. (See figure 6.) The first, third, fourth, and fifth locomotives of train 818 had derailed.

The electrical switches in the control cab were burned, but investigators were able to document the following: rear headlight switch off, gauge lights on, front headlight on in dim position, generator field switch not discernible, engine run switch not discernible, side wall heater switch on high, and throttle next to the "idle stop" position. The brake systems of all units were also inspected and found to be functioning as designed.

Figure 6.--Postaccident photographs of train 818's lead locomotive.
