**REPORT NO. 80-7  
ATCHISON, TOPEKA AND SANTA FE  
RAILWAY COMPANY  
CARNERO, NEW MEXICO  
DECEMBER 31, 1978**

ACCIDENT REPORT NO. 80-7

ATCHISON, TOPEKA AND SANTA FE RAILWAY COMPANY

DECEMBER 31, 1978

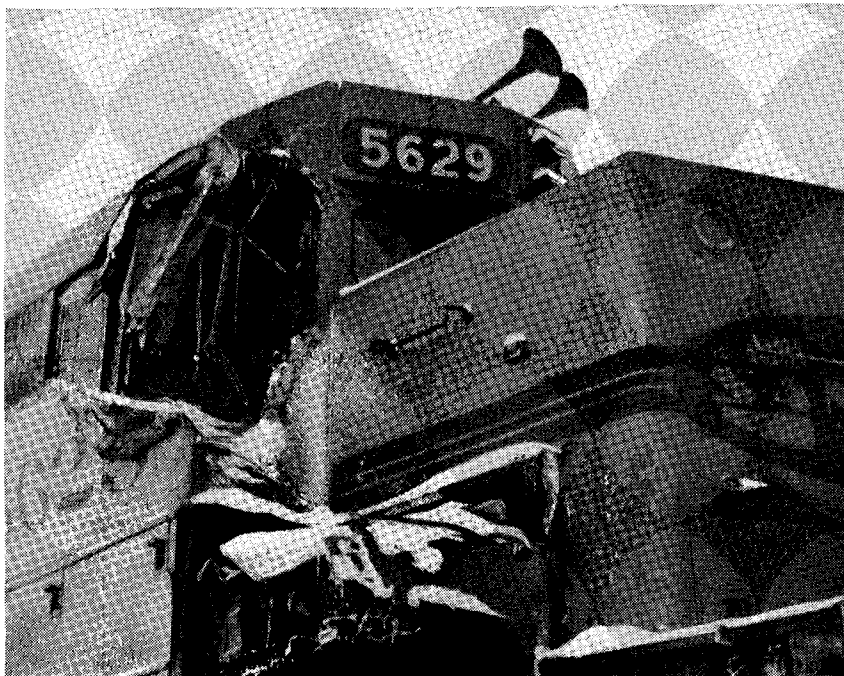
The upper corner of the caboose ripped through the cab of the lead locomotive unit of Extra 5629 West and tore away part of the cab. The locomotive unit was moderately damaged on the right front and side. None of the equipment of Extra 5629 West was derailed.

Lead Locomotive Unit of Extra 5629 West

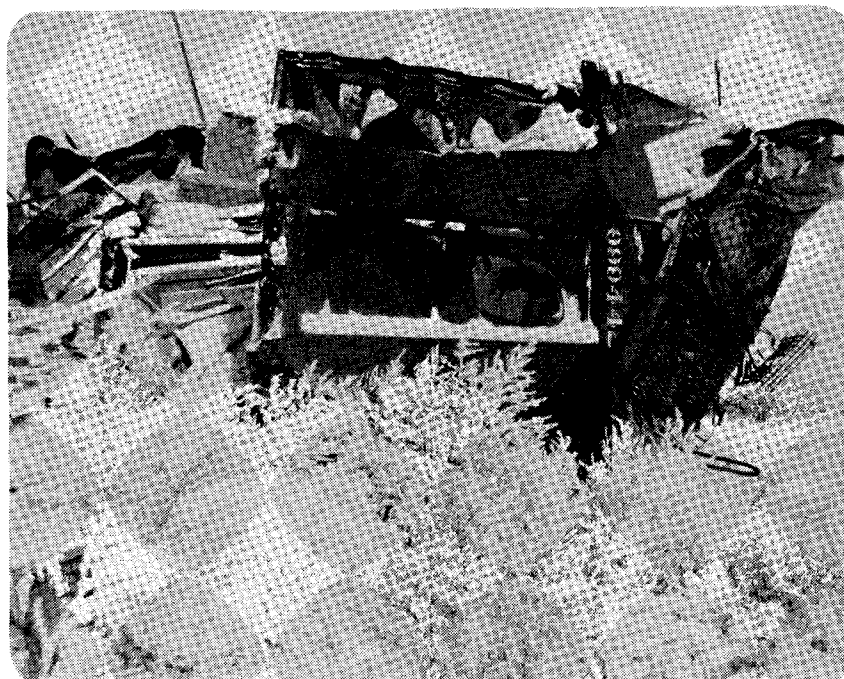
The caboose of Extra 5568 East uncoupled from the train and was thrown to the north side of the main track and into a signal mast. The caboose was destroyed. The trailing truck of the rear car was derailed and this car sustained minor damage.

Caboose of Extra 5568 East
