RAILROAD ACCIDENT INVESTIGATION.

REPORT NO 4185

THE ATCHISON, TOPEKA AND SANTA FE RAILWAY COMPANY

JUNE 9, 1972

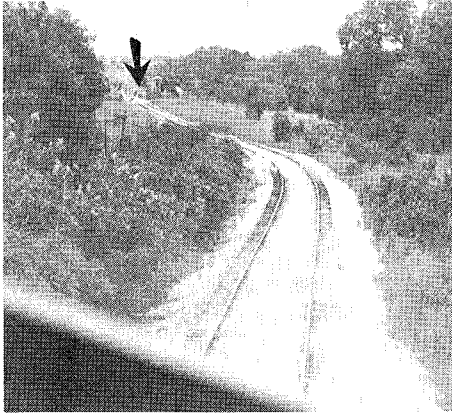
Because of track curvature and trees, a caboose standing at the collision point cannot be seen from an approaching eastbound locomotive at a distance greater than approximately 1500 feet (see photograph).

Looking eastward to collision point (arrow), about 1435 feet distant.

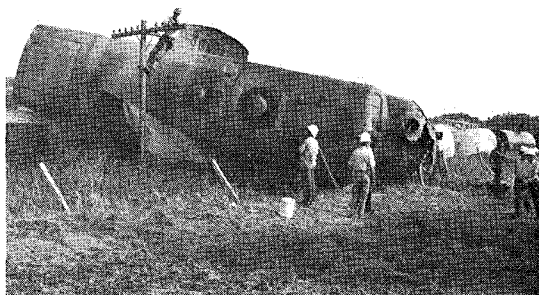
The caboose and last two cars of Extra 234 East were derailed. The caboose stopped on the north side of the track structure and was crushed underneath the first locomotive unit of the following train (see photograph on the following page).

Extra 274 East stopped with the front end 120 feet east of the collision point. All four locomotive units and the first five cars derailed and stopped in various positions on or near the track structure. The first locomotive unit overturned onto its right side, caught on fire, and stopped at right angles across the top of the caboose of the preceding train.

Caboose of Extra 234 East under first locomotive unit of Extra 274 East.
