RAILROAD ACCIDENT INVESTIGATION

REPORT NO 4173

UNION PACIFIC RAILROAD COMPANY

FEBRUARY 17, 1970

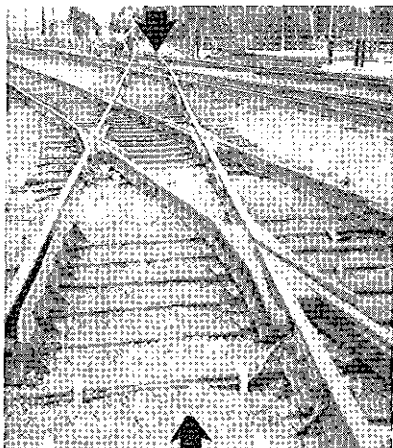
The 173-foot dead section of the UP main track extended across the ATSF tracks at the crossing, as indicated in the photograph below:

View eastward on UP main track. Jumpered-out section shown between arrows.

The ATSF maintains the Fullerton interlocking. Tests of the interlocking system disclosed that the system functioned properly, in accordance with its design. The design of the interlocking system, however, was such that it could not detect occupancy of a 173-foot section of the UP track extending from one side of the ATSF tracks at the crossing to the other. Thus, if a locomotive with a train not exceeding 173 feet in length between the front and rear pairs of wheels entered the interlocking and left the train standing entirely within the "dead" section of the UP main track at the crossing while it worked outside the interlocking limits, the effect on the interlocking system would be the same as if the UP main track within the interlocking was not occupied. Under such conditions, track occupancy lights associated with the ATSF dispatcher's traffic control machine would indicate the interlocking was unoccupied, and the dispatcher would be enabled, if he so desired, to establish the route for an ATSF train or another UP train to enter the interlocking.

The failure of the UP crew to leave its train clear of the ATSF tracks at the crossing was the primary cause of this accident. Other significant causal factors were the inability of the interlocking system to detect occupancy of a 173-foot section of the UP main track at the crossing and the dispatcher's and crew member's lack of knowledge concerning the extent of the protection afforded by this interlocking. The UP caboose and two cars evidently were stopped

As a result of the accident, the ATSF installed an overlay track circuit on the existing UP trap circuit within the Fullerton interlocking. The installation of the overlay circuit reduced the 173-foot "dead" section of UP track at the crossing to a total length of 27 feet, broken into three 9-foot sections, and provides for the desired isolation of the UP track circuits from the ATSF track circuits at the crossing. Since the former "dead" section of the UP track has been reduced to three separate 9-foot sections, detection of occupancy of the UP track in the interlocking, including the railroad crossing, has been significantly expanded.
