**RAILROAD ACCIDENT INVESTIGATION**

REPORT NO. 4110

**THE ATCHISON, TOPEKA AND SANTA FE RAILWAY COMPANY**

**JANUARY 26, 1967**

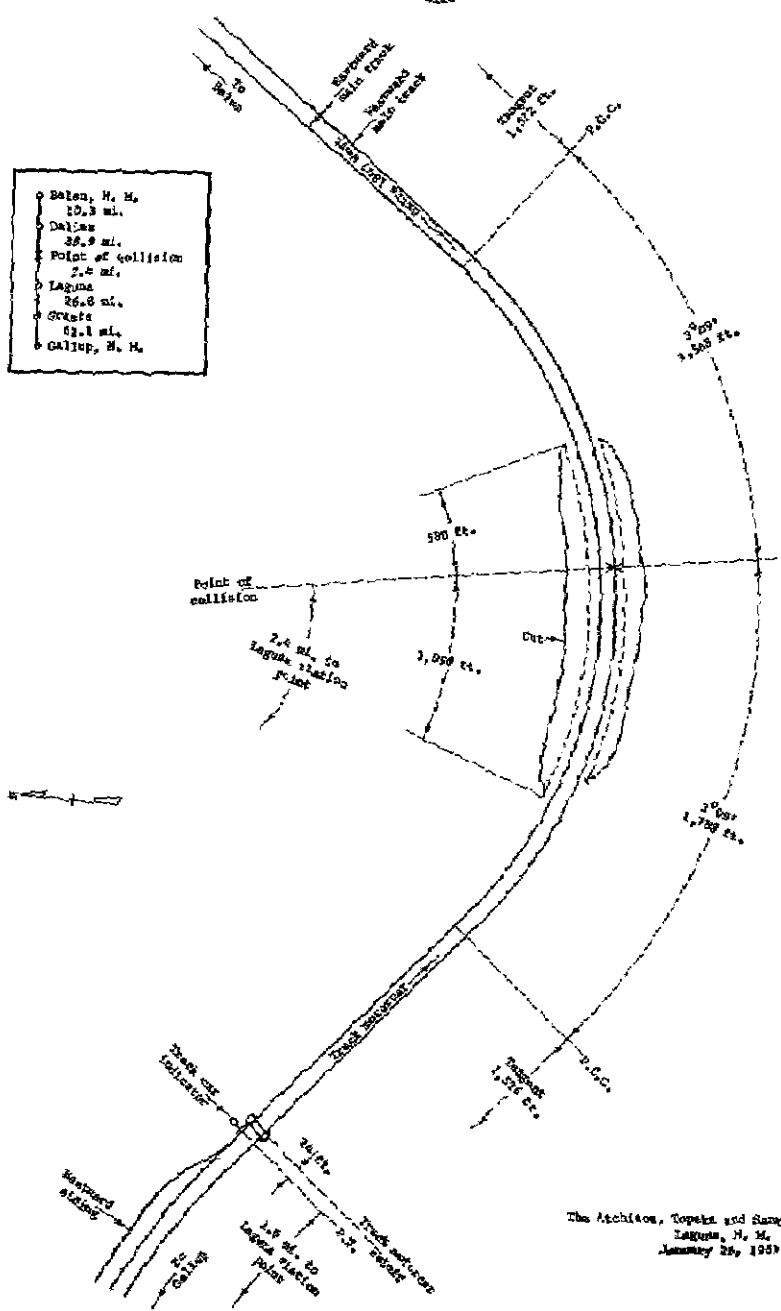
The Atchison, Topeka and Santa Fe Railway  
 Laguna, N. M.  
 January 26, 1951

- Balen, N. M. 10.3 mi.
- Dalles 38.9 mi.
- Point of collision 2.2 mi.
- Laguna 26.8 mi.
- Grasta 52.1 mi.
- Gallup, N. M.
