PB90-917007  
NTSB/RHR-90/01

## RAILROAD/HIGHWAY ACCIDENT REPORT

COLLISION OF AMTRAK PASSENGER TRAIN NO. 708  
ON ATCHISON, TOPEKA AND SANTA FE RAILWAY  
WITH TAB WAREHOUSE AND DISTRIBUTION CO.  
TRACTOR-SEMITRAILER  
STOCKTON, CALIFORNIA  
DECEMBER 19, 1989

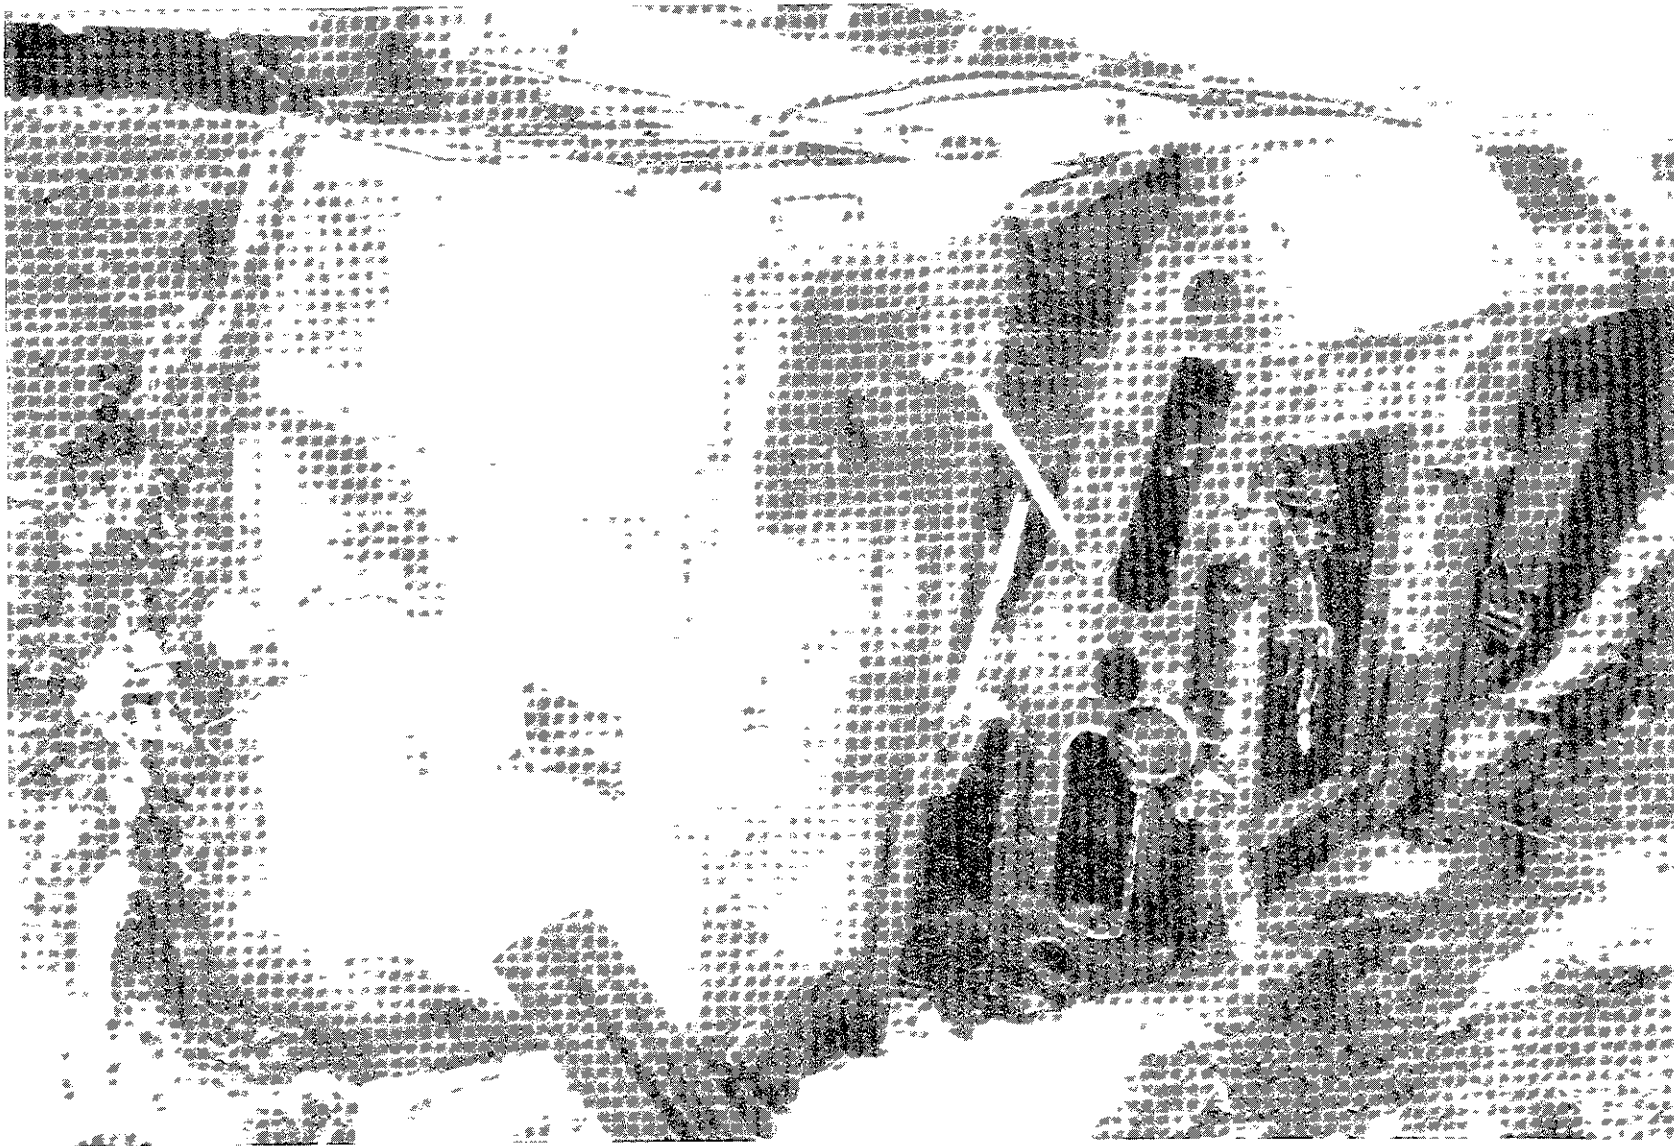
Figure 3--Front end of locomotive of train 708.

Damages--In the derailment the locomotive unit (#236) separated from the passenger cars and turned 180 degrees coming to rest on the fireman (left) side in a trackside ditch. (See figure 2.) The cab compartment and nose of the locomotive suffered collision damage. The roof of the cab was displaced downward so that the top of the windshield opening was just above hood level. Both windshield halves and side glass had been displaced from their original position. The interior sustained extensive fire damage both in the cab and engine room compartments. The fire damaged all gauges, control valves, and relays, as well as consuming the Barco speed recorder paper tape. The trucks separated from the locomotive in the derailment resulting in extensive damage to the truck frames, bearings, and traction motors. (See figure 3.)

Damages--The tractor was destroyed in the collision. The burned steering wheel, brake and accelerator pedals, and one door were separated and impacted against the front of the locomotive. (See figure 3.) All three of the tractor axles were separated from the chassis, and both 150-gallon fuel tanks were separated and ruptured. No evidence of burning was found on the fuel tanks. Both countershafts from the main transmission gear box had broken teeth on the second and fifth gears. Visual examination of the rear tractor lamps indicated that both the running lights and braking lamp filaments showed stretching and deformation.

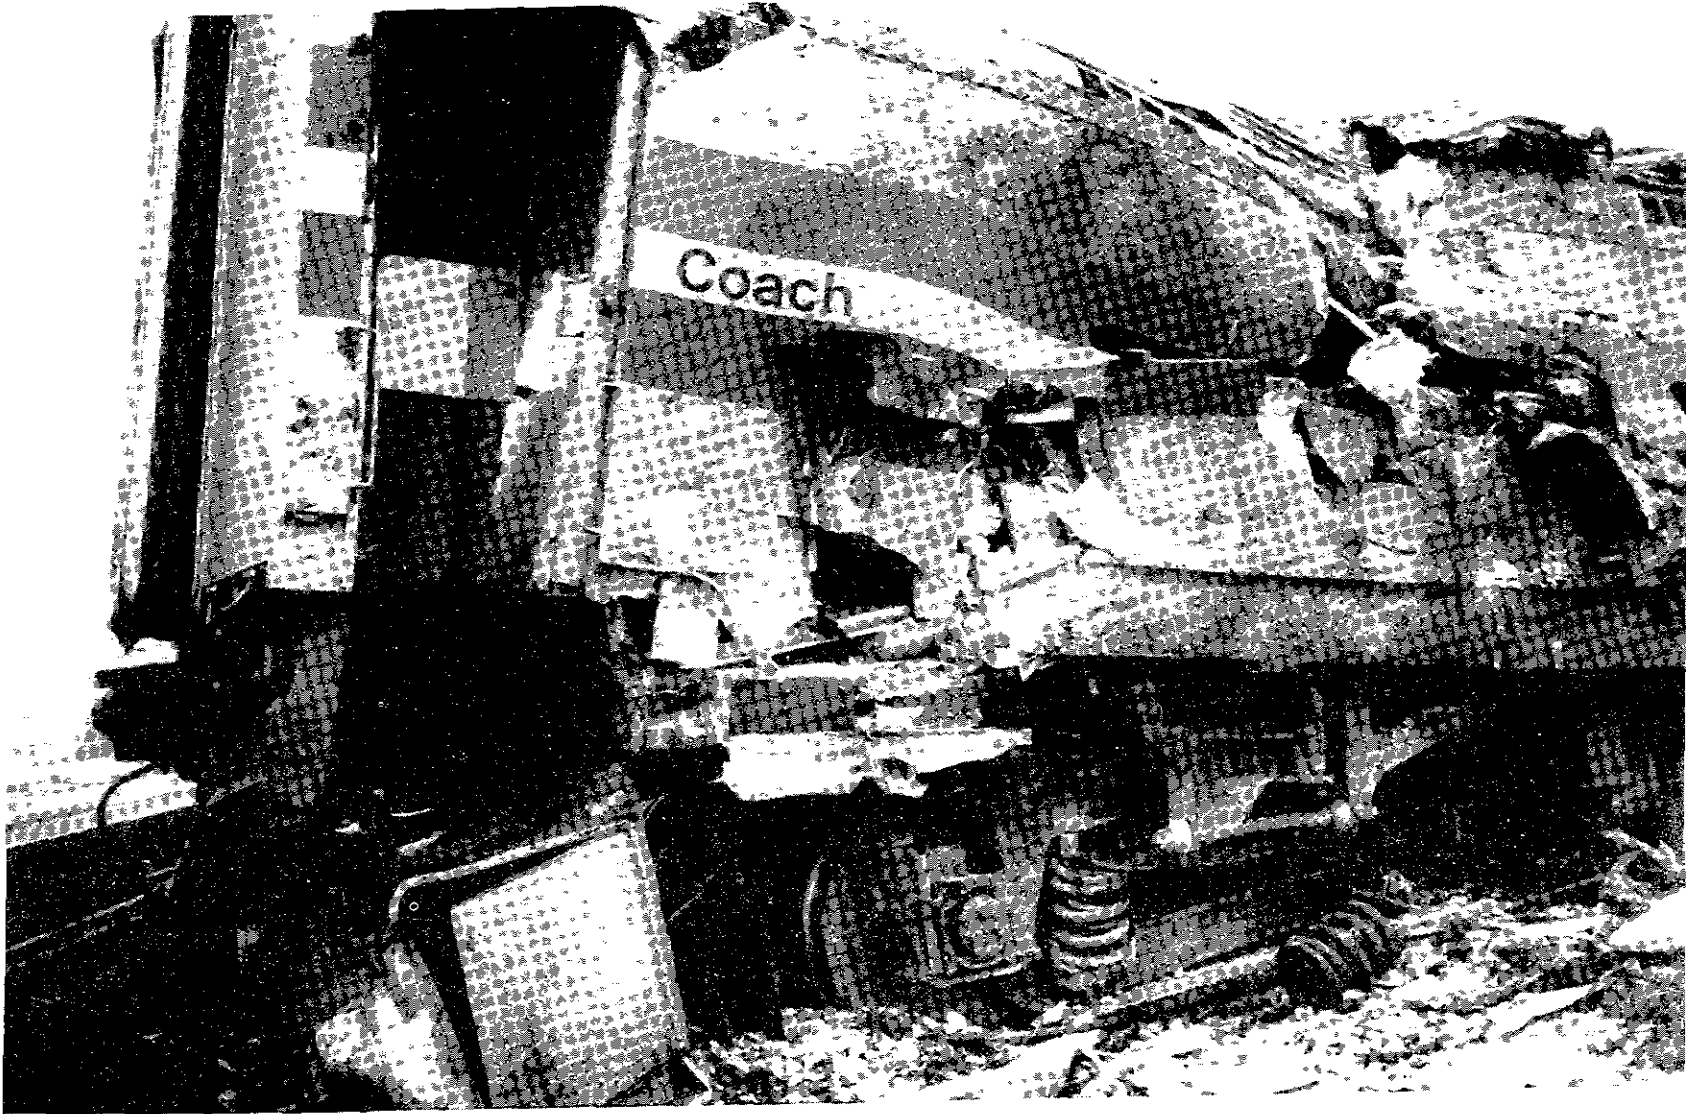
Figure 4--Side damage to Amtrak 54045.

The five passenger cars derailed at varying angles. The first car, coach AMTK 54045, sustained the most severe damage. (See figure 4.) This car separated from the locomotive and the second car. It came to rest in an upright position at right angles to the track with a large gaping hole in the right side of its trailing end. The second car, coach AMTK 54064, came to rest on its side. It was separated from, but in line with, the third car. The third, fourth, and fifth cars (AMTK 53000, AMTK 54057, and AMTK 54063) derailed in generally an upright position and did not separate. The second through fifth cars had minor interior and exterior damage to safety appliances, truck frames, and aluminum car bodies. Amtrak determined that the damage to #236 and AMTK 54045 was so severe that they would not be repaired.

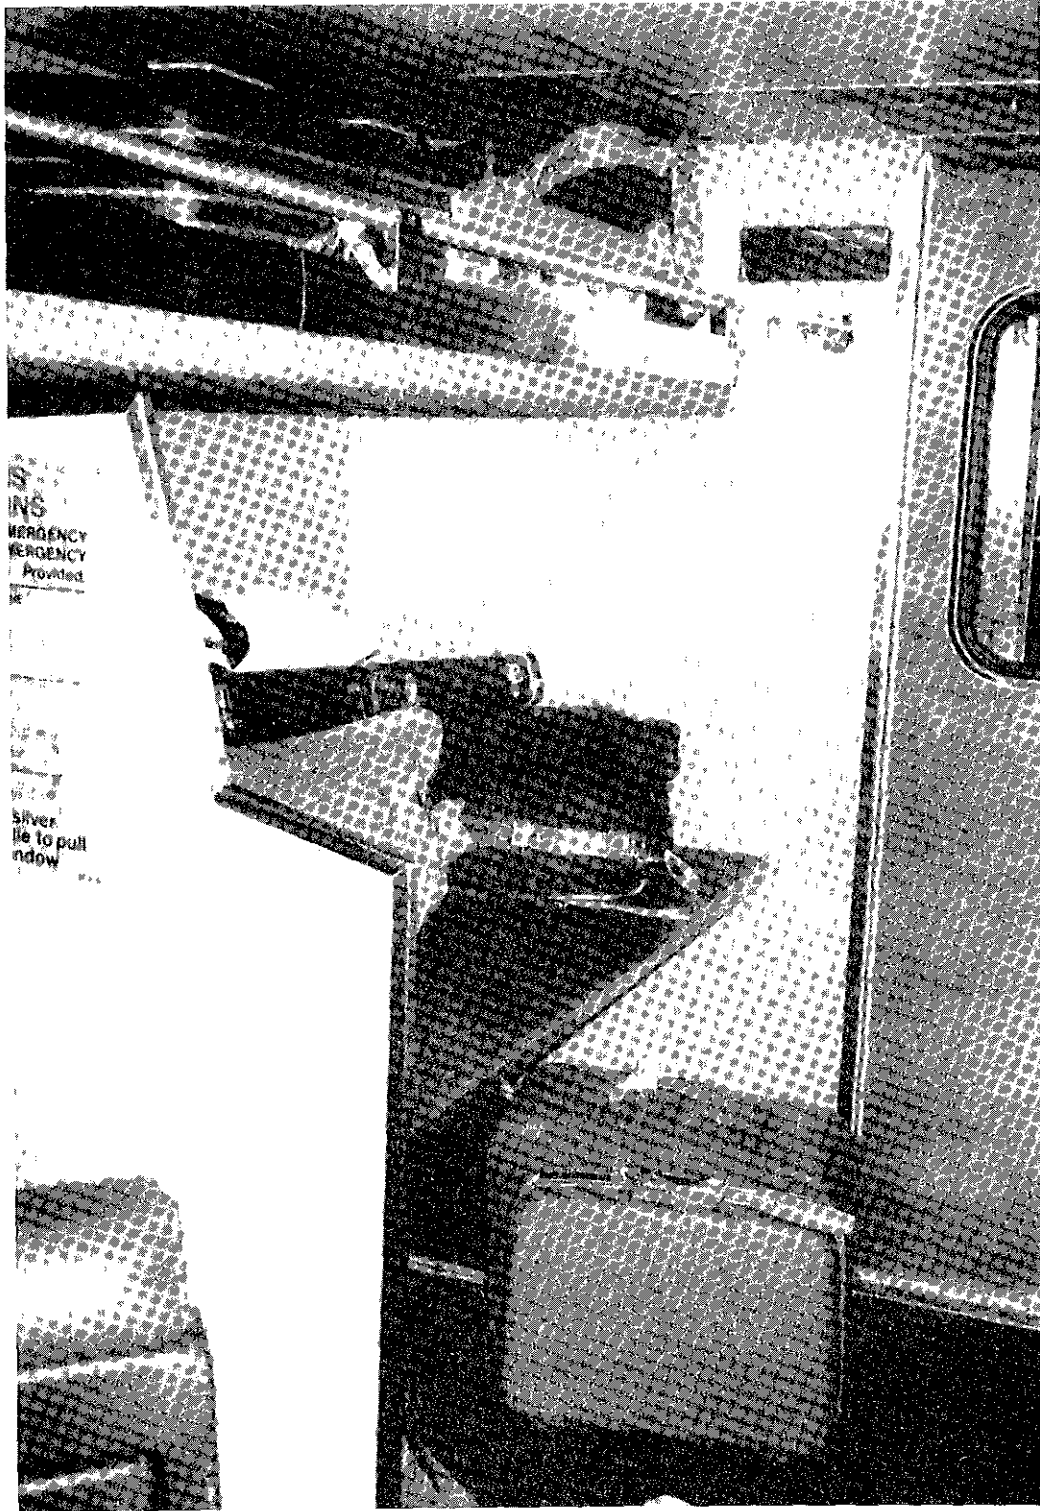
Figure 5--End of car luggage shelf.

Safety Board investigators observed during a visit to an Amtrak facility in October 1986 that it appeared the prototype luggage restraint would prevent longitudinal movement of luggage; however, the full effectiveness of the devices for lateral luggage restraint had not yet been evaluated by Amtrak (no evaluation of the luggage restraint performance when a car is rotated from the vertical position). Amtrak believes that the performance of the retention devices in the Stockton, California, and Batavia, Iowa<sup>37</sup> accidents precludes the need for further testing. In this accident, several cars derailed, one overturned, and one came to rest leaning at about a 45-degree angle. According to the CPUC documentation of the interior of the passenger cars immediately following the accident, all luggage was restrained in the overhead racks. Although the luggage restraints may have kept luggage in the overhead racks in this accident, the Safety Board cannot conclude that the amount of luggage placed in these racks is representative of a typical situation on Amtrak trains.
