# Railroad Accident Investigation Reports

REPORT No. 79-3

ATCHISON, TOPEKA AND SANTA FE RAILWAY COMPANY  
SUMMIT, CALIFORNIA  
MARCH 6, 1978

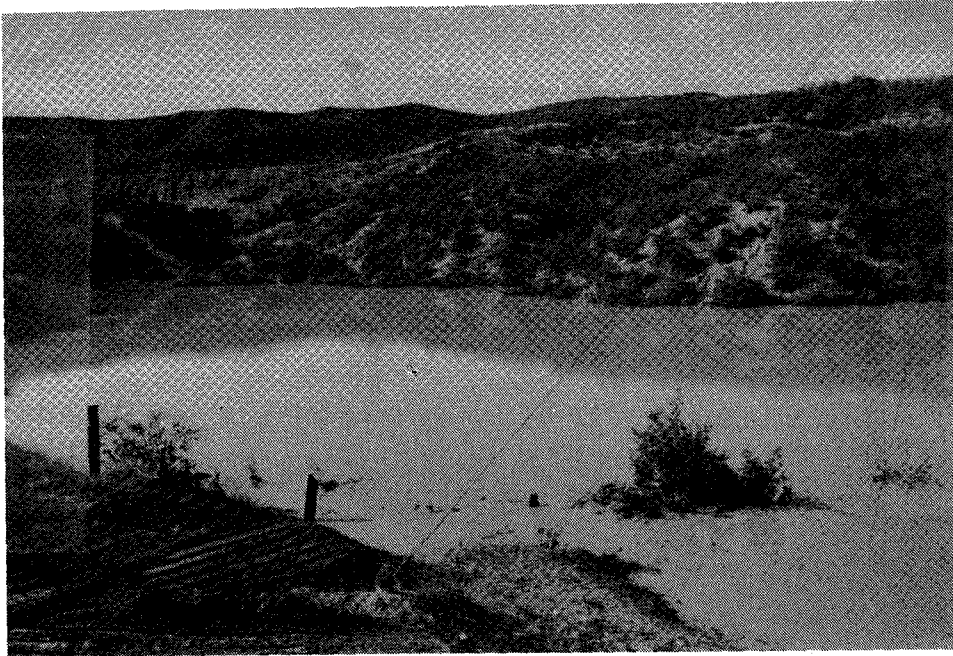
View looking north from "Spur Track No. 15" showing the water impounded north of the landfill.

Examination of the accident scene disclosed that the impounded water north of the main track eventually penetrated the base of the landfill. That penetration progressed until the binding agents of the landfill could no longer hold the fill together. At that point the landfill collapsed.

3. It is apparent that the landfill failure was caused by unusually heavy rainfall, and water being impounded north of the main tracks. This accumulation of water penetrated the base of the landfill and created the washout.

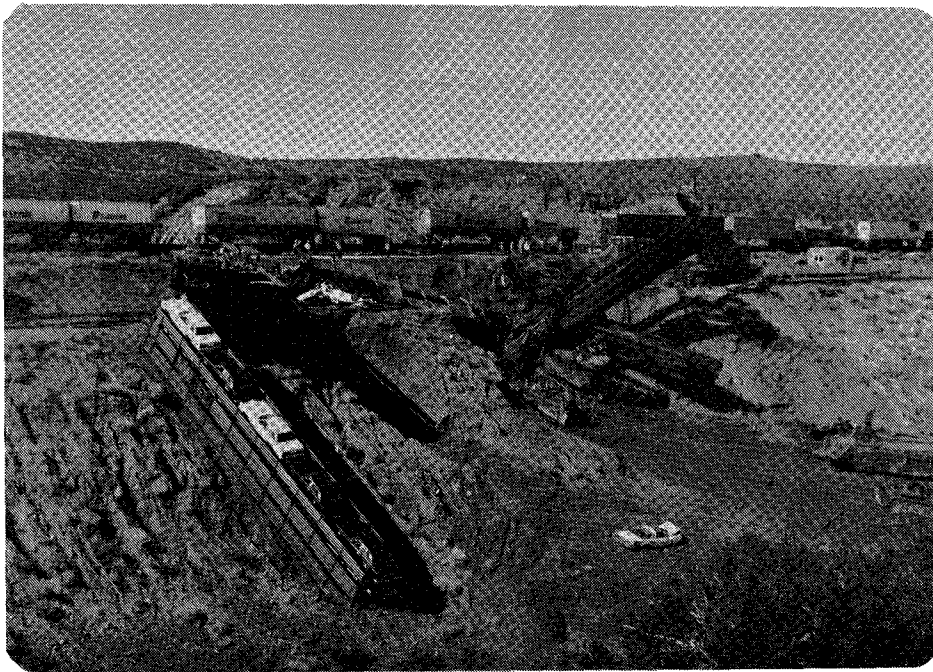
The momentum of the train carried the lead locomotive unit across the 95 foot washed out landfill and brought it to rest on the east edge of the area (as shown in the photograph). The three remaining locomotive units and the first six cars fell into the chasm created by the washout and immediately caught fire. The next ten cars were derailed and stopped on or near the track structure.
