ACCIDENT ON THE

ATCHISON, TOPEKA & SANTA FE RAILWAY

BARSTOW, CALIF.

INVESTIGATION NO. 2183

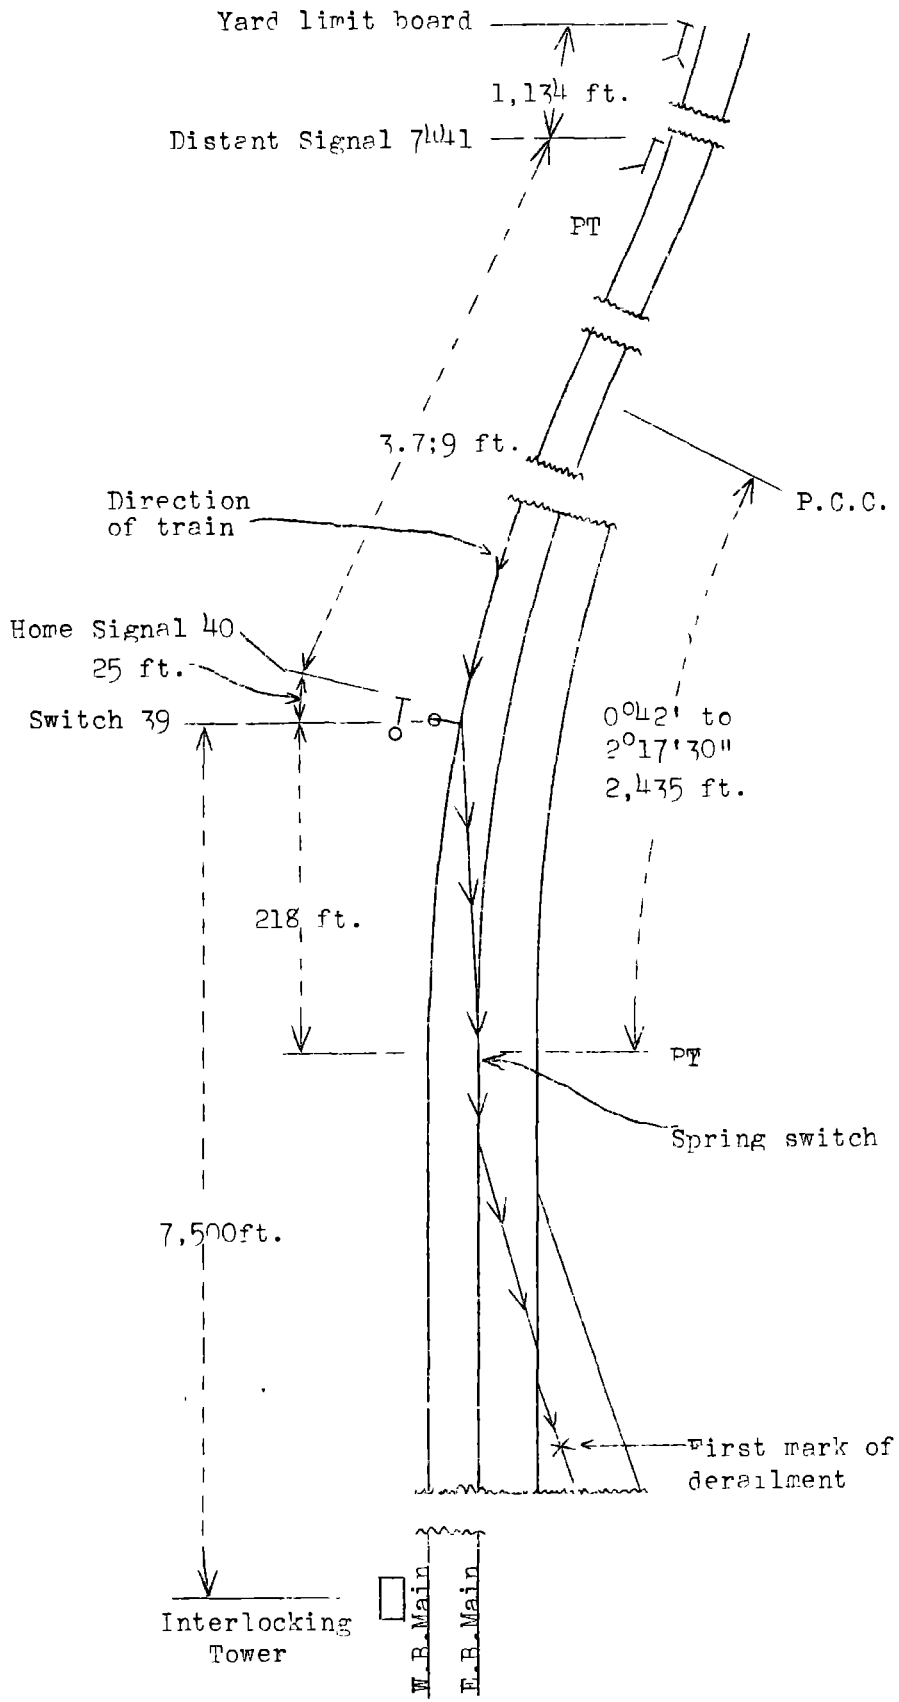
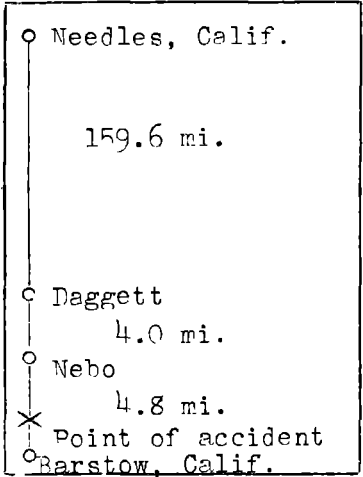
Inv. No. 2183
 Atchison, Topeka & Santa Fe Ry.
 Barstow, Calif.
 June 29, 1937

The first marks of derailment appeared on yard track No. 10 at a point 471 feet west of switch 39. Approaching this point from the east there is a compound curve to the left 2,435 feet long, which ranges in curvature from $0^{\circ}42'$ to $2^{\circ}17'30''$, upon which switch 39 is located at a point 218 feet from its western end; then two No. 10 turnouts, each 90 feet long, extending from the westward main track to the yard lead and track 10.

Engine 3521 stopped on its right side on yard track 11, with its forward end 881 feet west of switch 39; the tender was also on its side, south of and opposite the engine, across yard tracks 9 and 10. All four cars were derailed, but remained practically upright across yard tracks 9 and 10. The employee injured was the engineman.
