INVESTIGATION NO. 2555

THE ATCHISON, TOPEKA & SANTA FE RAILWAY COMPANY

REPORT IN RE ACCIDENT

AT BARSTON, CALIF., ON

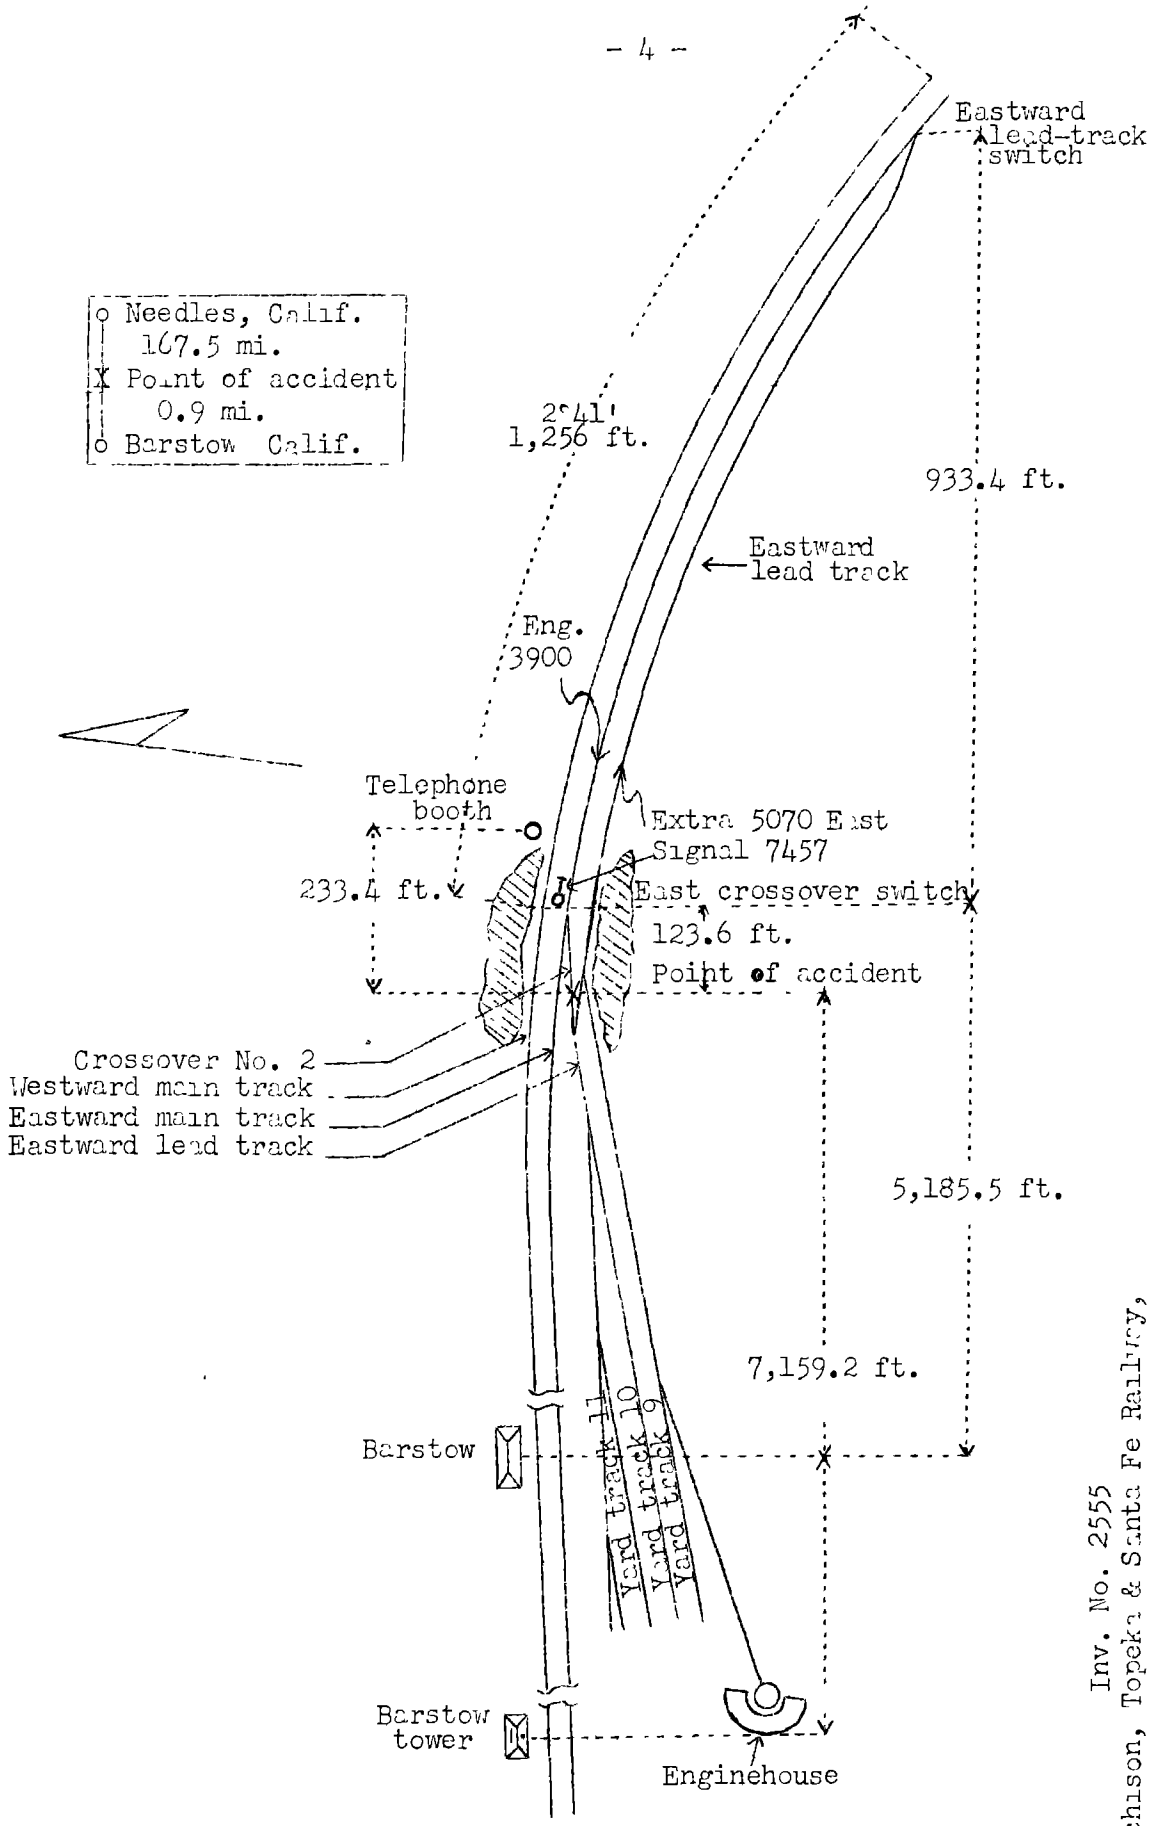
Inv. No. 2555  
 Atchison, Topeka & Santa Fe Railway,  
 Barstow, Calif.,  
 December 28, 1941.

In Barstow Yard trains of the Union Pacific Railroad, hereinafter referred to as the U.P., are operated over the tracks of the Atchison, Topeka & Santa Fe Railway, hereinafter referred to as the A.T.& S.F. This accident occurred on that part of the Arizona Division designated as the Second District, which extends between Needles and Barstow, Calif., a distance of 168.4 miles. In the vicinity of the point of accident this is a double-track line over which trains are operated with the current of traffic by an automatic block-signal system. Within yard limits at Barstow trains and engines move against the current of traffic by authority granted by signalmen. At Barstow the freight classification yard lies south of the main tracks. The eastward lead track of this yard parallels the main tracks and is connected to the eastward main track at a point 6,118.9 feet east of the station. Crossover No. 2, which is trailing-point for movement with the current of traffic, connects the eastward main track and the eastward lead track. The east switch of this crossover, which is of the spring type, is normally lined for west-bound movements from the eastward main track to the eastward lead track and is located 5,185.5 feet east of the station and 933.4 feet west of the east lead-track switch. The switchstand involved bears the letter "S" to designate that it is a spring switch. It is not equipped with either a lamp or a target. The accident occurred at the fouling point of crossover No. 2 at a point 123.6 feet west of the east crossover switch. As the point of accident is approached from the east on the eastward main track there is a compound curve to the left, which has a maximum curvature of 2°41' and extends 1,256 feet to the east switch of crossover No. 2. At the point of accident the grade is 0.33 percent descending westward.

Automatic signal 7457 is of the dwarf, 2-indication, color-light type, and is located between the eastward and the westward main tracks at a point about 10 feet east of the east switch of crossover No. 2. It displays a green aspect when the east crossover switch is lined for entry to the crossover and a red aspect when this switch is lined for a west-bound movement on the eastward main track.

Engine 3900 entered the eastward main track at the east lead-track switch, then, in backward motion, it moved westward against the current of traffic on the eastward main track, entered crossover No. 2 and while moving at an estimated speed of 1 to 6 miles per hour it collided with the eighth car of Extra 5070 East.

Because of track curvature and the lead track being occupied by a train, the view from either side of an engine moving backward against the current of traffic on the eastward main track was considerably restricted.
