INVESTIGATION NO. 2597
THE ATCHISON, TOPEKA & SANTA FE RAILWAY COMPANY
REPORT IN RE ACCIDENT
NEAR CALZONA, CALIF., ON
JUNE 25, 1942

Accident near Calzona, Calif., on June 25, 1942, caused by
a bridge being burned out.

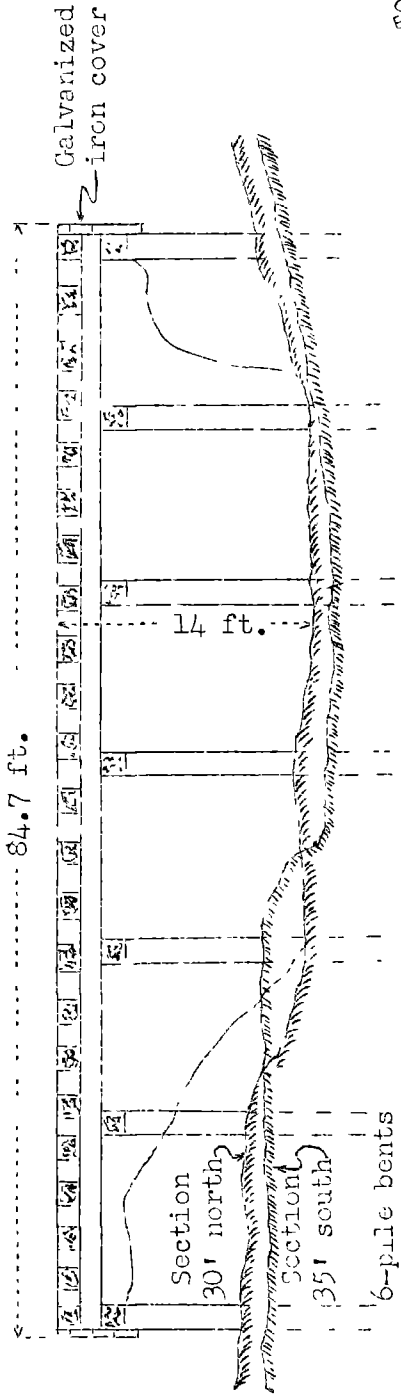
Side view of
Bridge 111-P

The investigation disclosed that prior to the time of the accident all the deck and practically all the piles of this bridge had been destroyed by fire. The manner in which the bridge was burned indicated that the fire had started at the bottom of the bents and burned upward. Some of the piles were burned 4 to 5 inches below the ground level. Immediately after the accident occurred no flame was visible, but the abutment bents were still smouldering. Ashes had been blown away by a 35-mile-per-hour wind that had prevailed throughout the evening. Charcoal and ashes from the bridge were found at points 500 feet north of the location of the bridge. The evidence indicates that only the rails remained in place. Because of tangent track throughout a distance of 1,089 feet east of Bridge 111-B, the enginemen could have had an unobstructed view of the bridge. Since both enginemen were killed in the accident it could not be determined when they first became aware of the defective condition of the bridge, but apparently the engine was close to the east end of the bridge as the brakes were not applied until about 2 seconds before the accident occurred.
