REPORT OF THE DIRECTOR OF THE BUREAU OF SAFETY CONCERNING AN
ACCIDENT ON THE ATCHISON, TOPEKA & SANTA FE RAILWAY
NEAR CAMBRIDGE, KANS., ON SEPTEMBER 7, 1934.

November 8, 1934.

Inv. No. 1930
Atchison, Topeka & Santa Fe Ry.,
Cambridge, Kansas
Sept. 7, 1934

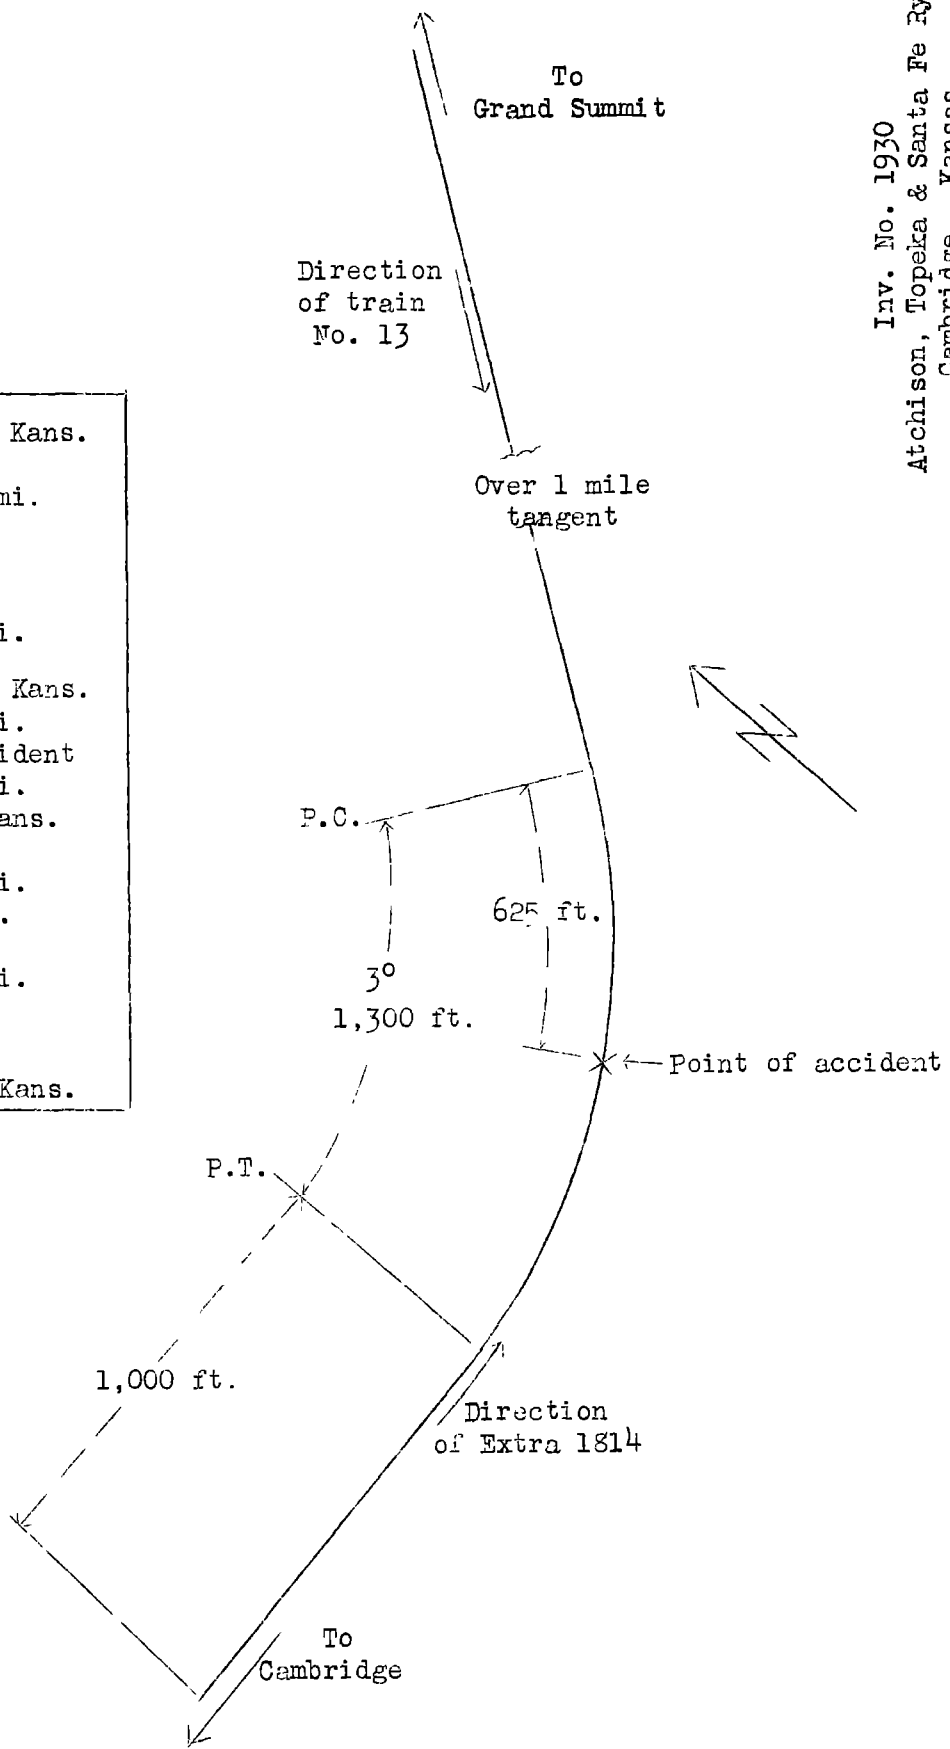
Owing to a cut about 10 feet in depth and a field of corn on the inside of the curve the view was restricted to a very short distance.

Point of accident
