INVESTIGATION NO. 2746

THE ATCHISON, TOPEKA & SANTA FE RAILWAY COMPANY,

REPORT IN RE ACCIDENT

AT DEVORE, CALIF., ON

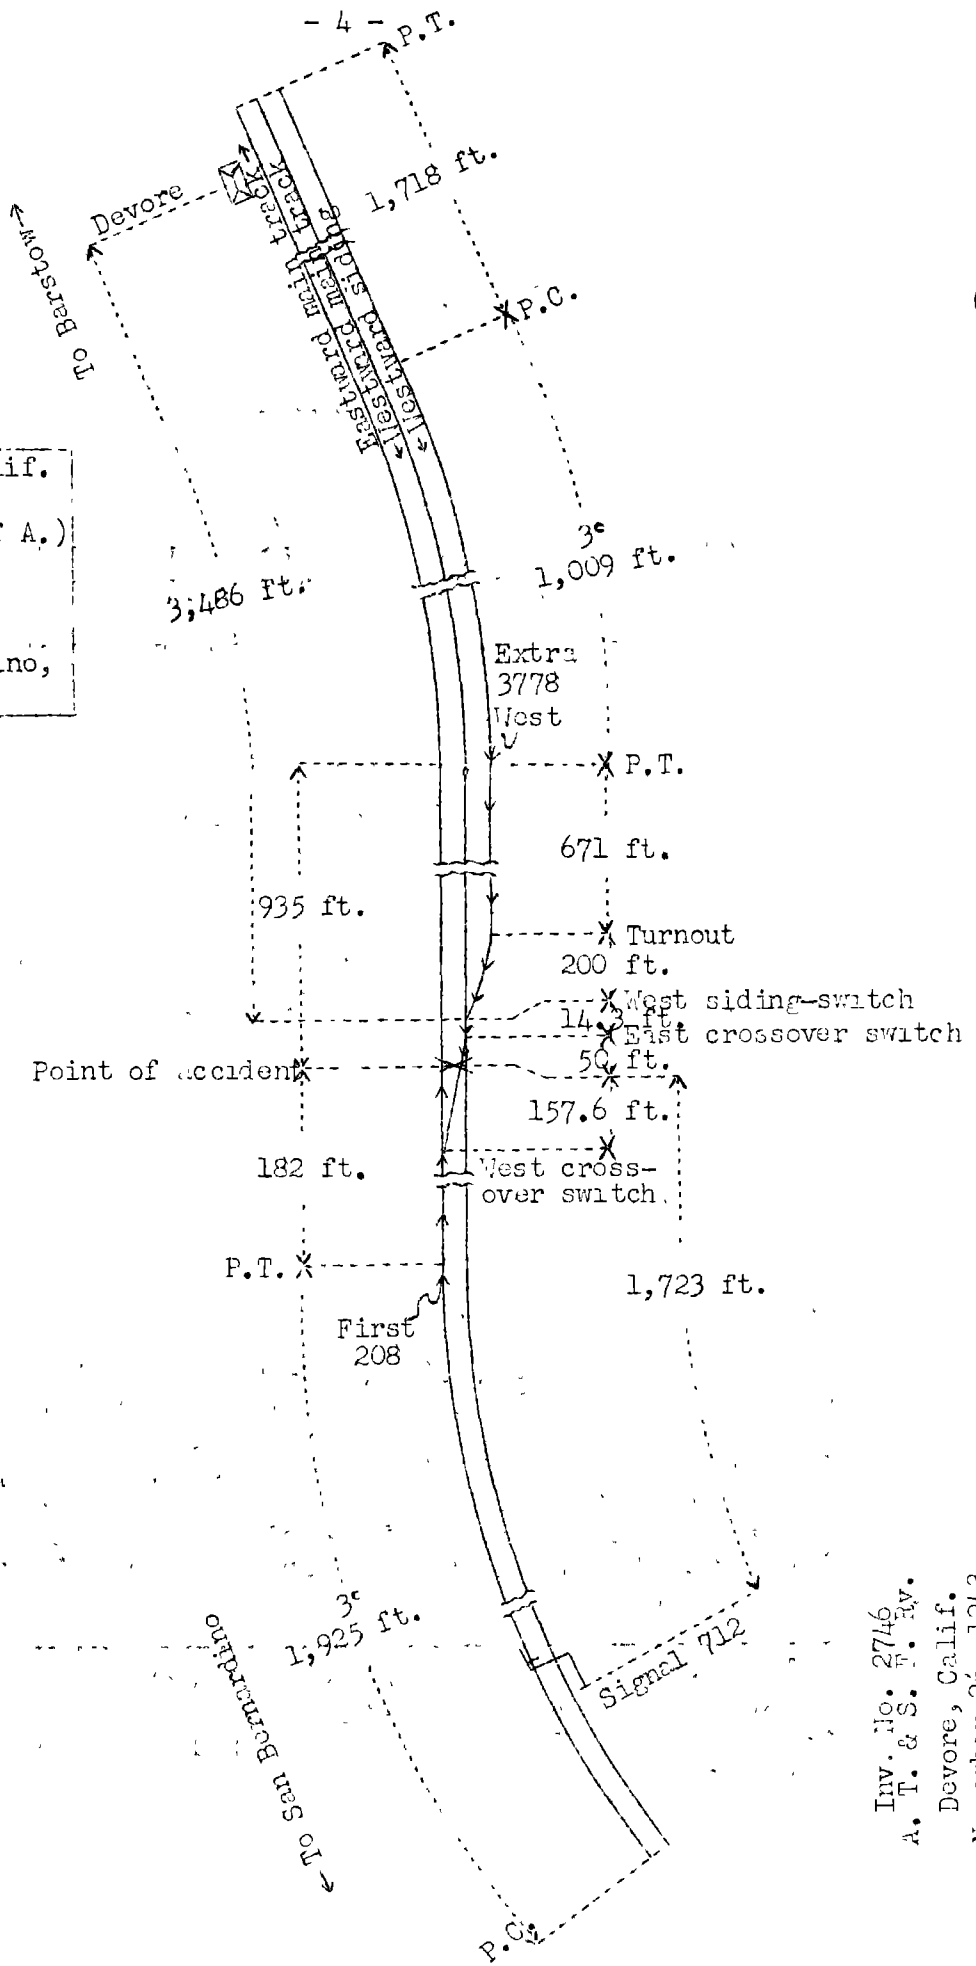
Inv. No. 2746  
A. T. & S. F. Ry.  
Devore, Calif.  
November 26, 1943

The rear truck of the seventh car, and the eighth, ninth and tenth cars of First 208 were derailed and considerably damaged. The seventh and tenth cars remained upright and in line with the eastward main track. The eighth and ninth cars stopped on their left sides north of the eastward main track and parallel to it. Engine 3778 was derailed and stopped, considerably damaged, upright and in line with the crossover.

If the switches of the crossover at Devore had been equipped with electric switch-locking, it would not have been possible to operate the switches to permit movement on the crossover when a train was moving on the eastward main track in the vicinity of the crossover, as in this case and the accident would not have occurred.

It is found that this accident was caused by the unintentional throwing of a switch immediately in front of an approaching train.

It is recommended that the Atchison, Topeka & Santa Fe Railway Company install electric switch-locking at main-track hand-operated switches in automatic block-signal territory.
