REPORT OF THE DIRECTOR

ACCIDENT ON THE

ATCHISON, TOPEKA & SANTA FE RAILWAY

INVESTIGATION NO. 2132

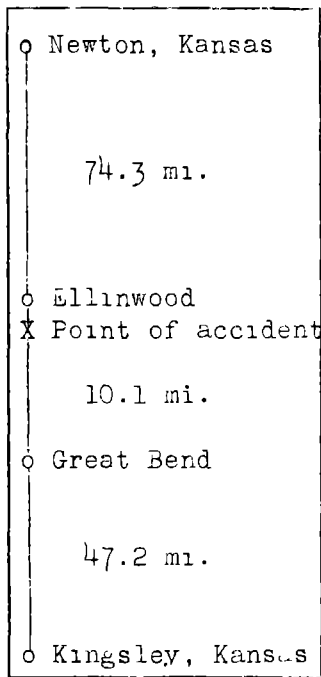
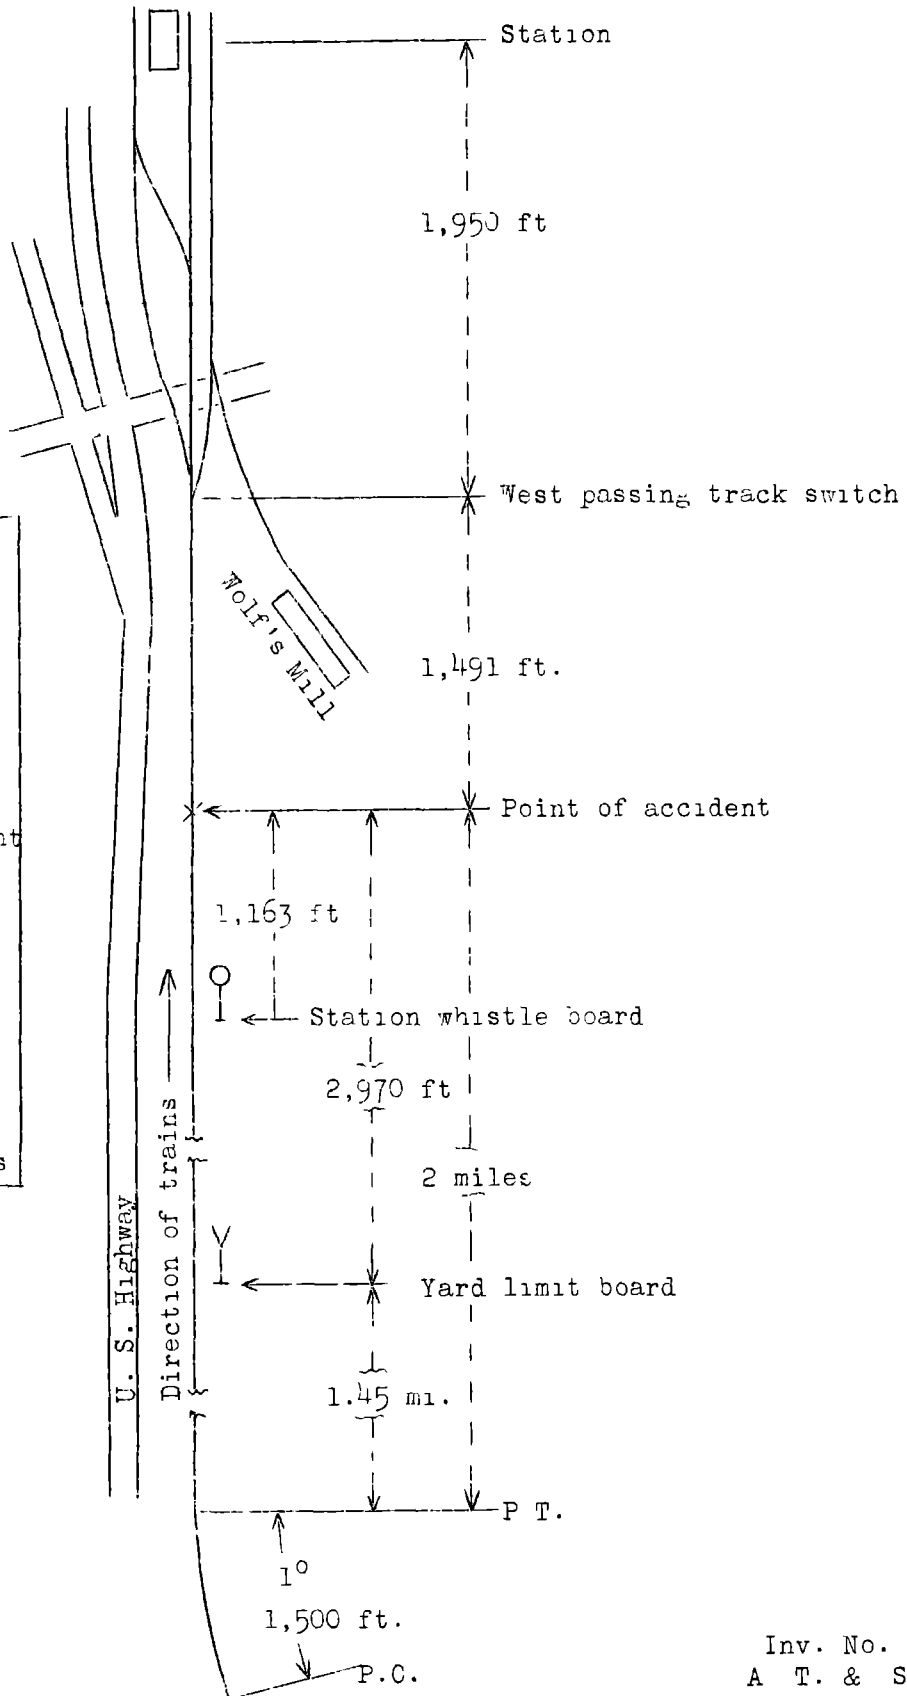
Inv. No. 2132  
 A T. & S F. Ry.  
 Ellinwood, Kansas  
 January 2, 1937.

The caboose, the drover's car and two rear cars of Extra 1807 were derailed to the right; the caboose and rear stock car were destroyed and the drover's car and the other stock car were badly damaged. Engine 1207 was derailed to the left of the track and stopped leaning at an angle of about 45°, with its front end about 150 feet beyond the point of accident. The tender, and the front trucks of the first two cars, were derailed, but neither of the cars was damaged. The employee killed was the conductor
