REPORT NO. 3296

THE ATCHISON, TOPEKA AND SANTA FE
RAILWAY COMPANY

AT KINCAID, CALIF., ON

Accident at Kincaid, Calif., on October 30, 1949, caused
by a broken switch-rail.

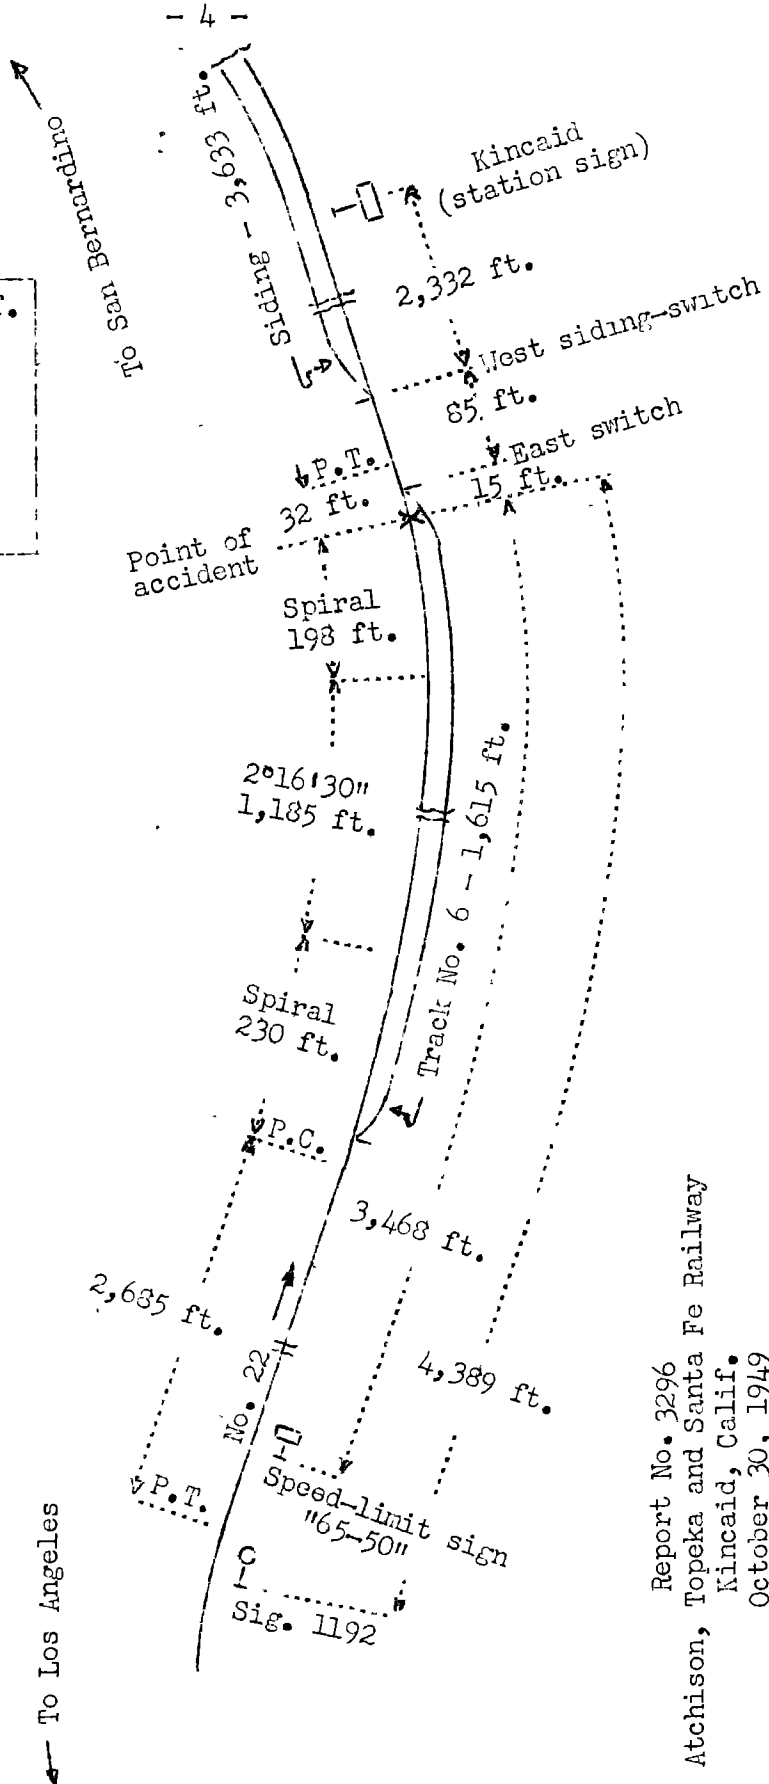
Sketch showing broken switch rail - south side of track

Examination of the track after the accident occurred disclosed that the normally closed switch-rail of the east switch of track No. 6 was broken. The break was a progressive fracture. It occurred about 2 inches east of the easterly edge of a switch tie. A section at the heel of the switch-rail measuring 16 inches along the head and 23-1/2 inches along the base remained bolted in place. Another section measuring 14 feet 9 inches along the head and 14 feet 6-1/2 inches along the base was lying on the ties, between the rails and approximately 2-1/2 feet east of its original position. A triangular section of the head and web of the rail 5 inches in length measured along the head and extending downward about 3 inches to a rivet hole was not recovered. The metal was discolored throughout a distance of about 3/16 inch from the base. This condition indicated that the fracture had existed for some time prior to the derailment. The head of the rail on each side of the missing section was heavily battered. On the east end of the break there were flange marks on top of the rail which extended diagonally to the gage side. These marks indicated that wheels had mounted the rail at the break and then had dropped back into their normal position on the rail. At the lower portion of the rivet hole a lip had been formed on either side of the web.

Apparently the initial break was across the base of the switch-rail, and it progressed upward to the rivet hole and then diagonally upward through the head. After the break occurred, the point end of the rail was held in position only by the two switch rods which were connected near the point. The battering on either side of the break indicated that the triangular section which was not recovered was broken by a preceding train. Apparently the point end of the switch-rail was moved out of alignment by a train preceding No. 22, and then the free end was dislodged and overturned by the first Diesel-electric unit of No. 22.
