INTERSTATE COMMERCE COMMISSION

ACCIDENT ON THE

ATCHISON, TOPEKA & SANTA FE RAILWAY

KINGMAN, ARIZ.

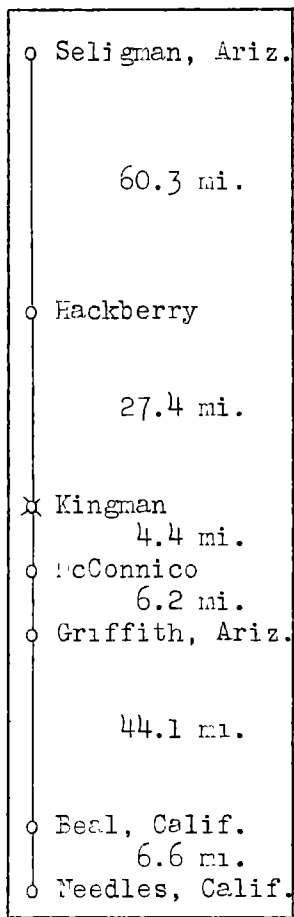
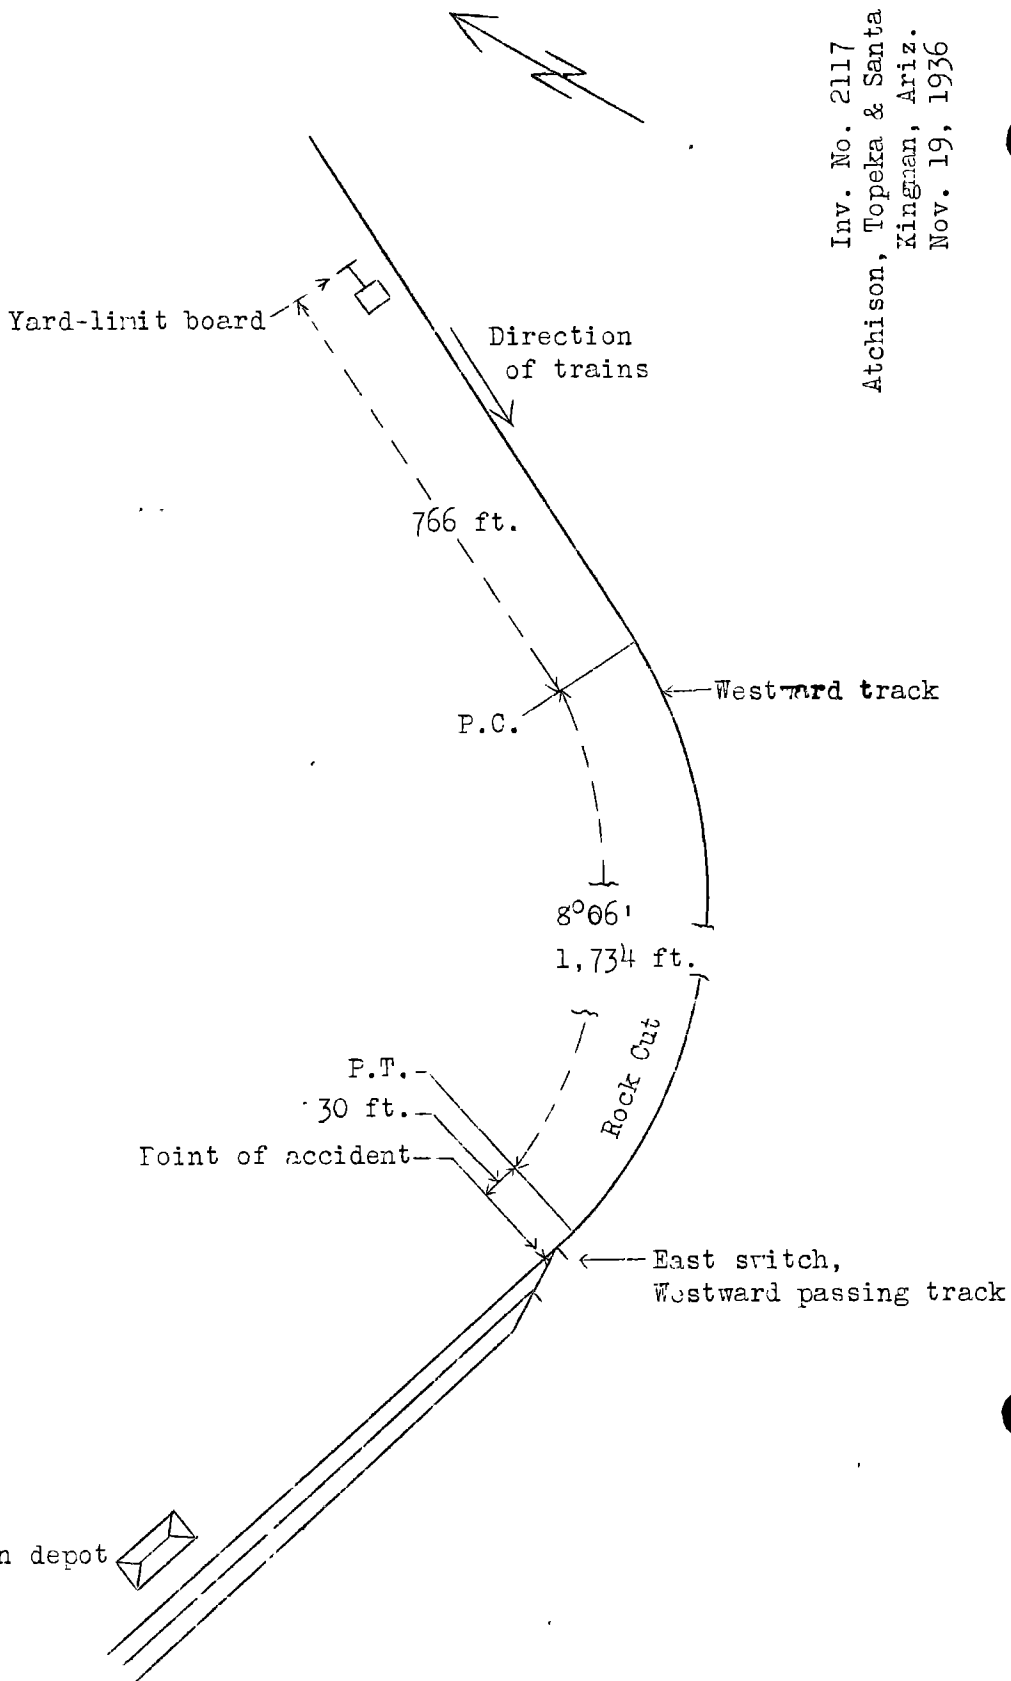
Inv. No. 2117  
Atchison, Topeka & Santa Fe Ry.  
Kingman, Ariz.  
Nov. 19, 1936

The accident occurred within yard limits, on the west-bound main track, at the east switch of the westward passing track, 2,530 feet west of the east yard-limit board; approaching this point from the east, beginning at the yard-limit board, the track is tangent for a distance of 766 feet, then there is a compound curve to the right 1,734 feet in length, with a maximum curvature of  $2^{\circ} 06'$ , followed by 30 feet of tangent track to the east switch of the westward passing track, this tangent extending for a considerable distance beyond. The grade for west-bound trains is descending, varying from 1.4 to 1.8 percent, and is at its maximum at the point of accident.

At the point where the accident occurred in Kingman yard the two main tracks are located a considerable distance apart; the westward passing track parallels the west-bound main track on the south. A rock cut on the inside of the curve involved restricts the view from the right side of the cab of a west-bound engine to a distance of less than 500 feet.
