INVESTIGATION NO. 2808

THE ATCHISON, TOPEKA & SANTA FE RAILWAY COMPANY

REPORT IN RE ACCIDENT

AT KIOWA, KANS., ON

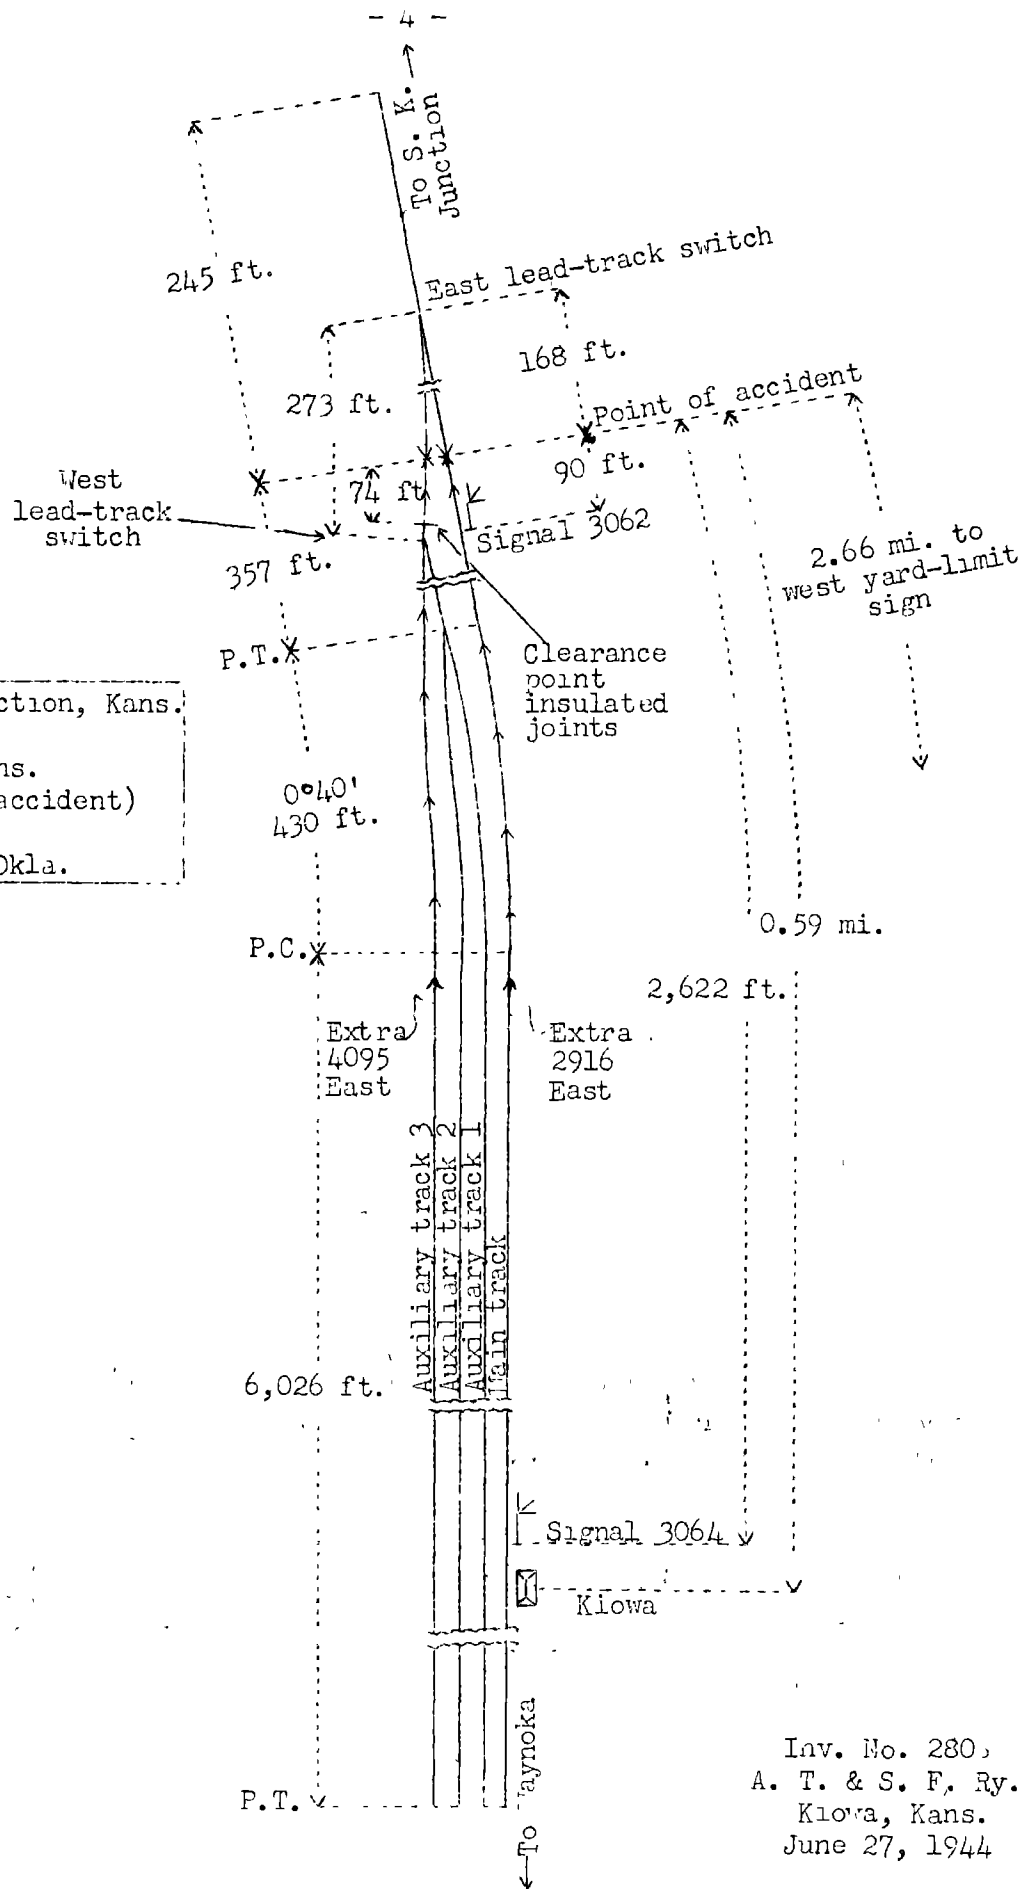
Inv. No. 280,
 A. T. & S. F. Ry.
 Kiowa, Kans.
 June 27, 1944

Location of Accident and Method of Operation
