INVESTIGATION NO. 3209

THE ATCHISON, TOPEKA AND SANTA FE
RAILWAY COMPANY

REPORT IN RE ACCIDENT

Accident near Mansfield, Kans., on October 21, 1948,
caused by a broken rail.

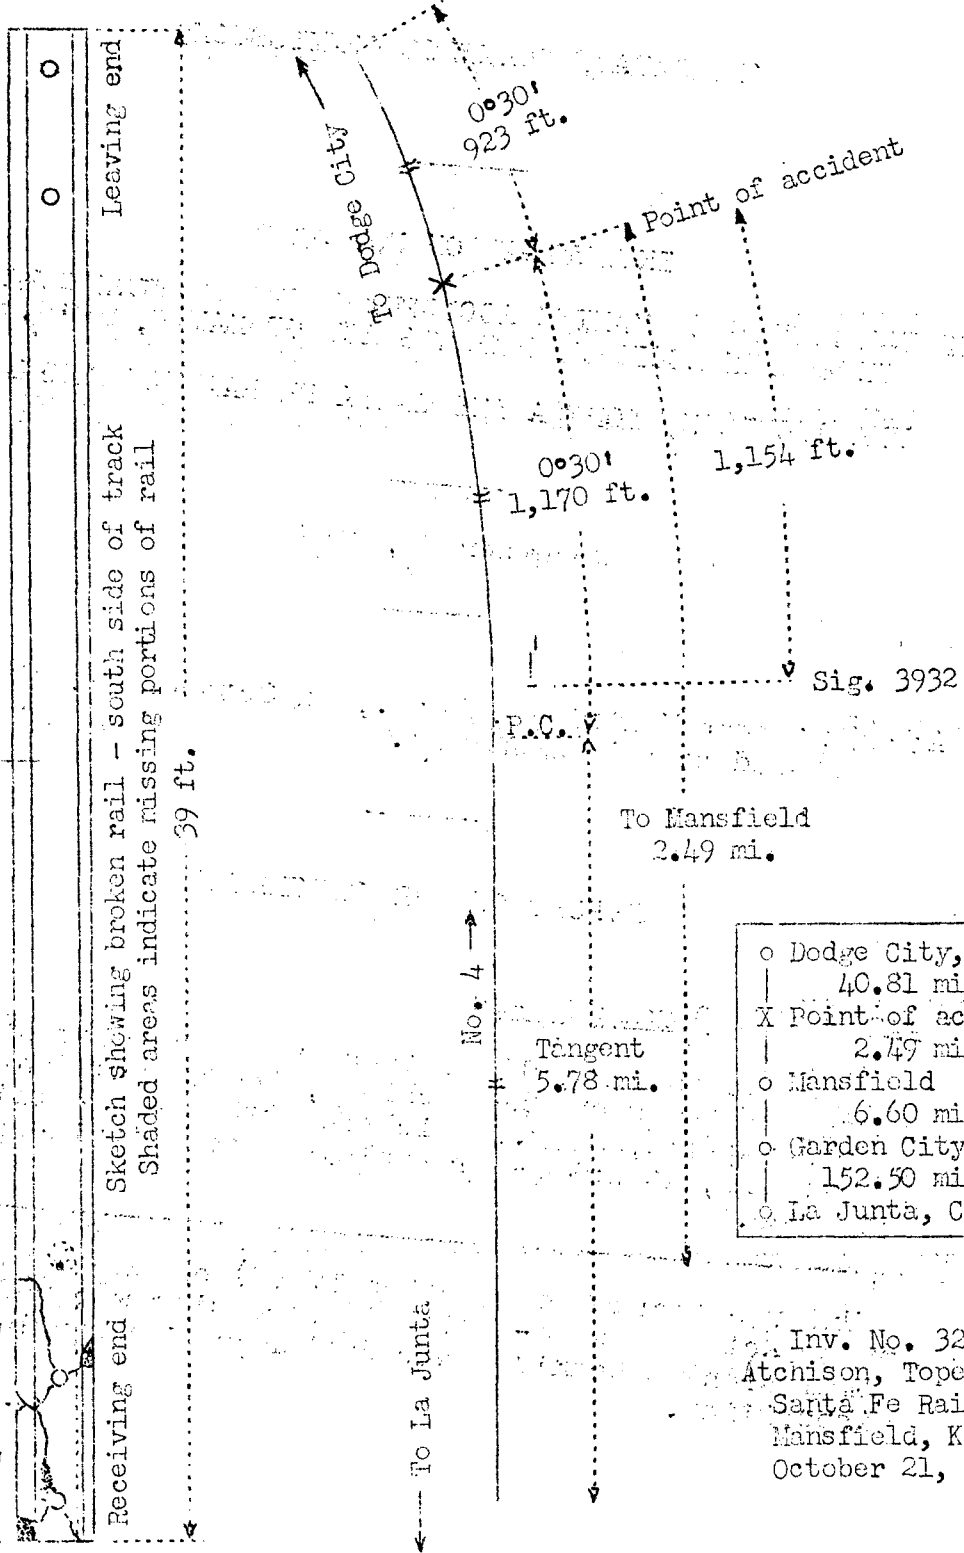
Inv. No. 3209
 Atchison, Topeka and
 Santa Fe Railway
 Mansfield, Kans.
 October 21, 1948

Break #2
 6-21/32"
 Break #1
 6-27/32"

Receiving end
 Leaving end

After the accident a broken rail was found on the south, or high, side of the curve at a point 1,170 feet east of the west end of the curve. This rail was manufactured by the Colorado Fuel and Iron Company in March, 1928. The heat number was 2863, Ingot S, Letter D. The rail was broken into nine pieces, six of which were recovered. The first break occurred within the limits of the joint bars at the receiving end of the rail. This break, which resulted from a crack in the web fillet beginning at a point $1-3/16$ inches from the receiving end, extended diagonally downward through the web to the No. 1 bolt hole, thence upward and away from the end of the rail thereby forming a triangle with the No. 1 hole as its apex and the head of the rail as its base. The crack had existed for some time prior to the derailment. The second break, which was a new fracture, extended upward from bolt hole No. 2 in an irregular diagonal line $4-7/8$ inches long and through the head at a point $13-1/2$ inches east of the end of the rail. This piece was battered downward and lipped over at an angle of about 35 degrees at its west end. The remainder of the breaks extended through the web and the base, and were a result of the derailment.

The division engineer said that the first break occurred as a result of a fatigue crack. He said that the marks on the rail and the manner in which it was broken indicated that the first break occurred under a west-bound train, and that a section of the head, 6-27/32 inches long, at the west end fell from the rail at that time. Then, when the front truck of the first Diesel-electric unit of No. 4 passed over the joint in question, a second section, 6-21/32 inches long, was broken from the head of the rail, and the derailment occurred.
