INVESTIGATION NO. 2896
THE ATCHISON, TOPEKA AND SANTA FE
RAILWAY COMPANY
REPORT IN RE ACCIDENT
AT NEMO, ILL., ON
JUNE 8, 1945

Accident at Nemo, Ill., on June 8, 1945, caused by a movement being made on an auxiliary track which was fouled by a car on a turnout of an adjacent auxiliary track.

Inv. No. 2896
 Atchison, Topeka and Santa Fe Railway
 Nemo, Ill.
 June 8, 1945

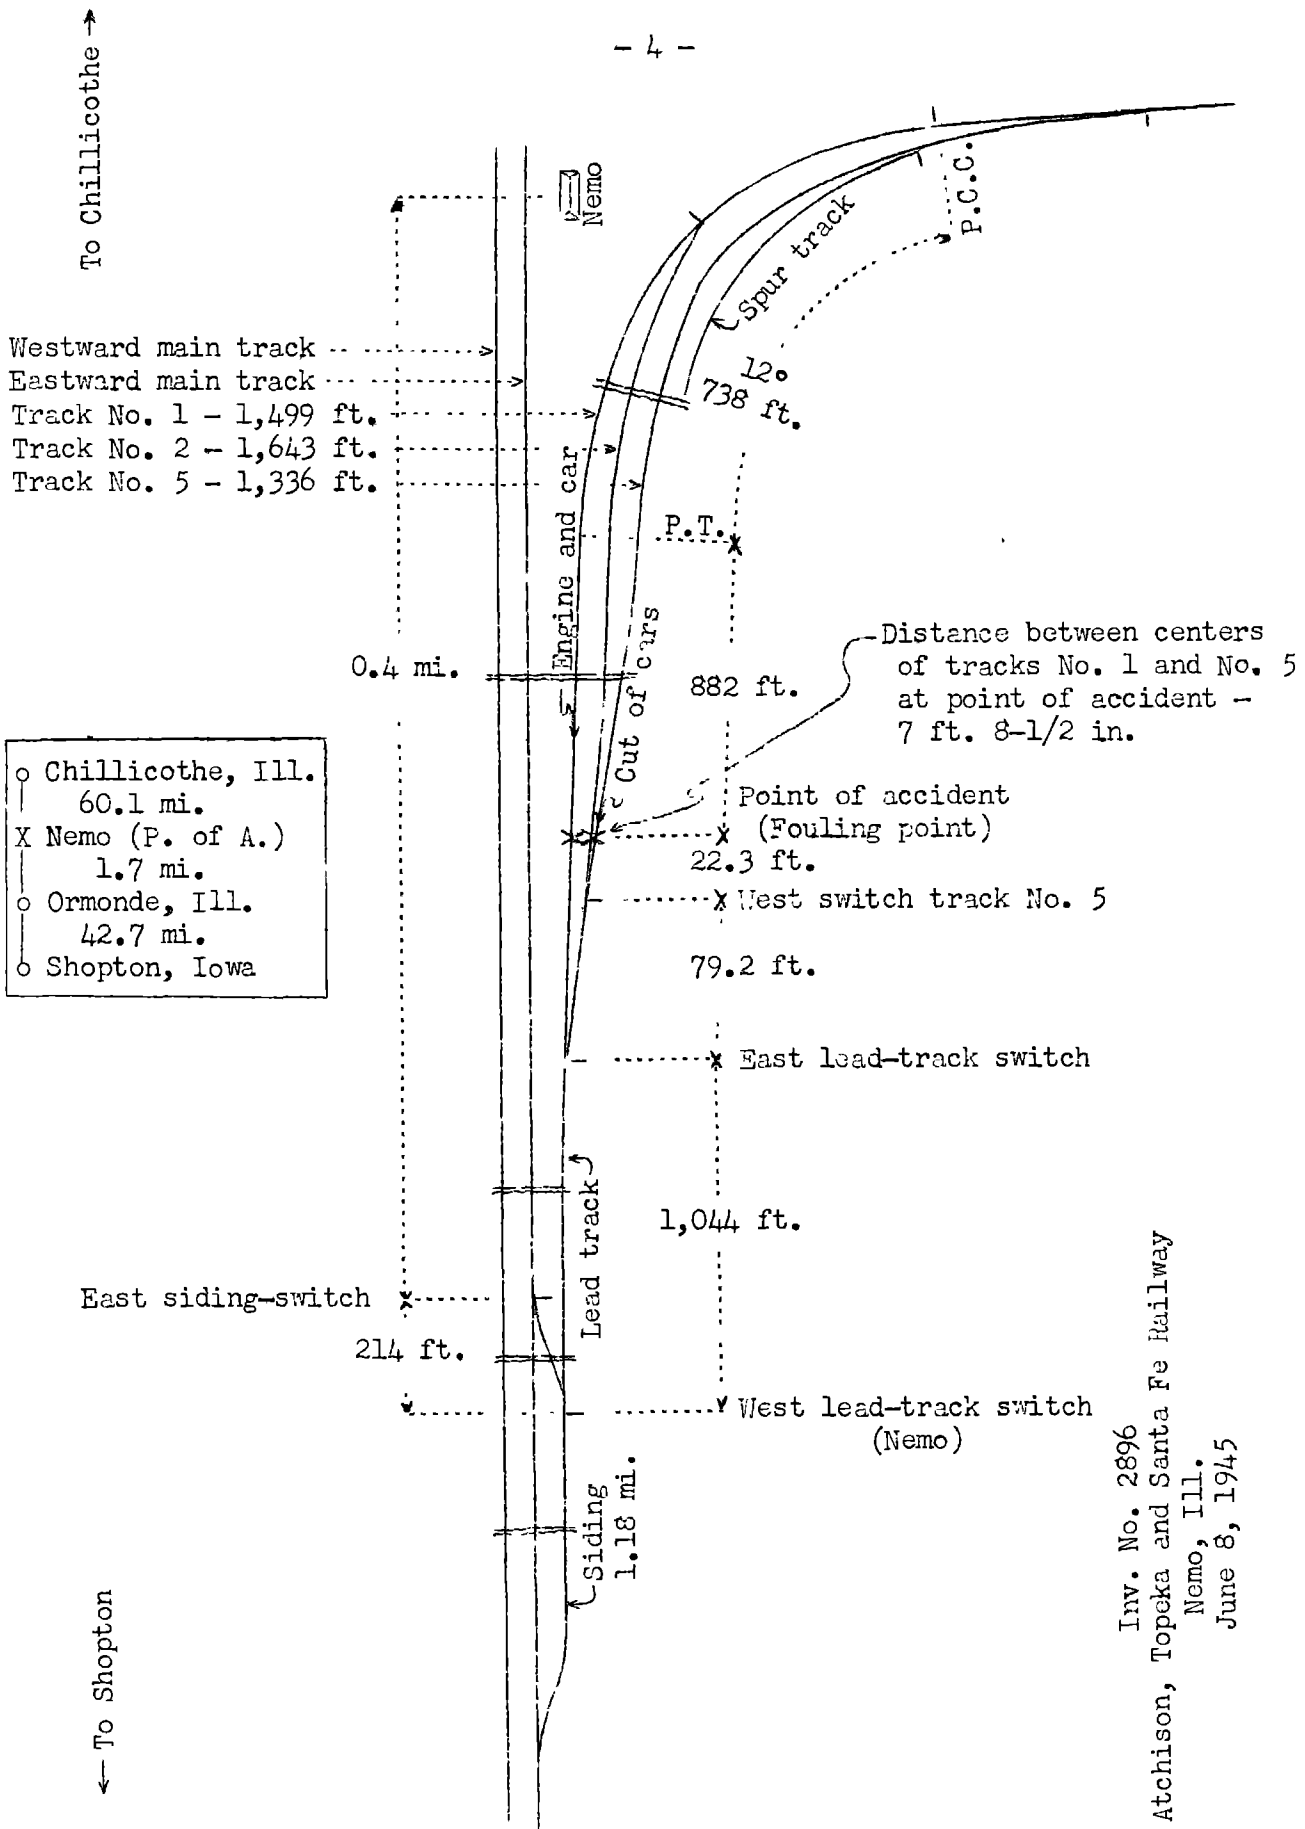
Location of Accident and Method of Operation

This accident occurred on that part of the Illinois Division designated as the Second District and extending eastward from Snopton, Iowa, to Chillicothe, Ill., 104.5 miles, a double-track line in the vicinity of the point of accident over which trains moving with the current of traffic are operated by signal indications and an automatic train-control system. Between Ormonde and Nemo, respectively, 42.7 and 44.4 miles east of Snopton, a siding 1.13 miles long parallels the main tracks on the south. The east switch of this siding is 0.4 mile west of the station at Nemo. The west switch of a lead track 1,044 feet long is 214 feet west of the east siding-switch. This track connects the east end of the siding and the west ends of three auxiliary tracks, designated from north to south as tracks No. 1, No. 2 and No. 5, which are, respectively, 1,499, 1,643 and 1,336 feet long. The west switch of track No. 5 is 79.2 feet east of the east lead-track switch, and is provided with a No. 8 turnout. The distance between the centers of track No. 1 and the turnout of the west switch of track No. 5 at the fouling point is 7 feet 8-1/2 inches. The accident occurred at the fouling point of track No. 1 and the turnout of the west switch of track No. 5, at a point 22.3 feet east of the west switch. From the east on track No. 1 there is a compound curve to the left 738 feet in length, the maximum curvature of which is 12°, which is followed by a tangent 882 feet to the point of accident. At the point of accident the grade is 0.54 percent ascending westward.

Extra 3190 East, an east-bound freight train, consisting of engine 3190, 69 cars and a caboose, stopped on the siding in the vicinity of the east switch at Nemo about 10 p. m. Soon afterward the engine and the first eight cars were detached and moved eastward on the lead track and track No. 1 to the east switch of track No. 5. Then the eighth car was coupled to the east end of a cut of 23 cars on track No. 5, and the 31 cars were moved westward on track No. 5 a sufficient distance for the east car to clear the turnout of the switch of a spur track located south of track No. 5. The engine was then detached from the cars on track No. 5 and coupled to a car of stock on the spur track. The engine, in backward motion and pushing the stock car, proceeded westward on track No. 1 and while moving at an estimated speed of 10 miles per hour the car being pushed by the engine struck the west car of the cut of 31 cars on track No. 5, at the fouling point of track No. 1 and the turnout of the west switch of track No. 5.

Engine 3190 was pushing a car westward on track No. 1 when the car struck the west car of a cut of 31 cars, which was standing on the turnout of track No. 5 and fouling track No. 1. It was dark, and night signals were being used. The front brakeman, who was on the west end and the south side of the car that was being pushed by the engine, was killed in the accident.
