REPORT NO. 3343
THE ATCHISON, TOPEKA AND SANTA FE
RAILWAY COMPANY
IN RE ACCIDENT
AT MONICA, ILL., ON
JULY 6, 1950

Accident at Monica, Ill., on July 6, 1950, caused by
dragging equipment, and by a derailed car obstructing
an adjacent main track in front of an approaching
train.

Report No. 3343
 Atchison, Topeka and
 Santa Fe Railway
 Monica, Ill.
 July 6, 1950

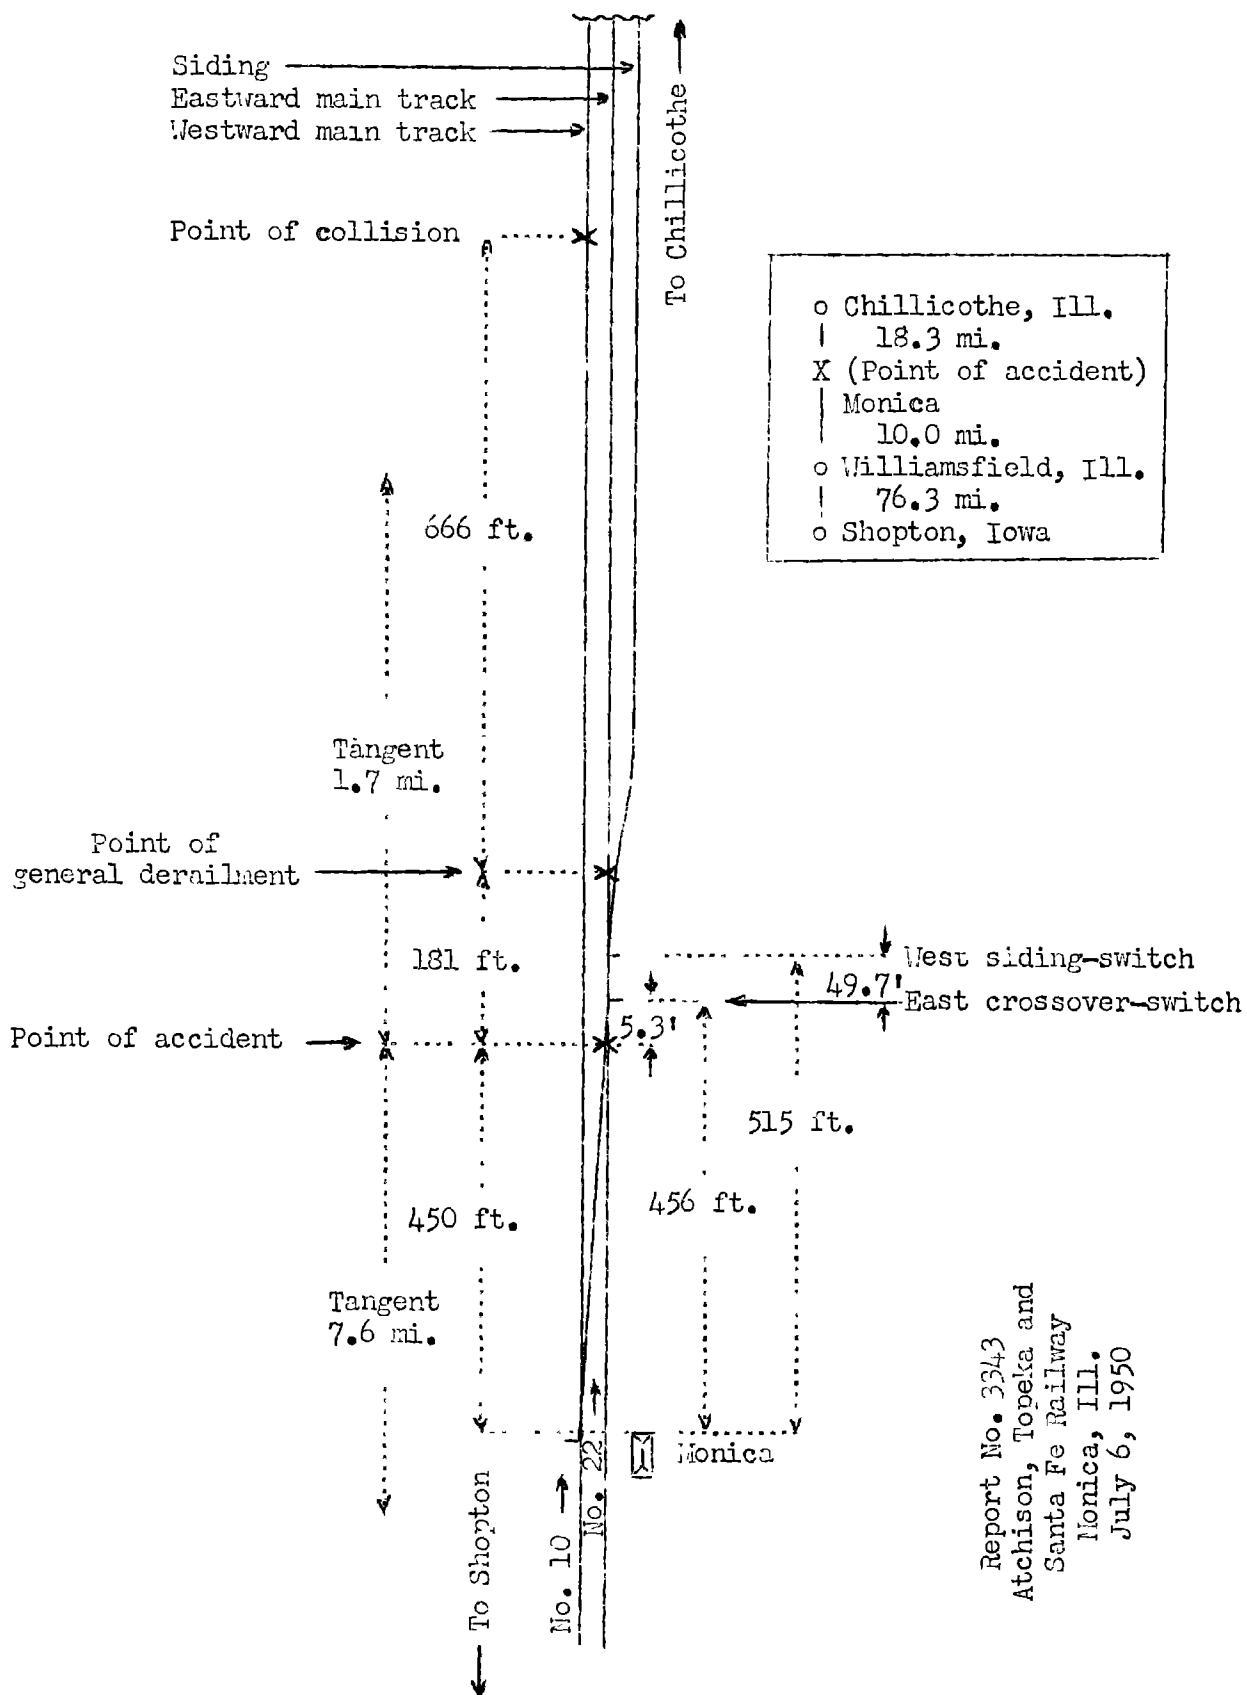
This accident occurred on that part of the Illinois Division extending between Shopton, Iowa, and Crillicoth, Ill., 104.6 miles. In the vicinity of the point of accident this is a double-track line, over which trains are operated in either direction on either track by automatic cab signal indications and an automatic train-control system of the three-speed continuous-inductive type. There are no wayside signals except at interlockings. From south to north the main tracks are designated as eastward and westward. At Monica, Ill., 86.3 miles east of Shopton, a siding, designated as the eastward siding, parallels the eastward main track on the south. The west switch of this siding is located 515 feet east of the station. The east switch of a crossover, which connects the eastward and westward main tracks, is located 456 feet east of the station. This switch is trailing-point for east-bound movements on the eastward main track. The initial derailment occurred on the eastward main track 450 feet east of the station at Monica, and the general derailment occurred 181 feet eastward. The collision occurred on the westward main track 666 feet east of the point of general derailment. From the west the main tracks are tangent 7.6 miles to the point of accident and 1.7 miles eastward. In the vicinity of the point of accident the grade is practically level.
