INVESTIGATION NO. 2868  
THE ATCHISON, TOPEKA & SANTA FE RAILWAY COMPANY  
REPORT IN RE ACCIDENT  
AT STAFFORD, KANS., ON  
FEBRUARY 10, 1945

Railroad: Atchison, Topeka & Santa Fe  
Date: February 10, 1945  
Location: Stafford, Kans.  
Kind of accident: Rear-end collision  
Trains involved: Passenger : Passenger  
Train numbers: 68 : Extra 1473 East  
Engine numbers: Gas-electric M-182 : 1473  
Consist: Motor-car : 17 cars  
Estimated speed: Standing : 25 m. p. h.  
Operation: Timetable, train orders and  
automatic block-signal system  
Track: Single; tangent; 0.162 percent  
descending grade eastward  
Weather: Clear  
Time: 10:43 p. m.  
Casualties: 1 killed; 11 injured  
Cause: Failure properly to control speed  
of following train in accordance  
with signal indications

Accident at Stafford, Kans., on February 10, 1945, caused  
by failure properly to control the speed of the  
following train in accordance with signal indications.

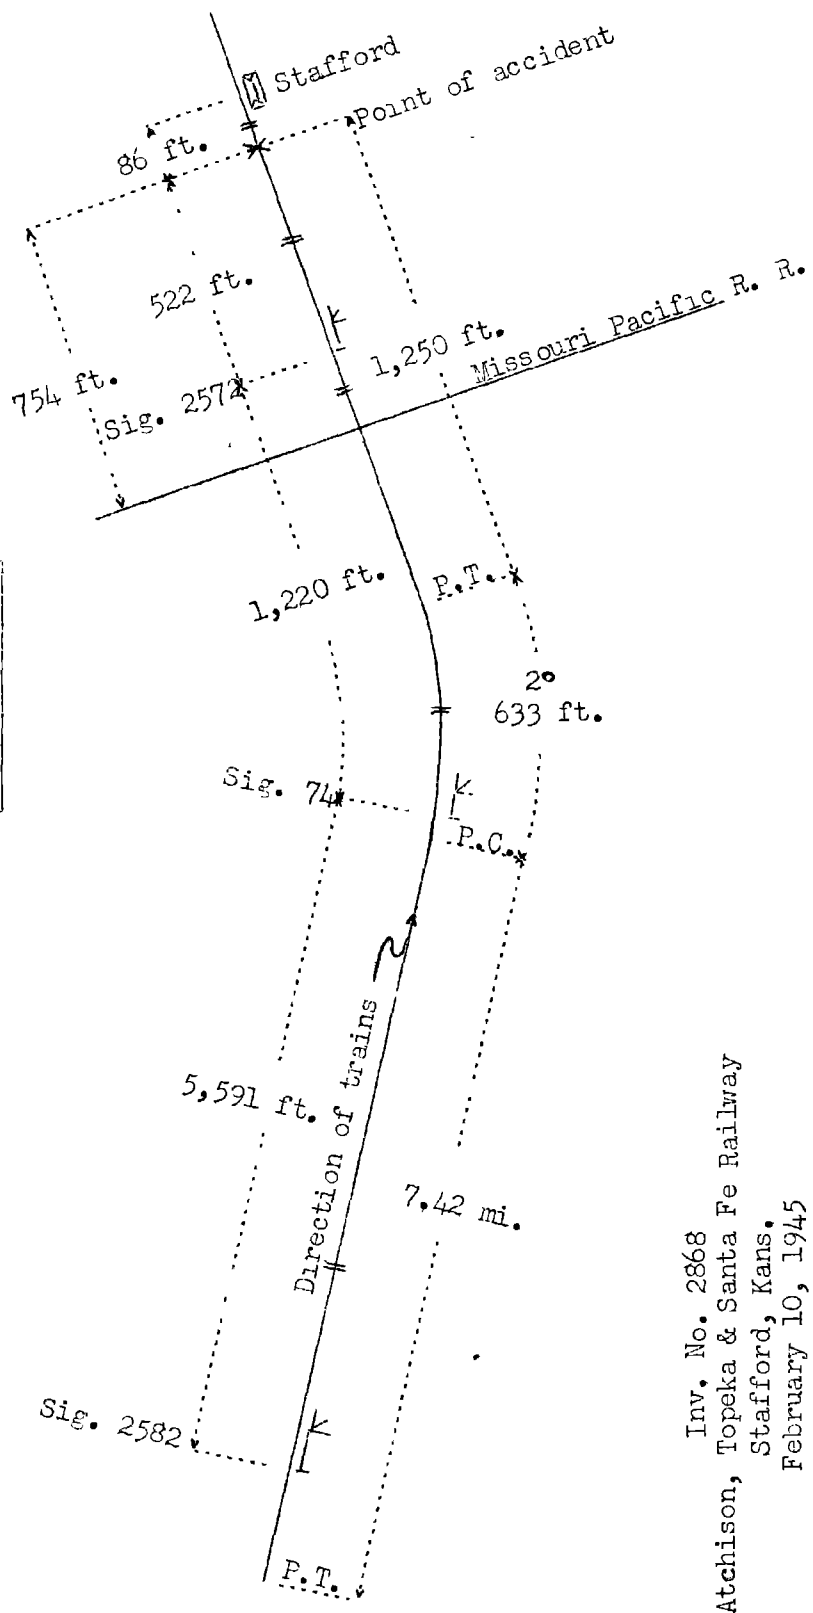
Inv. No. 2868  
 Atchison, Topeka & Santa Fe Railway  
 Stafford, Kans.  
 February 10, 1945

Signals 2582, 74 and 2572, governing east-bound movements, were, respectively, 7,333, 1,742 and 522 feet west of the point of accident. The involved night aspects and corresponding indications and names of these signals were as follows:

The controlling track circuits were so arranged that, when an east-bound train occupied the main track in the block immediately east of signal 2572, signal 2572 would display stop-and-proceed and signals 74 and 2582 would display proceed-at-restricted-speed.

The force of the impact crushed the passenger compartment of motor-car M-182 a distance of 13 feet 8 inches, and the car was moved eastward about 470 feet. The front end of engine 1473 was considerably damaged.
