RAILROAD ACCIDENT INVESTIGATION

Report No 4007

THE ATCHISON, TOPEKA AND SANTA FE RAILWAY COMPANY

April 5, 1964

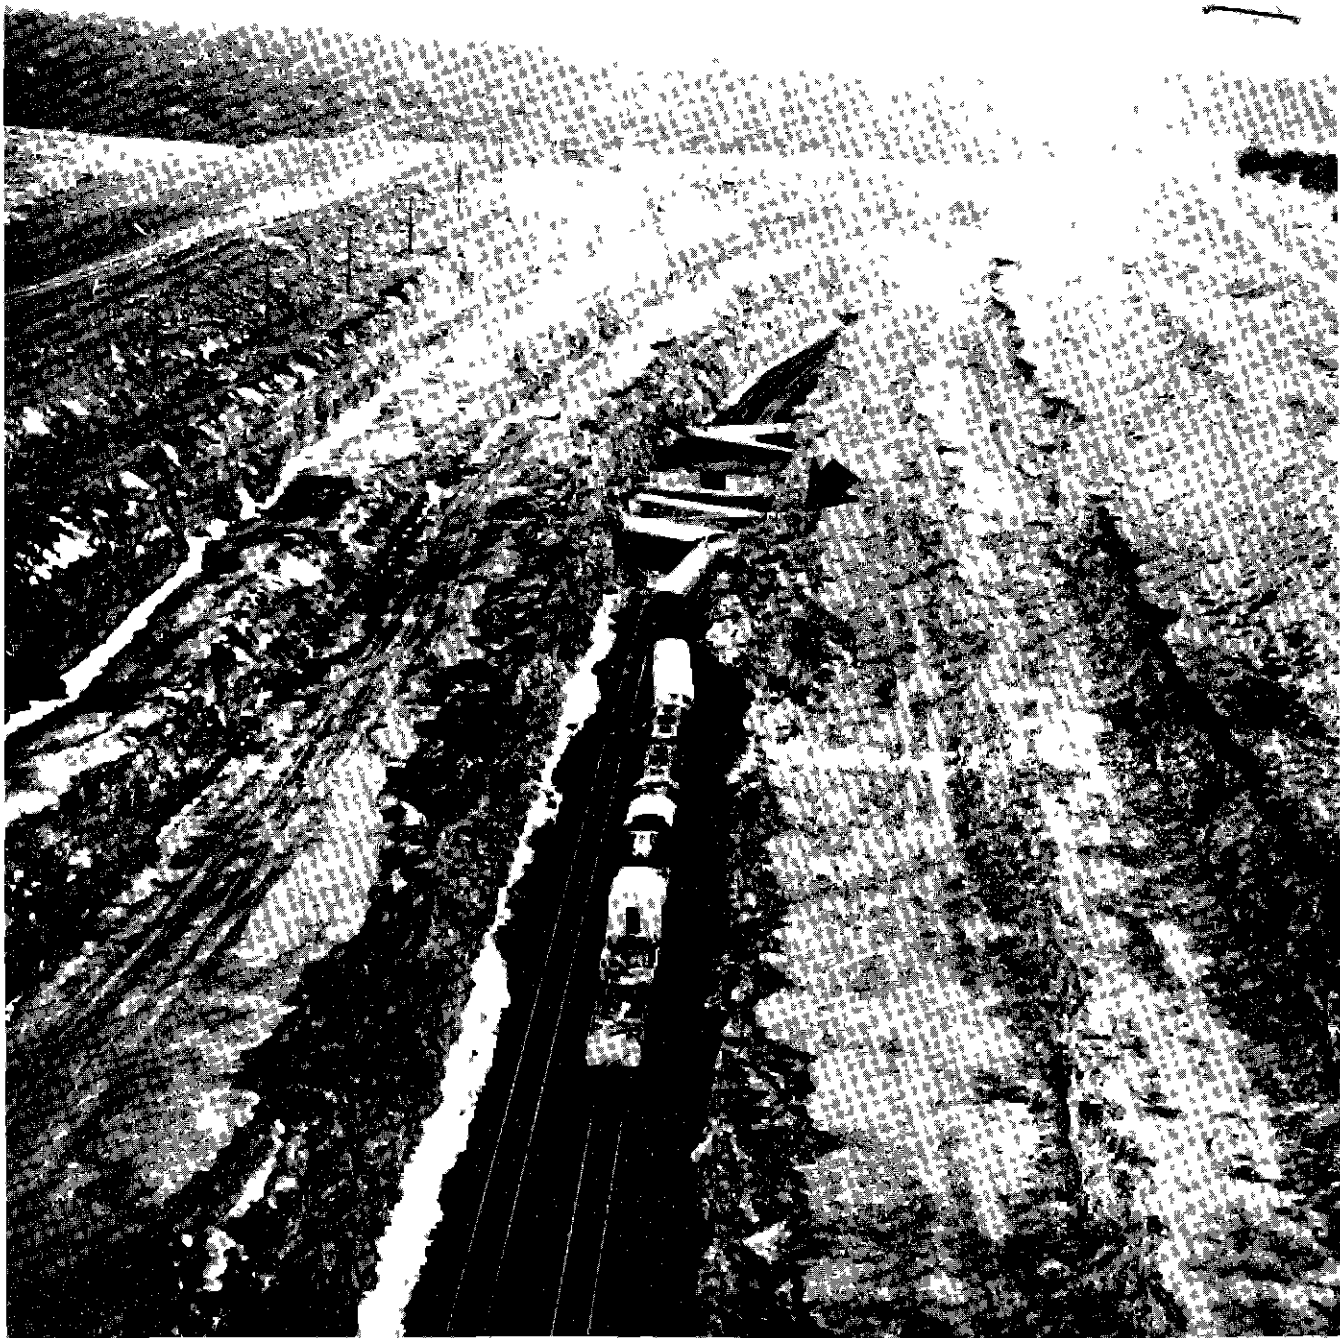
Westward view Wrecking train in center foreground. Arrow shows point where rock slide occurred.

Examination of the north wall of the cut revealed a large, fresh, V-shaped cavity opposite the point of derailment. Beginning near the base of the wall, the cavity extended upward about 40 feet to a bench in the cut. At the top of the bench, the cavity was approximately 100 feet long and 14 feet wide. Rocks and earth from this area fell on the structure of the tracks and caused the derailment.

It is apparent the rock slide was caused by the precipitation followed by alternate freezing and thawing that occurred during the 35-day period preceding the day of the accident. The slide occurred within a period of about 1 hour 39 minutes before No. 123 passed Doublea and did not affect the circuits of the wayside signal system. Signal 2L displayed a proceed aspect as the train locomotive approached and passed it at a speed of 81 miles per hour. It is evident the engineer was unable to see the rock slide obstructing the westward track in sufficient time to materially reduce the speed prior to the derailment. Unless the slide occurred immediately in front of the approaching train, a rock slide detector fence installed along the base of the north wall probably would have averted this derailment.

This accident was caused by the track being obstructed by a rock slide.

It is recommended that rock slide detector fences be installed along both sides of the track structure throughout the length of the cut.

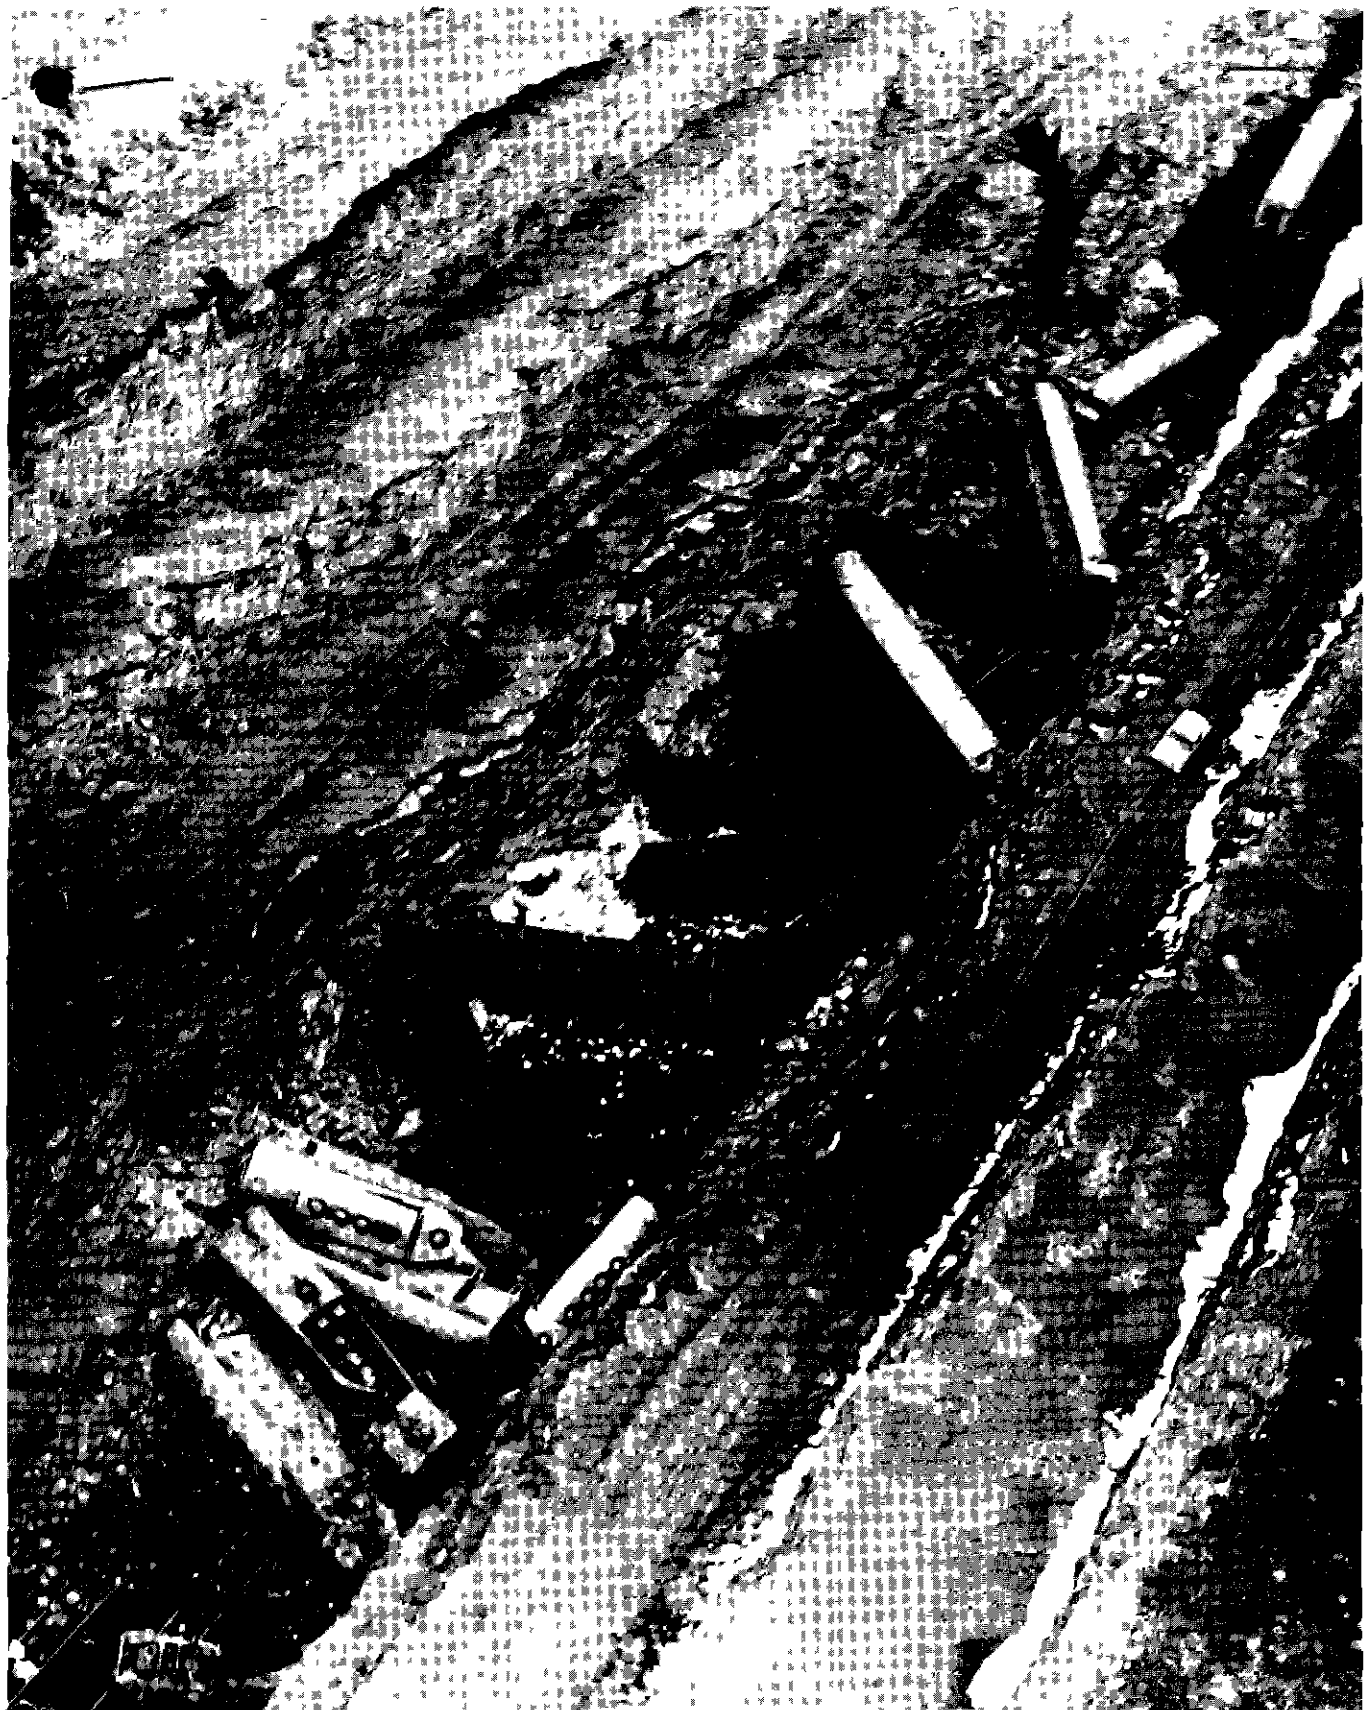
View eastward Arrow at top right-hand corner points to cavity left by rock slide
