RAILROAD ACCIDENT INVESTIGATION

Report No 3957

THE ATCHISON, TOPEKA AND SANTA FE RAILWAY COMPANY

JULY 6, 1962

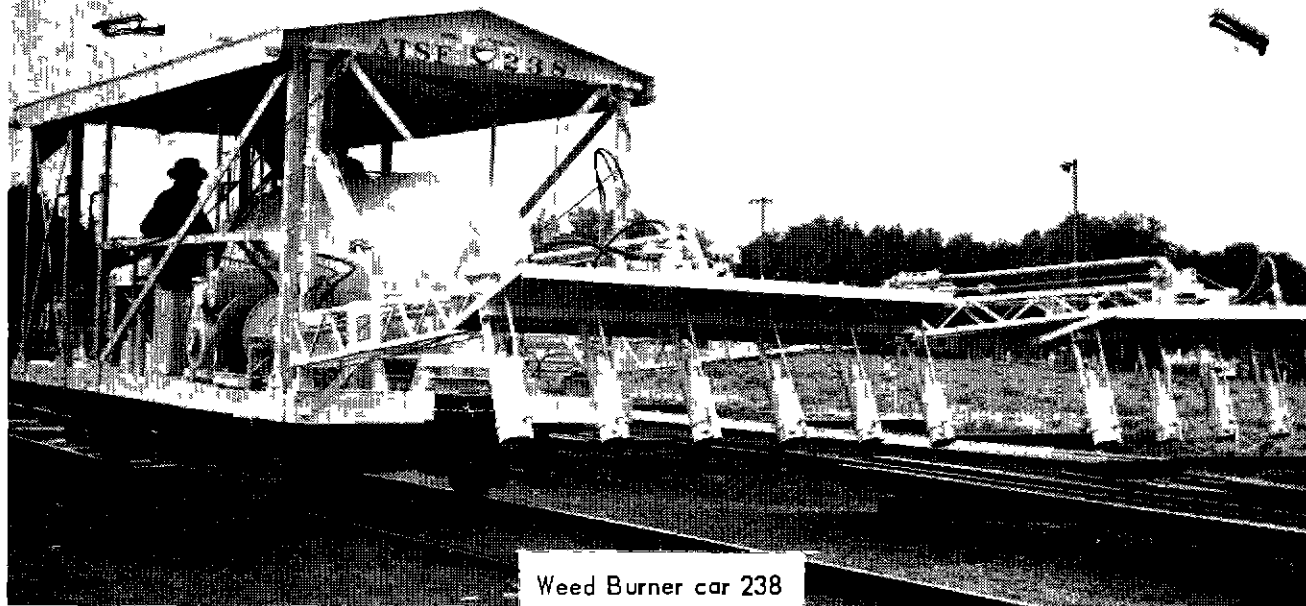
Plate 1

Weed-burner unit 238 (Plate 1) was 23 feet in length and 8 feet in width. It was provided with weed-burning apparatus and a top. It was mounted on four wheels on axles spaced 10 feet 9 inches between centers. It was equipped with air brakes, a 6-cylinder 126-horsepower propane gas engine, another propane gas engine for operating a hydraulic pump, and a 1,000-gallon fuel tank. The weed-burning apparatus consisted of 12 burner heads mounted on two manifolds, each of which was mounted on a boom 14 feet in length. The booms were attached to the unit in such manner as to permit burning of weeds throughout a distance of 24 feet in either direction from the centerline of the track. At the time of the accident the fuel tank contained about 600 gallons of propane, and the total weight of the unit was approximately 20,000 pounds. This unit was not insulated to prevent shunting of track circuits, which indicated it was intended to actuate the signal system.

Examination of the weed-burner unit after the accident occurred disclosed that the tread of the wheels on one axle bore an oily foreign substance from 1 to 1½ inches in width throughout the circumference of the wheels. The other wheels of the weed-burner apparently had moved through ballast which cleaned their treads. Apparently the oily foreign substance found on the treads of the wheels was sufficient to prevent these wheels from shunting track circuits. From statements made by the conductor-pilot, the signal supervisor and the division superintendent involved, it was common knowledge that although weed-burner unit 238 was designed to shunt track circuits, it frequently failed to shunt track circuits or shunted them only intermittently.

The investigation disclosed that when Work Extra 238 departed eastward from Syracuse in the block of signal 4532, it apparently shunted the track circuit and actuated the signals. While this train was moving in the block of signal 4532, apparently foreign substances accumulated on the treads of the wheels of the weed-burner and was sufficient to prevent the weed-burner from shunting the track circuit. This resulted in loss to Work Extra 238 of protection of the automatic block system. The conductor-pilot of Work Extra 238 was unaware that the weed-burner had failed to keep the track circuit shunted before his train reached the 0°30' curve while en route to the siding at Syracuse. At this time he observed that westward signal 4531 was displaying a restrictive aspect which indicated to him that Second 8 was closely approaching Syracuse, and about the same time he observed that the semaphore arm of signal 4532 was in vertical position, indicating that this signal was displaying a Clear aspect although its block was occupied by the maintenance-of-way train.

It is recommended that the Atchison, Topeka and Santa Fe Railway Company provide adequate protection for the movement of weed-burner or similar equipment on its line.
