RAILROAD ACCIDENT INVESTIGATION

Report No 4006

THE ATCHISON, TOPEKA AND SANTA FE RAILWAY COMPANY

JANUARY 2, 1964

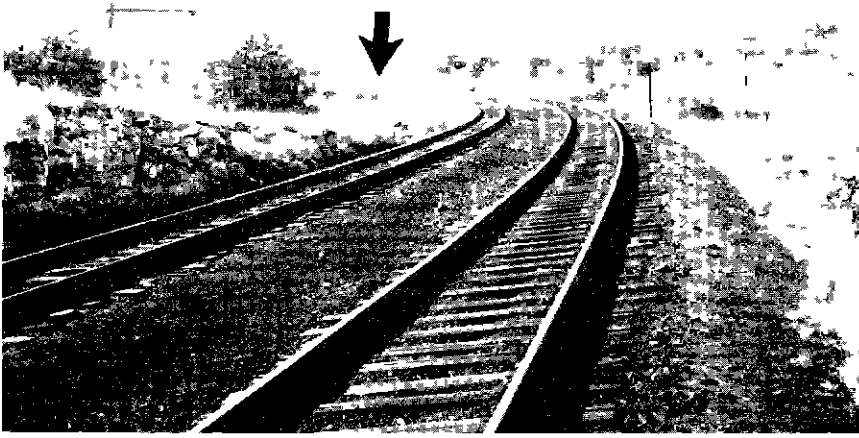
View westward toward point of accident (arrow)

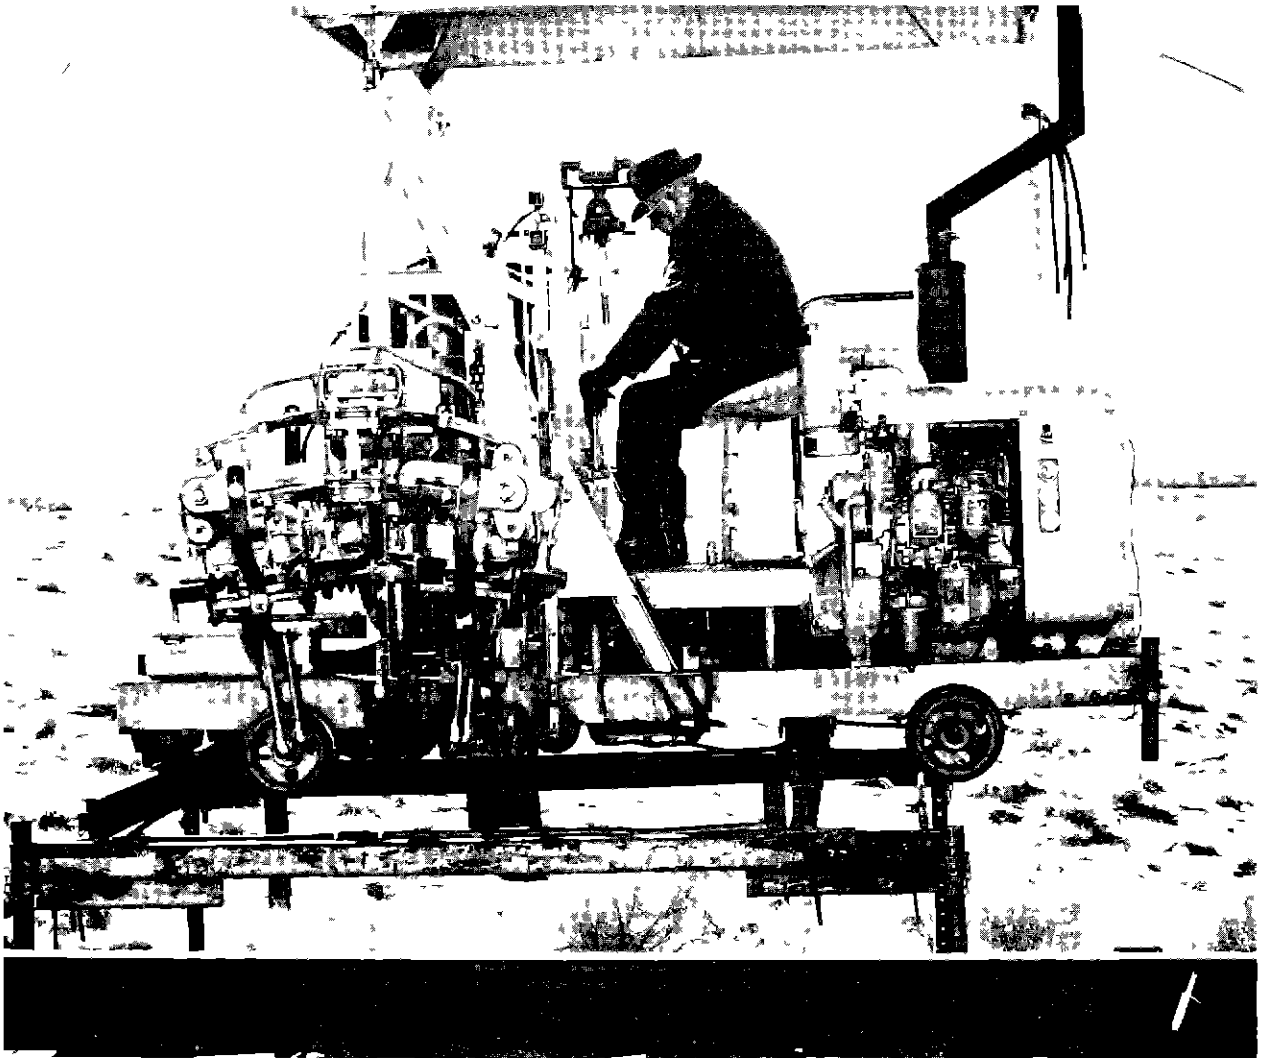
Combination jack and tie-tamping machine on portable set-off This machine is similar to one of the maintenance-of-way machines involved
