INTERSTATE COMMERCE COMMISSION
WASHINGTON

REPORT OF THE DIRECTOR
BUREAU OF SAFETY

ACCIDENT ON THE
ATLANTA JOINT TERMINALS

INVESTIGATION NO. 2058

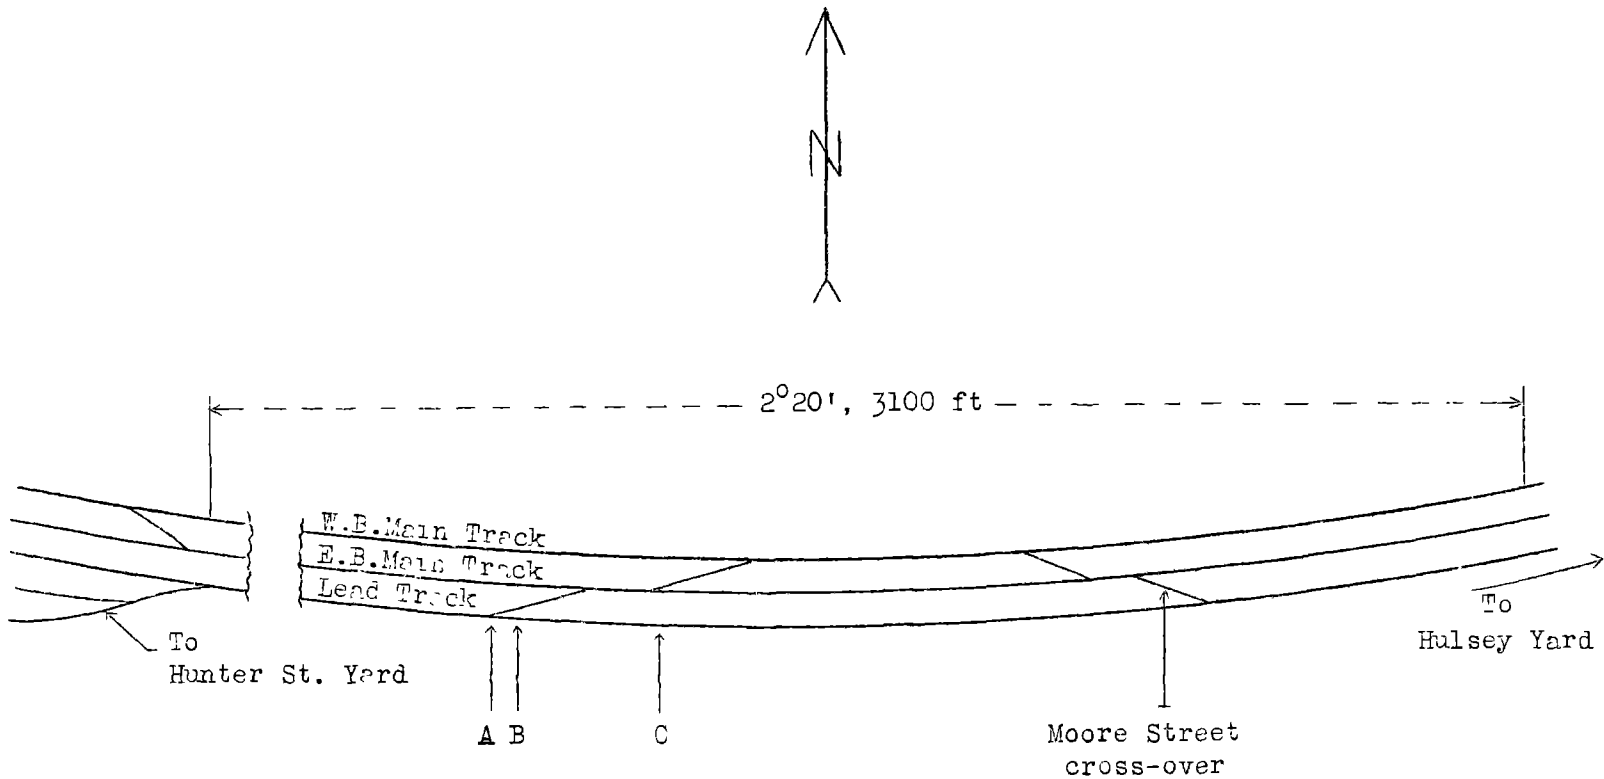
Inv. No. 2058
 Atlanta Joint Terminals
 Atlanta, Ga.
 April 22, 1936

- A - Lead track switch of House cross-over.
- B - Initial point of derailment.
- C - Point where tender stopped.

Distance from A to B, 15' 9"
 Distance from B to C, 103' 5"
 Distance from A to C, 119' 2"
