INVESTIGATION NO. 2912

ATLANTA, BIRMINGHAM AND COAST RAILROAD COMPANY

REPORT IN RE ACCIDENT

JULY 4, 1945

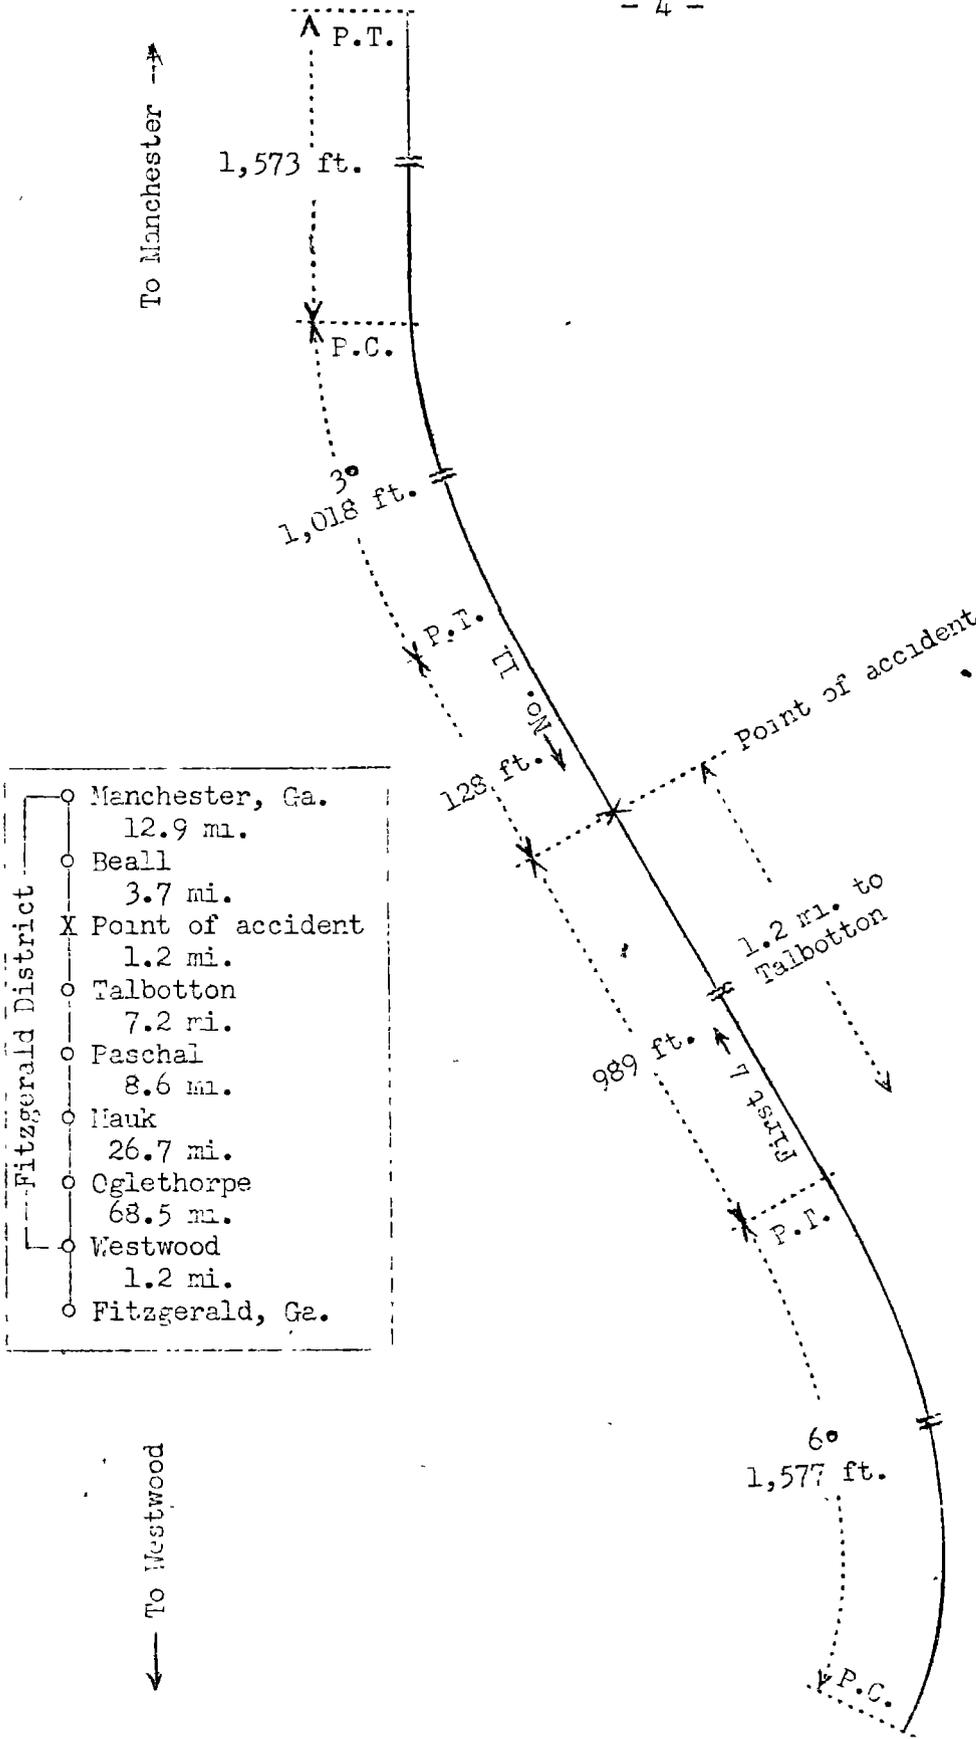
Irv. No. 2912  
 Atlanta, Birmingham and Coast Railroad  
 Talbotton, Ga.  
 July 4, 1945

Location of Accident and Method of Operation

This accident occurred on that part of the railroad designated as the Fitzgerald District and extending northward from Westwood to Manchester, Ga., 128.8 miles, a single-track line over which trains are operated by timetable and train orders. There is no block system in use. The accident occurred on the main track 112.2 miles north of Westwood, at a point 1.2 miles north of the station at Talbotton. From the south there is a 6° curve to the left 1,577 feet in length, which is followed by a tangent 989 feet to the point of accident and 128 feet northward. From the north there are, in succession, a tangent 1,573 feet in length, a 3° curve to the left 1,018 feet and the tangent on which the accident occurred. The grade is 1.0 percent descending northward.
