INTERSTATE COMMERCE COMMISSION

ACCIDENT ON THE

ATLANTIC COAST LINE RAILROAD

INVESTIGATION NO. 2167

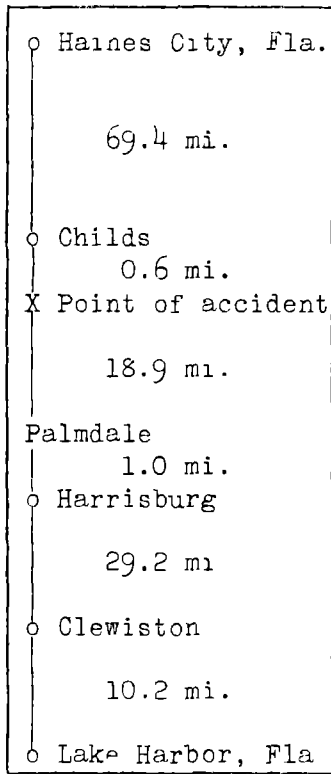
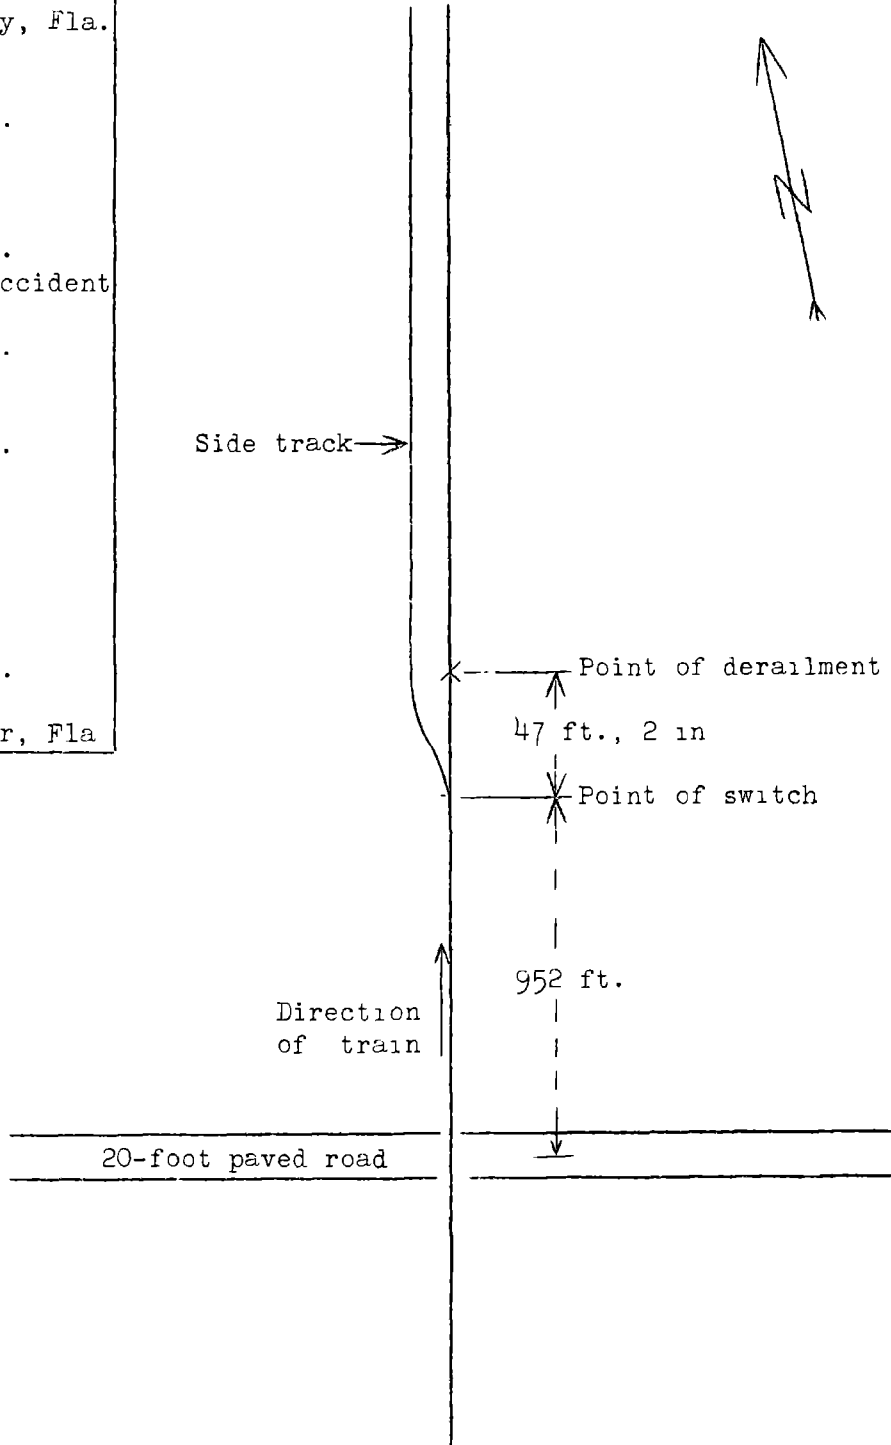
Inv. No. 2167  
 Atlantic Coast Line R.R.  
 Childs, Fla.  
 April 2, 1937

The first mark preceding the point of derailment was at a highway crossing 952 feet south of the south switch of the siding at Childs; this and subsequent marks indicated that the arch bar broke at, or just before reaching the road crossing and the truck sagged enough to permit the lower ends of the column bolts to scrape the surface of the crossing plank. It is evident that the truck sagged rather rapidly; as it approached the south switch of the siding, the arch bar and bottom ends of the column bolts were below the level of the top of the rails and on reaching the turnout rail of this switch, they struck and skidded along the outer edge of this rail, forcing the truck to the west until it became derailed. The abrasions on the arch bar, column bolts and outer edge of the turnout rail, together with the flange marks on top of the west main-line rail and ties, are conclusive that the derailment was caused by the failure of the arch bar.

The arch bar broke at the forward bend, on the west side of the rear truck; except for a small crack, this was a clean break. It was evident that this small crack could not have been detected by inspection prior to a complete separation of the bar at this point, which demonstrates, as in numerous similar instances, that regardless of care and precaution in

1. That arch-bar trucks be removed from service at the earliest practicable date.
2. That until arch-bar trucks can be eliminated from service, a reduction sufficient to guarantee safety of operation should be made in the permissible load limit on cars equipped with such trucks.
3. That inflammables, explosives or other dangerous articles should not be transported in cars which are equipped with arch bar trucks.
4. That provision be made in interchange rules whereby a receiving line may refuse to accept from a connecting line any car equipped with arch-bar trucks.
