INTERSTATE COMMERCE COMMISSION
WASHINGTON

REPORT OF THE DIRECTOR
BUREAU OF SAFETY

ACCIDENT ON THE
ATLANTIC COAST LINE RAILROAD

FAYETTEVILLE, N. C.

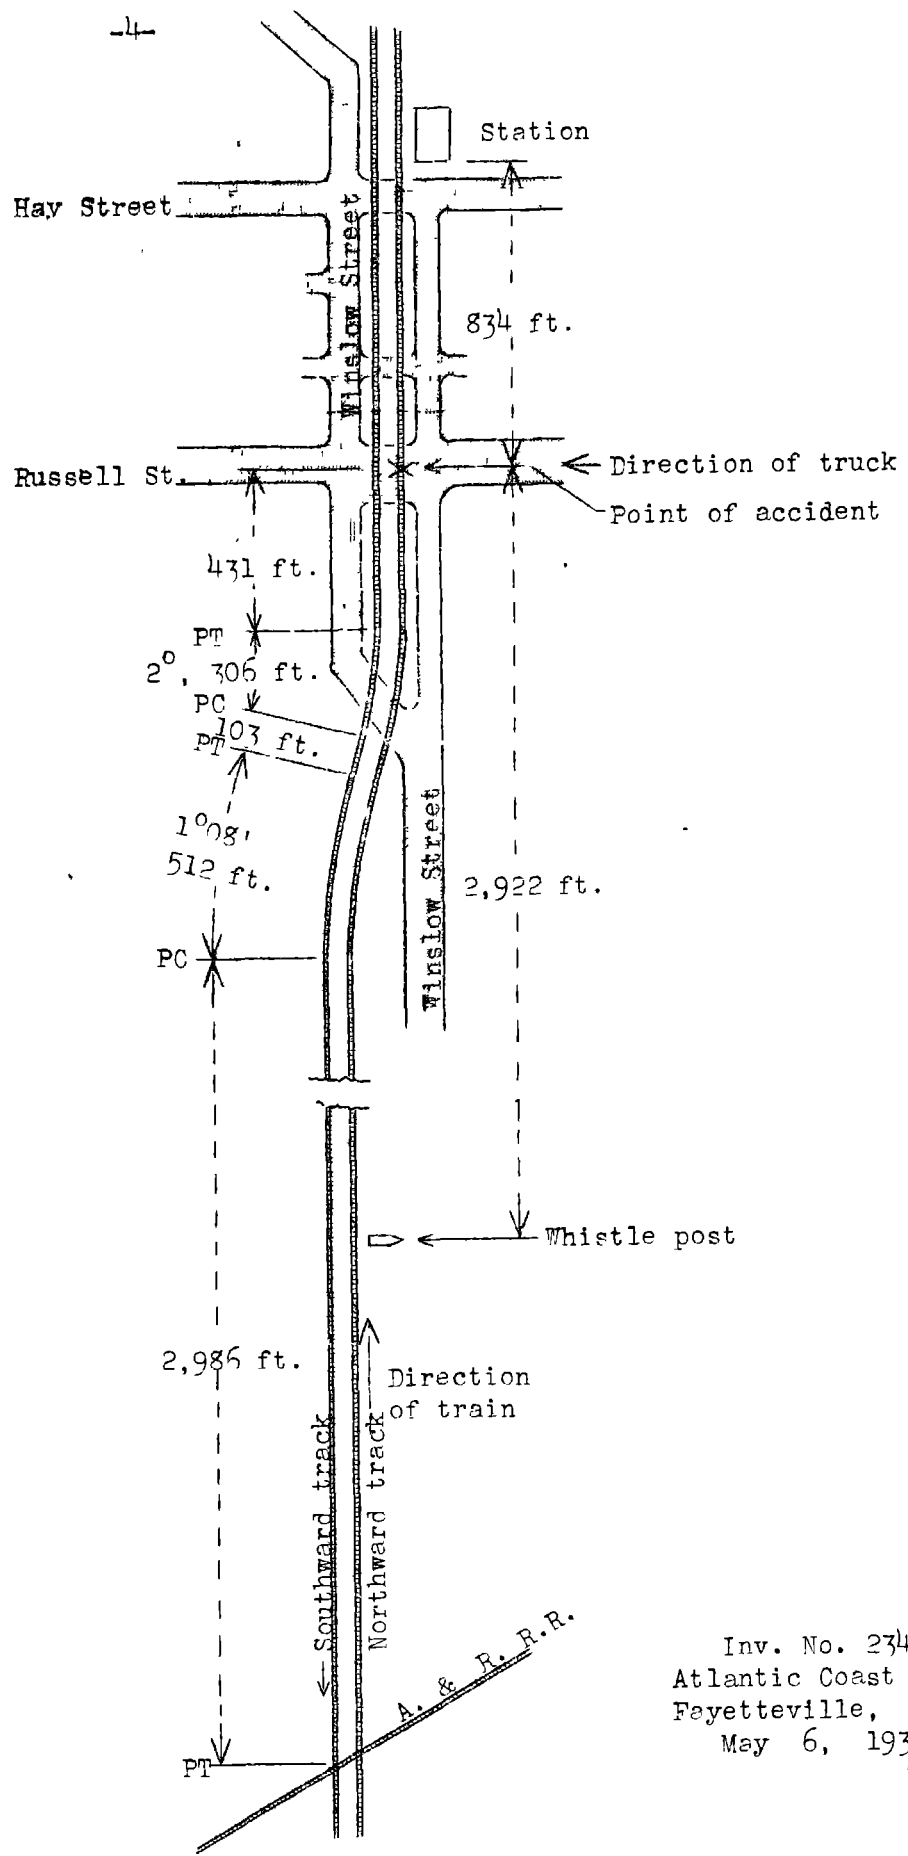
Inv. No. 2349
 Atlantic Coast Line
 Fayetteville, N.C.
 May 6, 1939

Russell Street extends east and west and crosses Winslow Street at right angles; it is paved with concrete and is 40 feet in width, except that it is 79 feet in width at the point where it crosses the tracks. The two lanes of Winslow Street also are paved, each lane being 18 feet wide, but that portion of Russell Street which crosses the tracks, a distance of 25 feet, is constructed of bituminal mixture on crushed stone. Approaching the crossing the grade for west-bound vehicles is slightly ascending; the crossing is level and in good condition.

A building 35 feet by 50 feet, located in the southeast corner of the crossing, materially restricts the view toward the south of the driver of a west-bound vehicle. When the driver is from 177 to 122 feet from the center-line of the northward track he can see diagonally behind the building the headlight of an engine 245 feet south of the crossing. When at a point 25 feet from the center-line of the northward track, the driver has a

clear view of a headlight of an approaching train a distance of 2,850 feet. No signals or warning sign of any type are installed at this crossing.

it is recommended that stop signs be installed or that crossing signals be provided to give warning when a train is approaching.
