INTERSTATE COMMERCE COMMISSION

REPORT OF THE DIRECTOR OF THE BUREAU OF SAFETY CONCERNING AN
ACCIDENT ON THE ATLANTIC COAST LINE RAILROAD AT
FORRESTER, FLA., ON DECEMBER 3, 1934.

January 21, 1935.

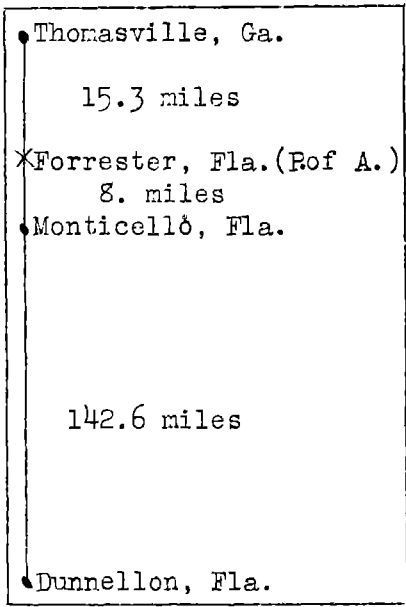
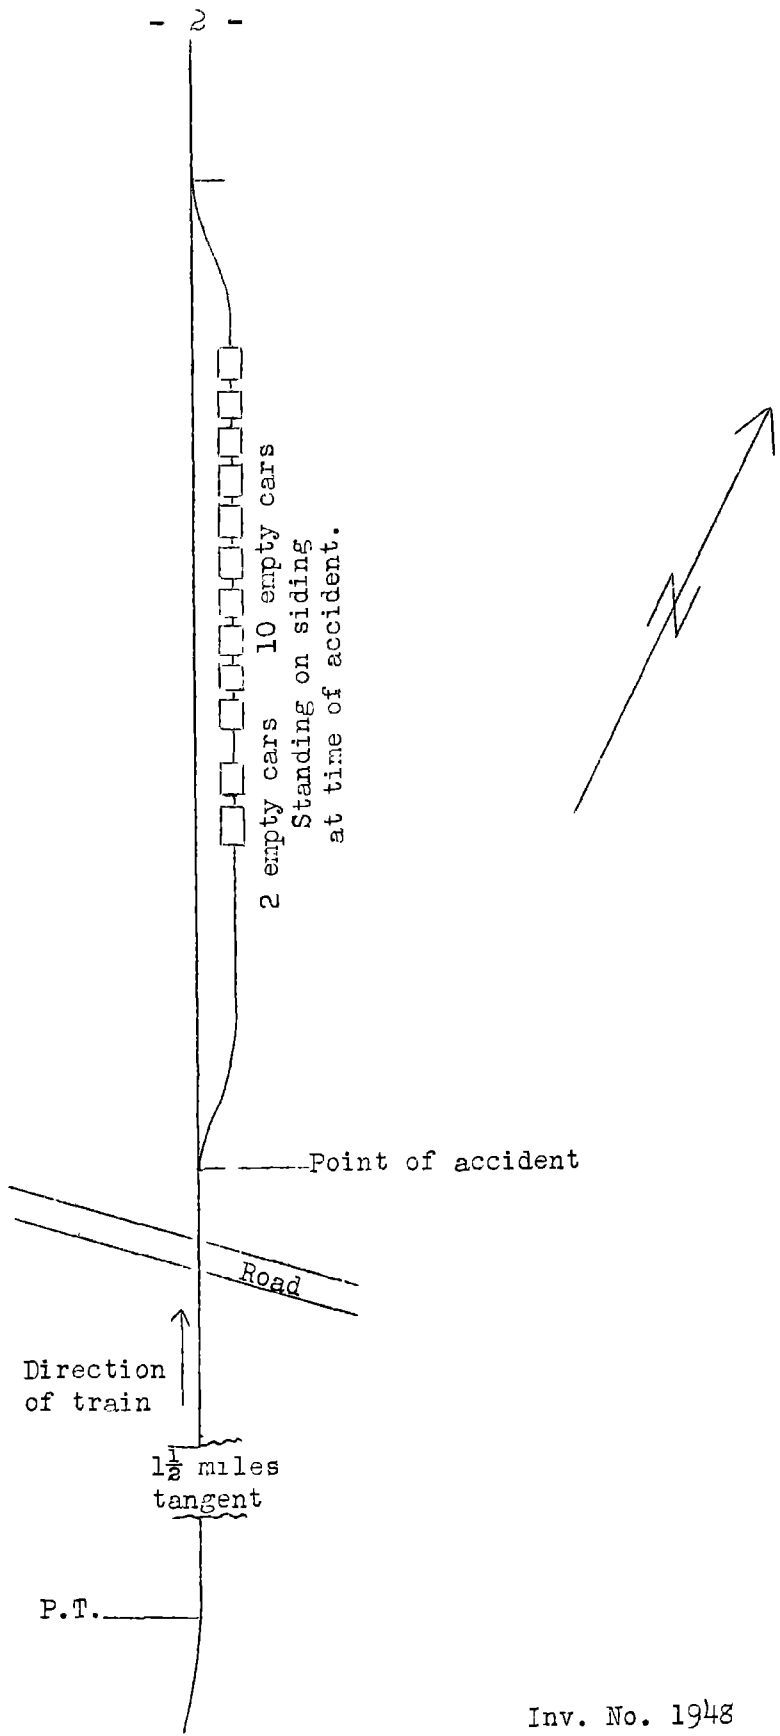
Inv. No. 1948
 Atlantic Coast Line RR,
 Forrester, Florida
 Dec. 3, 1934

Inspection made by the Commission's inspectors failed to disclose any indication of dragging equipment south of the point of accident. The wheels of the engine were found to be in good condition and the brake rigging was intact. It was evident that the wheels straddled the cocked or partly-opened switch points and that the lead wheels of the truck were the first to be derailed. There was a well-defined mark on the stock rail at a point 13 feet 2 inches north of the switch points where the right engine-truck wheel dropped inside, and a corresponding mark on the gauge side of the opposite or west main track rail at a point 18 feet 3 inches north of the switch points, where the left engine-truck wheel dropped inside of that particular rail; the engine then ran on the ties to a point 6 feet north of the frog of the switch, following which the track was destroyed for a distance of 200 feet.

This accident was caused by a cocked or partly-opened switch, apparently due to malicious tampering.

The engineman stated that the switch was open, and examination of the switch and its appurtenances after the accident indicated that it had been tampered with and that it was opened far enough to permit the wheels to straddle the switch points, thus precipitating the derailment; it also appeared that the switch lock was missing and the lever raised from the hasp. No previous trouble due to tampering had been experienced in this locality, nor was there any defective condition about the track or equipment which would have caused the accident. The switch was last used on November 9, 1934; it was last inspected and greased 2 days prior to the accident, at which time the switch lock was intact, and the last train to pass over the switch on the main track was a south-bound freight extra, a trailing-point movement,

Under the operating rules of this company, if the switch stand had been equipped with a switch lamp the dangerous condition of the switch in the case here under investigation would probably have been discovered in time to avert the accident, and in view

of this accident, as well as of previous accidents which were due to the same cause, responsible officers of this railroad company should promptly give consideration to the need for switch lamps on its main lines. Likewise consideration should be given to the need for the additional protection which would be afforded by the installation of a block system.
