REPORT NO. 3426
ATLANTIC COAST LINE RAILROAD COMPANY
IN RE ACCIDENT
NEAR FOUR OAKS, N. C., ON
AUGUST 12, 1951

Date: August 12, 1951

REPORT NO. 3426

Accident near Four Oaks, N. C., on August 12, 1951, caused
by the displacement of a fill.

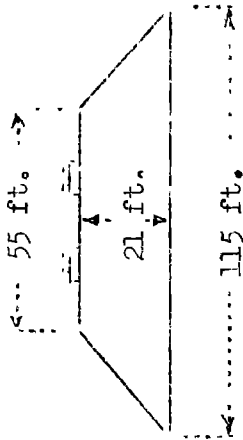
Cross section of fill at point of accident

Examination of the track after the accident occurred disclosed that between points 78 feet and 214 feet south of the culvert a portion of the material in the east side of the fill had become displaced. The displaced material had moved eastward at the toe of the fill a maximum distance of about 15 feet, and the top surface of the fill had subsided a maximum distance of 13 feet. At its maximum width, the depression in the top surface extended to the west rail of the northward main track. From the south the northward main track was in normal surface and alinement to a point 251 feet south of the culvert. North of this point the track was shifted to the east throughout a distance of about 120 feet and was destroyed throughout a distance of 495 feet farther northward. The portion of the fill under the southward main track was not disturbed.

Apparently water had seeped from the top into the portion of the fill constructed in 1914 and had become impounded. The investigation disclosed that some of the material of the fill is capable of absorbing water up to about 50 percent of its volume. When saturated, this material becomes semi-fluid and has very little cohesion. Evidently the impounding of the water had occurred over a considerable period of time and had caused internal pressure within the fill to build up gradually to the degree at which the additional pressure caused by the weight of the train caused the fill to give way suddenly.
