ACCIDENT ON THE
ATLANTIC COAST LINE RAILROAD

HAINES CITY, FLA.

JUNE 18, 1939

INVESTIGATION NO. 2365

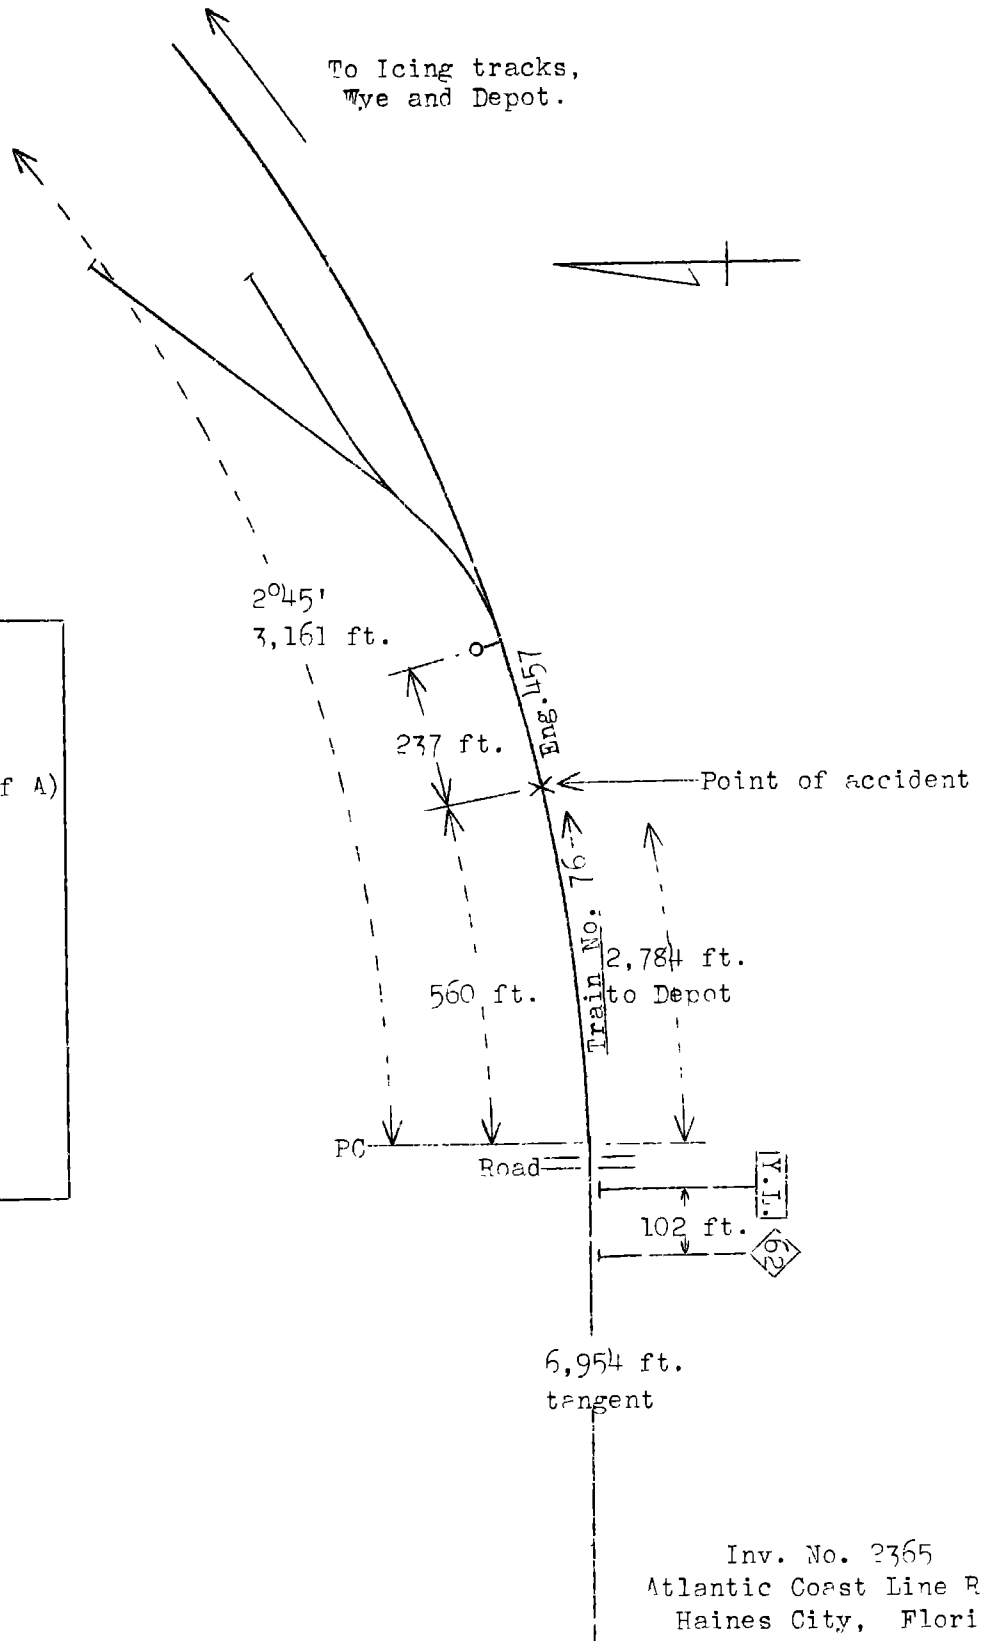
Inv. No. 2365
 Atlantic Coast Line R.R.
 Haines City, Florida.
 June 18, 1939

To Icing tracks,
Wye and Depot.

o	Sanford, Fla.
	61.1 mi.
o	Haines City (P of A)
	6.7 mi.
o	Lake Alfred
	14.9 mi.
o	Lakeland
	41.0 mi.
o	Port Tampa, Fla.
