INVESTIGATION NO. 2548  
THE ATLANTIC COAST LINE RAILROAD COMPANY  
REPORT IN RE ACCIDENT  
NEAR HORTENSE, GA., ON  
NOVEMBER 27, 1941

Accident near Hortense, Ga., on November 27, 1941, caused  
by broken rail, as result of presence of transverse  
fissure.

Inv. No. 2548  
 Atlantic Coast Line Railroad,  
 Hortense, Ga.,  
 November 27, 1941.

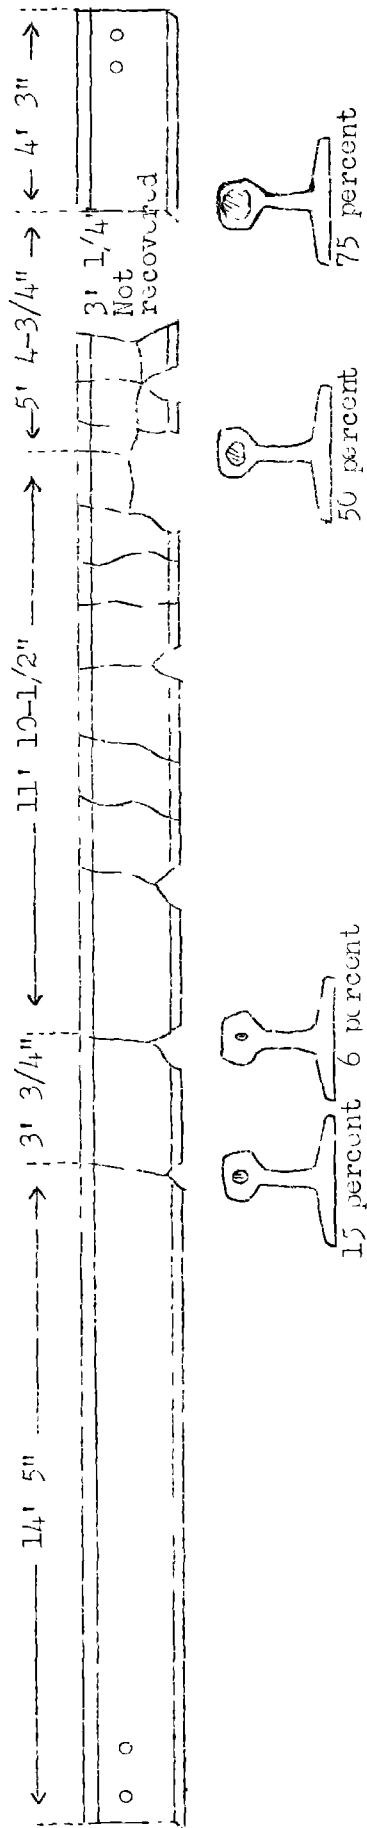
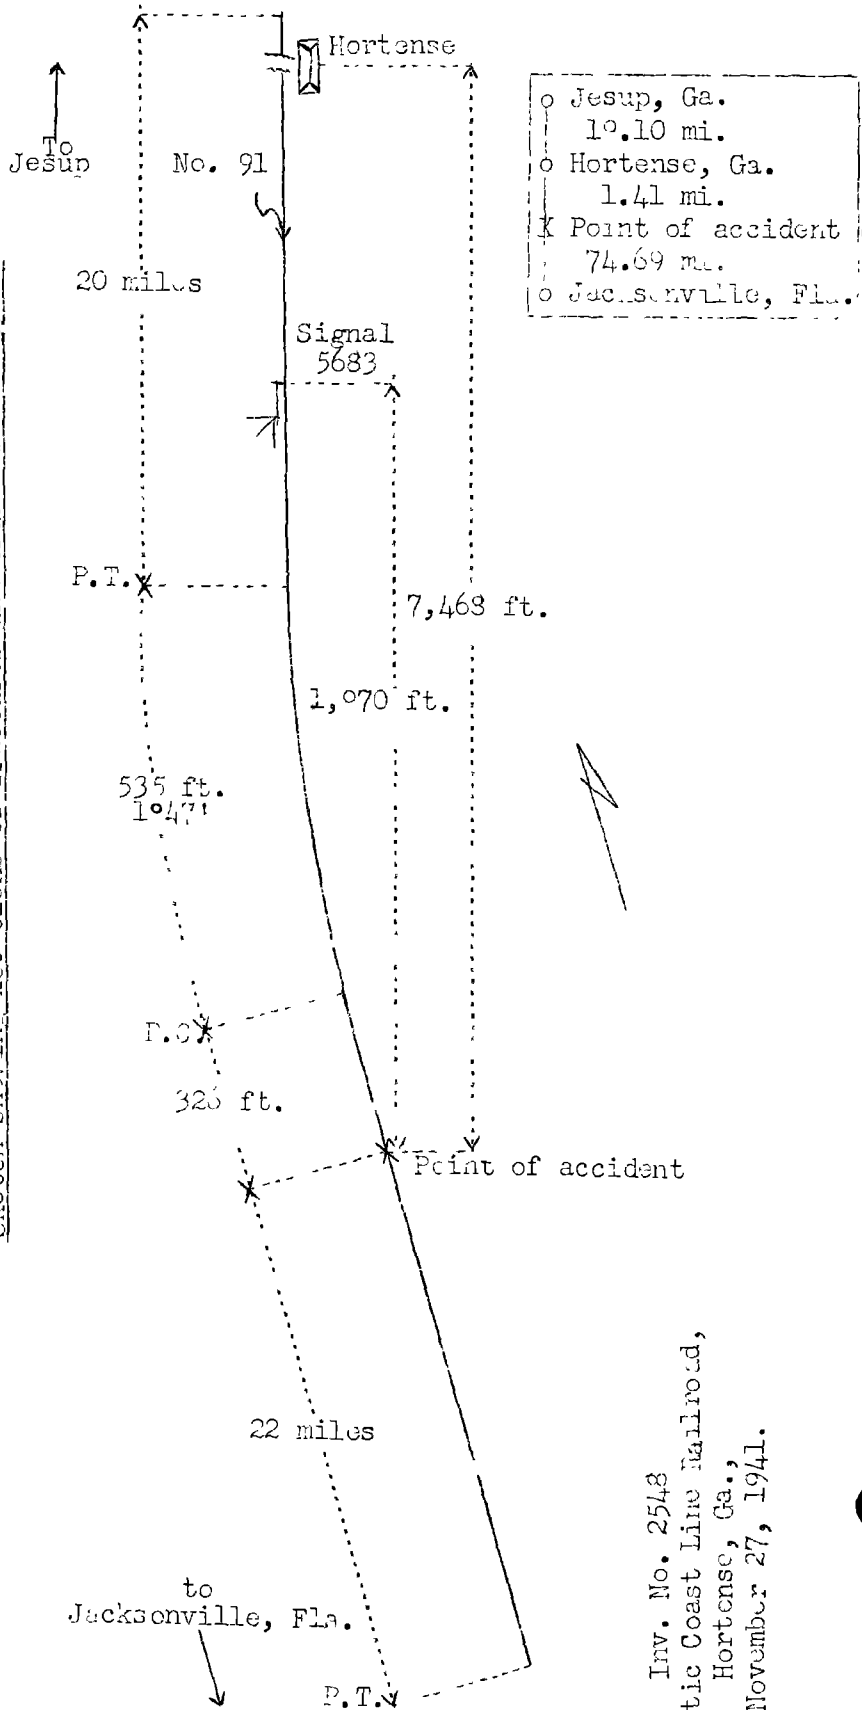
Sketch showing locations of fractures and transverse fissures

The first break occurred on a tie at a point 4 feet 3 inches south of the receiving end of the rail. From this point southward 14 additional breaks in the rail occurred. At the first break a transverse fissure covering about 75 percent of the cross-sectional area of the head was observed. At points 9 feet 7-3/4 inches, 21 feet 6-1/4 inches, and 24 feet 7 inches south of the receiving end of the rail there were transverse fissures, which covered, respectively, 50 percent, 6 percent, and 15 percent of the cross-sectional area of the head. All pieces of the broken rail were recovered except a portion 3 feet 1/4 inch in length immediately south of the first fracture.

Soon after the derailment occurred, a broken rail with four transverse fissures was found on the east side of the track. The rail was broken into at least fifteen pieces. The first fissure was 4 feet 3 inches from the receiving end of the rail and covered about 75 percent of the cross-sectional area of the head of the rail but had not progressed to the outer surface at any point. The second fissure was 9 feet 7-3/4 inches from the receiving end of the rail and covered about 50 percent of the cross-sectional area of the head of the rail. The third and fourth fissures were, respectively, 21 feet 6-1/4 inches and 24 feet 7 inches from the receiving end and, respectively, covered 6 percent and 15 percent of the cross-sectional area of the head. The other breaks in the rail appeared to have resulted during the process of de-

railment. Apparently the derailment occurred at the first fissure and the rail did not become broken until after the front part of the train had passed this point.

It is found that this accident was caused by a broken rail, as a result of a transverse fissure.

The track involved was last inspected from a motor car 5 days before the day of the accident and no defective condition was found. A detector car was last operated over this district on January 23, 1940. A few days before this accident occurred a broken rail was found 1,560 feet from the point of accident. About 2 months prior to the day of the accident another broken rail was found. The Commission investigated the derailment of a passenger train, as a result of a broken rail, on March 30, 1941, that occurred at a point 5.5 miles north of the point where the accident here under investigation occurred. The investigations of these accidents disclose that there is need for more frequent and thorough inspections of the track on this line.
