INVESTIGATION NO. 2847

THE ATLANTIC COAST LINE RAILROAD COMPANY

REPORT IN RE ACCIDENT

NEAR HORTENSE, GA., ON

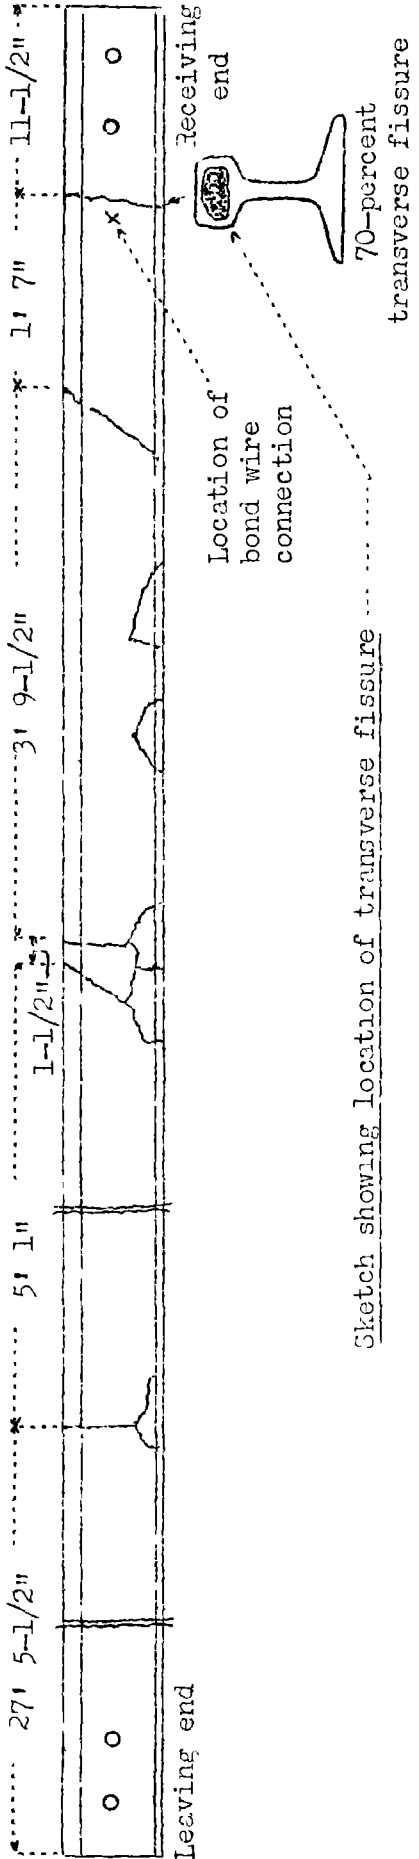
Sketch showing location of transverse fissure

After the accident a broken rail was found on the east side of the track. The rail was broken in many pieces, 10 of which were recovered. The pieces were scattered throughout a considerable distance south of the point of derailment. The first break occurred between two ties at a point about 12 inches south of the receiving end of the rail. Through the head of the rail the break was practically flush with the south ends of the angle bars, but through the base it was about 1 inch south of the south ends of the angle bars. Through the web of the rail the break was north of the bond-wire connection. This piece of rail, the rail to which it was attached, and several rails from each side of the track were displaced from their normal locations as a result of the derailment. At the first break there was a transverse fissure which covered 70 percent of the cross-sectional area of the head of the rail and had progressed very close to the outer surface. The battered condition of the rail at the south end of this break indicated that this failure had occurred some time prior to the accident. Wheel marks on the north end of the rail at another break, which was 5 feet 4-1/2 inches south of the first break, indicated that the derailment occurred between these fractures. The other fractures appeared to have occurred during the derailment.

The track involved was last inspected by the section foreman and the signal maintainer about 36 hours prior to the accident, but no defective condition was observed. A rail-detector car was last operated over this territory on November 11, 1944. This test disclosed transverse fissures in two rails that were replaced about 0.25 mile south of the point where the derailment occurred, but the detector tape indicated no defective condition of the rail in question. The roadmaster said a transverse fissure located in such close proximity to the rail joint would not be discovered by the rail-detector car.
