ACCIDENT ON THE
ATLANTIC COAST LINE RAILROAD

MANUNTA, GA.

JANUARY 16, 1940

INVESTIGATION NO. 2407

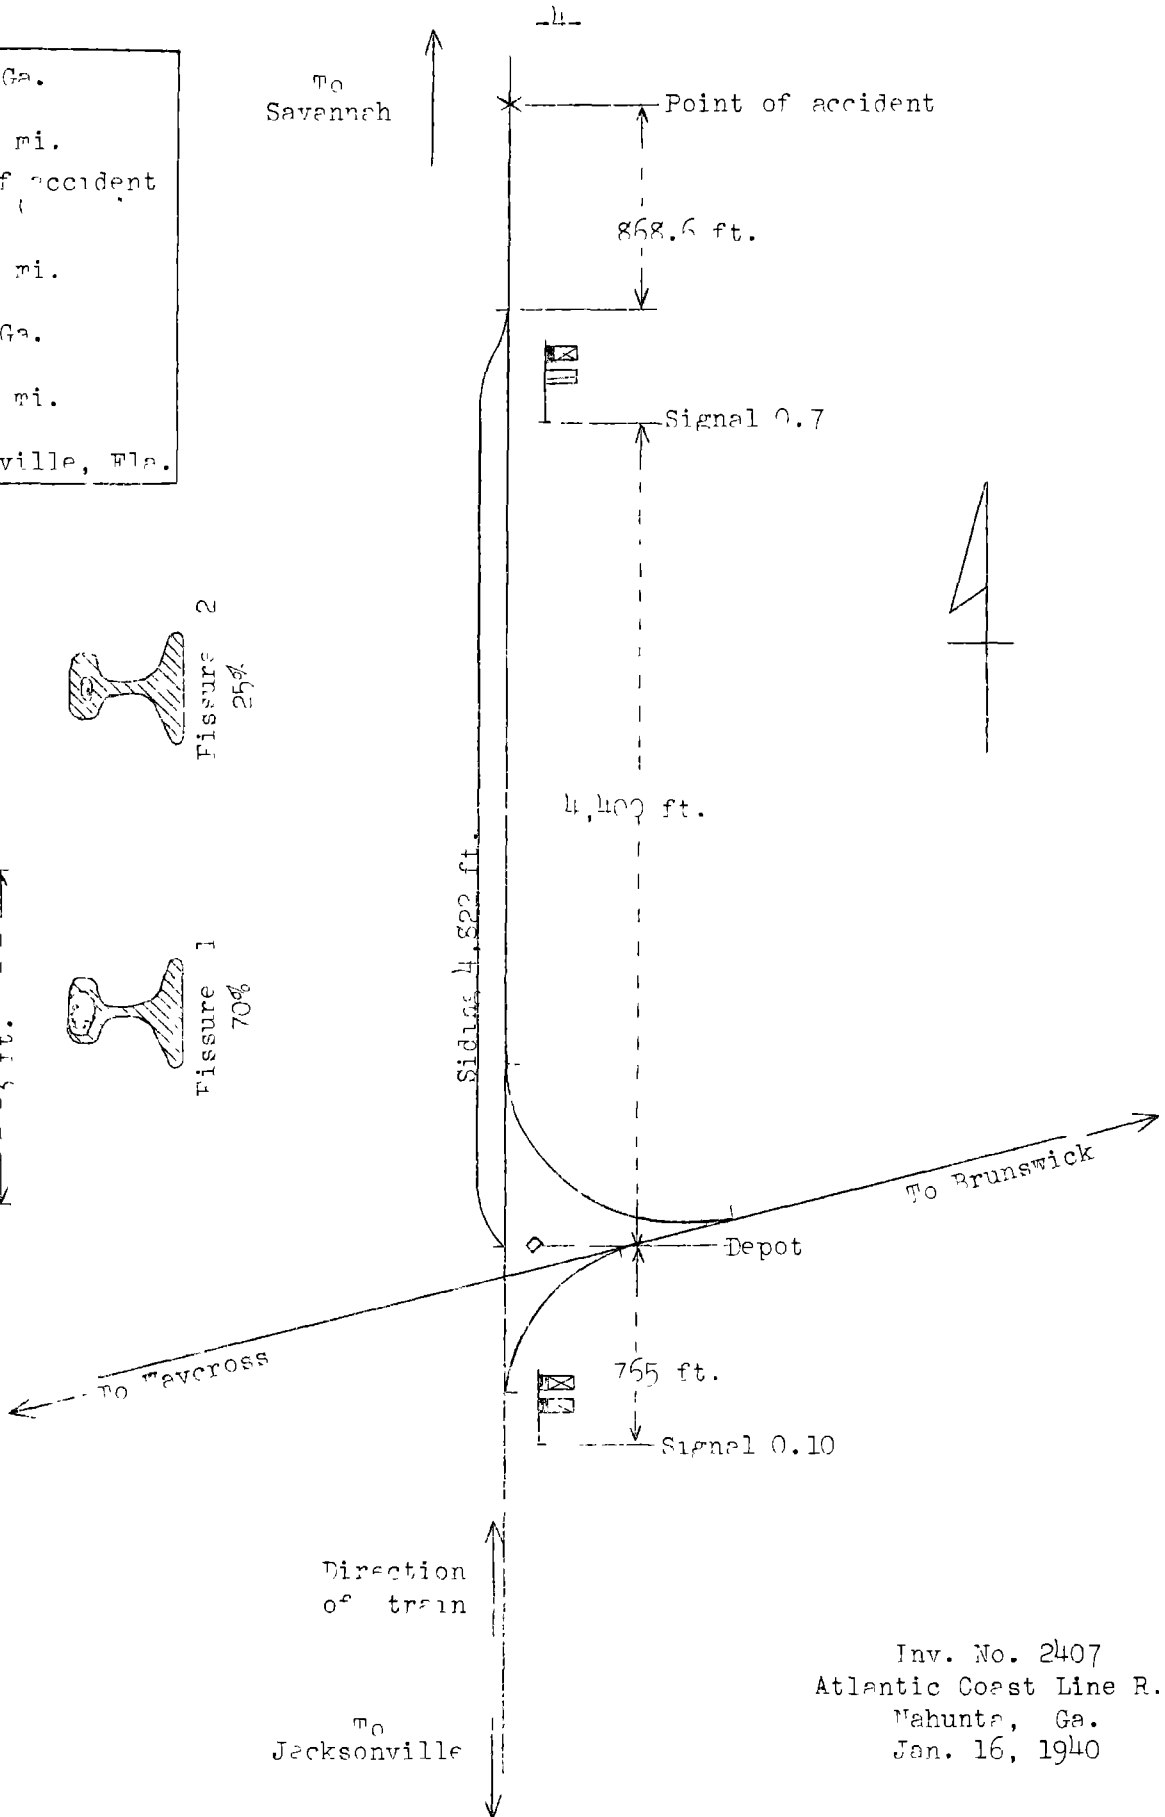
Receiving end
of west rail

After the accident a broken rail with two transverse fissures in the head was found on the west side of the track. The rail was broken into numerous pieces; 34 pieces totaling 29.4 feet were recovered, but the remaining portion could not be found. Fissure 1 was located at a point 3 feet from the receiving end of the rail and covered 70 percent of the cross-sectional area of the head. Fissure 2 covered about 25 percent of the cross-sectional area of the head but it could not be definitely determined where this piece fitted into the broken rail.

This accident was caused by a broken rail, resulting from the presence of transverse fissures.
