INVESTIGATION NO. 2751
THE ATLANTIC COAST LINE RAILROAD COMPANY
REPORT IN RE ACCIDENT
NEAR RENNERT, N. C., ON
DECEMBER 16, 1943

Railroad: Atlantic Coast Line
Date: December 16, 1943
Location: Rennert, N. C.
Kind of accident: Side collision
Trains involved: Passenger : Passenger
Train numbers: 91 : 8
Engine numbers: Diesel-electric : Diesel-electric
units 515-753-514 : units 506-503-500
Consist: 18 cars : 16 cars
Estimated speed: Standing : 80 m. p. h.
Operation: Timetable, train orders and
automatic block-signal and
automatic train-stop system
Track: Double; tangent; 0.42 percent
descending grade northward
Weather: Clear
Time: About 1:30 a. m.
Casualties: 72 killed; 187 injured
Cause: Failure to provide adequate
protection for derailed cars
which fouled adjacent main track

Accident near Rennert, N. C., on December 16, 1943, caused
by failure to provide adequate protection for derailed
cars which fouled adjacent main track.

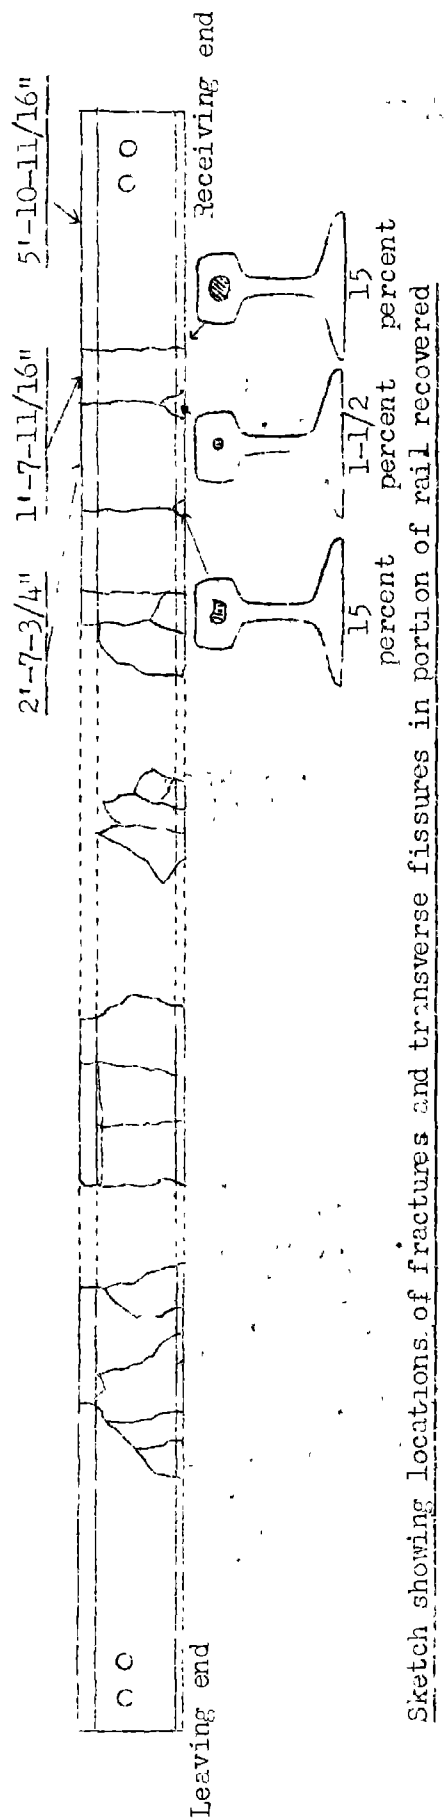
Sketch showing locations of fractures and transverse fissures in portion of rail recovered

After the accident a broken rail was found on the east side of the southward main track. The rail was broken into many pieces, 64 of which were recovered. The pieces were scattered throughout a distance of about 400 feet south of the point of derailment. The first break occurred between two ties at a point 5 feet 10-11/16 inches south of the receiving end of the rail. This piece of rail remained in normal position. At the first break there was a transverse fissure covering about 15 percent of the cross-sectional area of the head of the rail. At the second and third breaks, which occurred at points 7 feet 6-3/8 inches and 10 feet 2-1/8 inches south of the receiving end, there were transverse fissures covering, respectively, 1-1/2 percent and 15 percent of the cross-sectional area of the head. None of these fissures had progressed to the outer surface. Wheel marks on the rail at the south end of the third broken section indicated that the derailment occurred at that point. The other breaks in the rail appeared to have resulted during the derailment. Since the first automatic signal north of the broken rail displayed proceed and no abnormal condition of the track was felt when the front portion of No. 91 passed the point where the derailment occurred, it is apparent that the rail broke under the train. The track involved was last inspected by the section foreman from his motor-car on December 13, 1943, and no defective condition was found. A detector car was last operated over the track in this vicinity on October 17, 1943.
