RAILROAD ACCIDENT REPORT

AUTO-TRAIN CORPORATION TRAIN
DERAILMENT ON THE
SEABOARD COAST LINE RAILROAD

NEAR JARRATT, VIRGINIA
MAY 5, 1976

REPORT NUMBER: NTSB-RAR-76-11

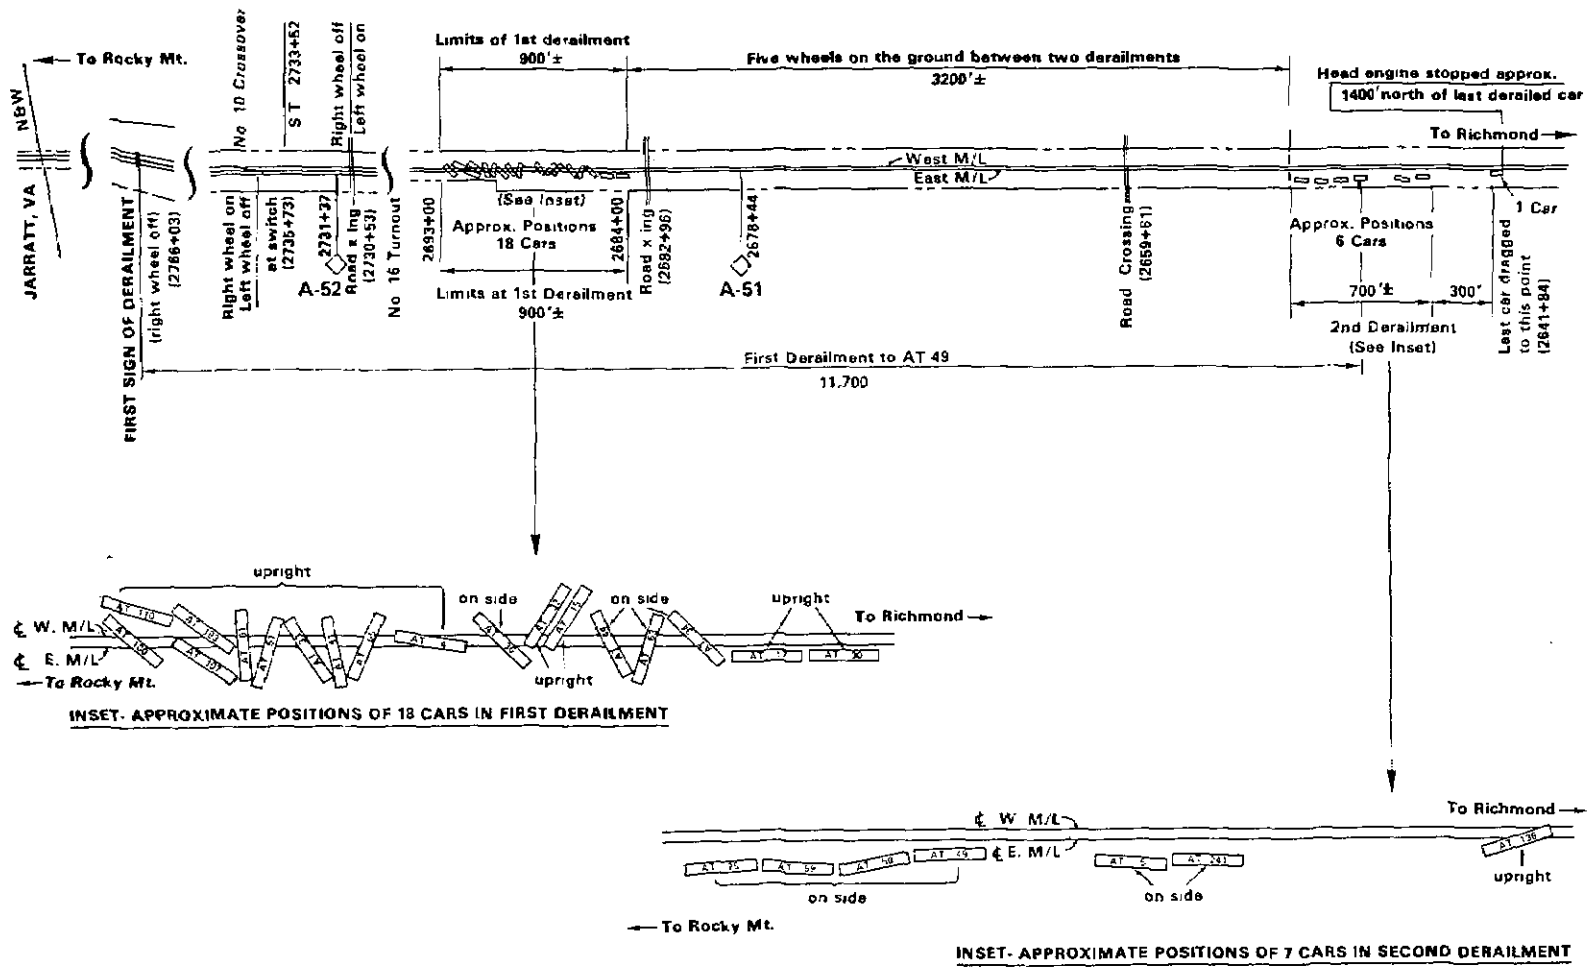
Figure 1. Plan of accident site.

Shortly after the train departed Jarratt, Virginia, moving northward on the east main track of the Seaboard Coast Line Railroad Company's (SCL) Rocky Mount Division, the R-3 wheel on car No. 49 dropped off the rail and struck components of the track structure. About 1.4 miles beyond this wheel derailment, near milepost (MP) 51, the train separated; 18 automobile carriers derailed and obstructed both main tracks. (See figure 1.) The train continued north for another 3,200 feet before it was stopped. Seven cars of this remaining section derailed.

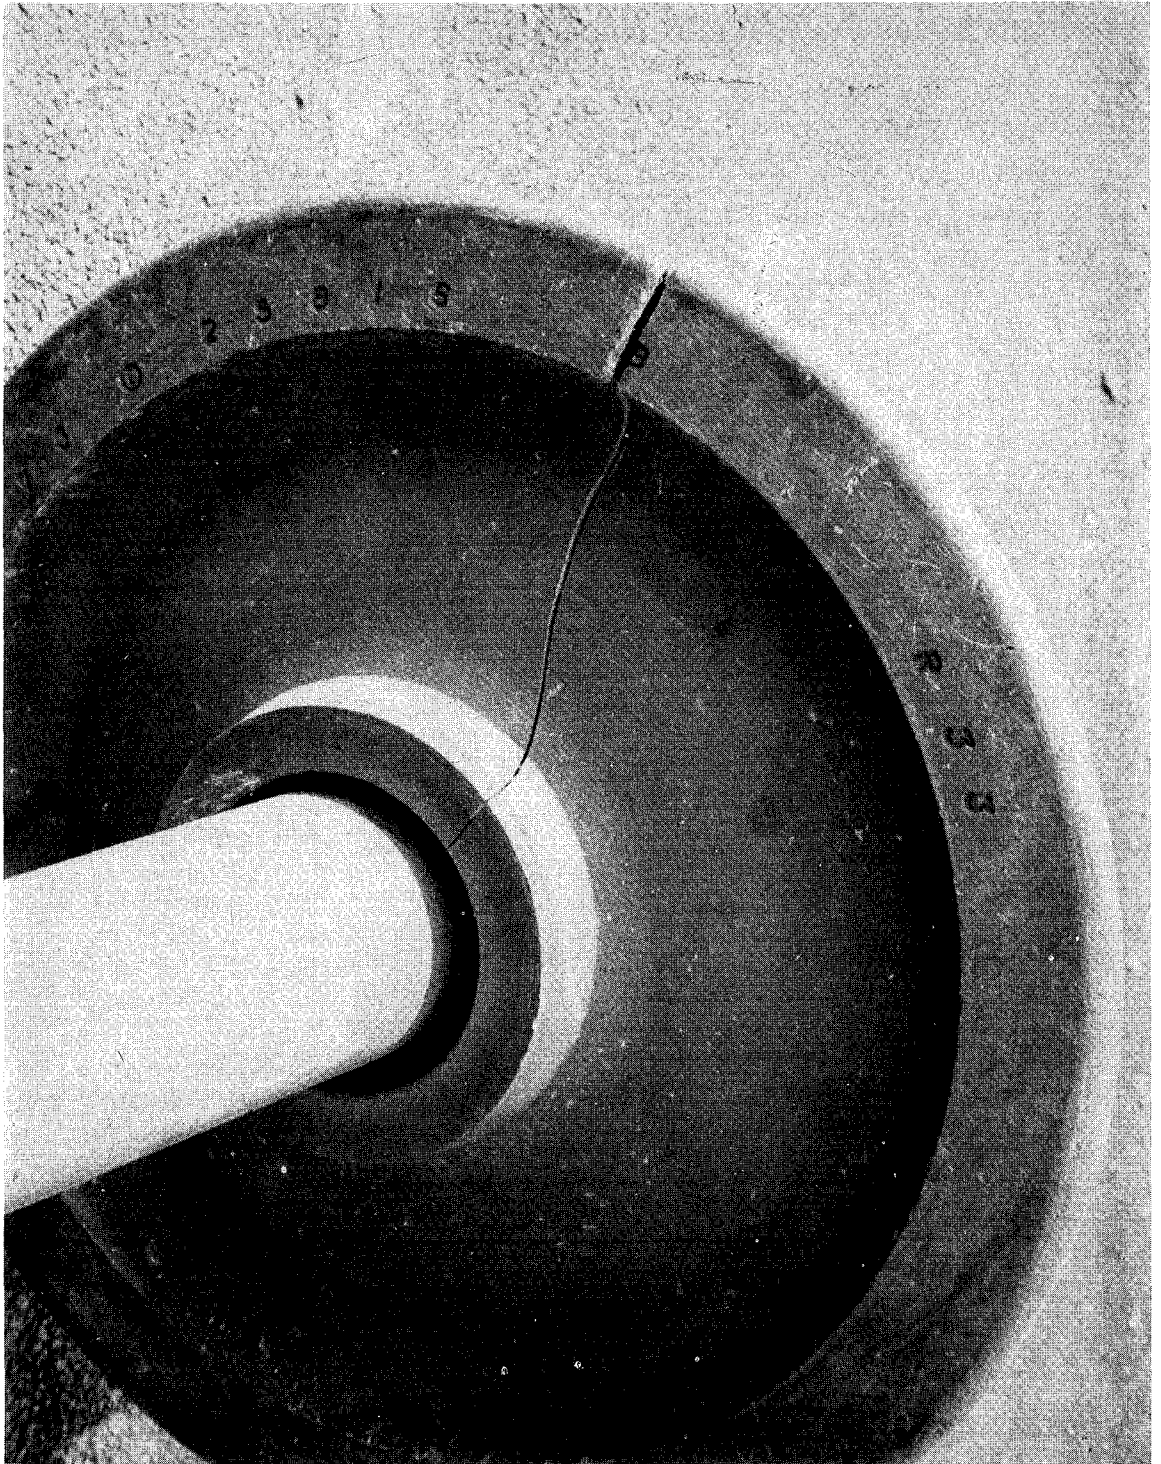
Figure 2. Back view of R-3 wheel from car No. 49.

The National Transportation Safety Board metallurgist examined part of the R-3 wheel from car No. 49 and determined that the fractured surface contained markings typical of fatigue. These markings emanated away from the bottom of the straight leg of the stamped letter "B" used to designate the class of the wheel material. Fatigue caused the crack to propagate radially into the wheel from this point of origin. The fracture outside of this fatigue region appeared typical of an overload. (See appendix A.)

The Safety Board asked Edgewater to comment on the failure. The company replied: "The hot stamped character acted as a point of stress concentration after the tread had been subjected to extended periods of overheating." It added, however, that "Any other sharp irregularities on this rim face, such as lathe dog or chuck marks, mechanical damage or machine tool marks, . . . can initiate a fatigue crack of this nature . . . if there is prolonged rim heating. Even with the elimination of these surface irregularities, failures can still occur from severe overheating of the wheel tread and flange."

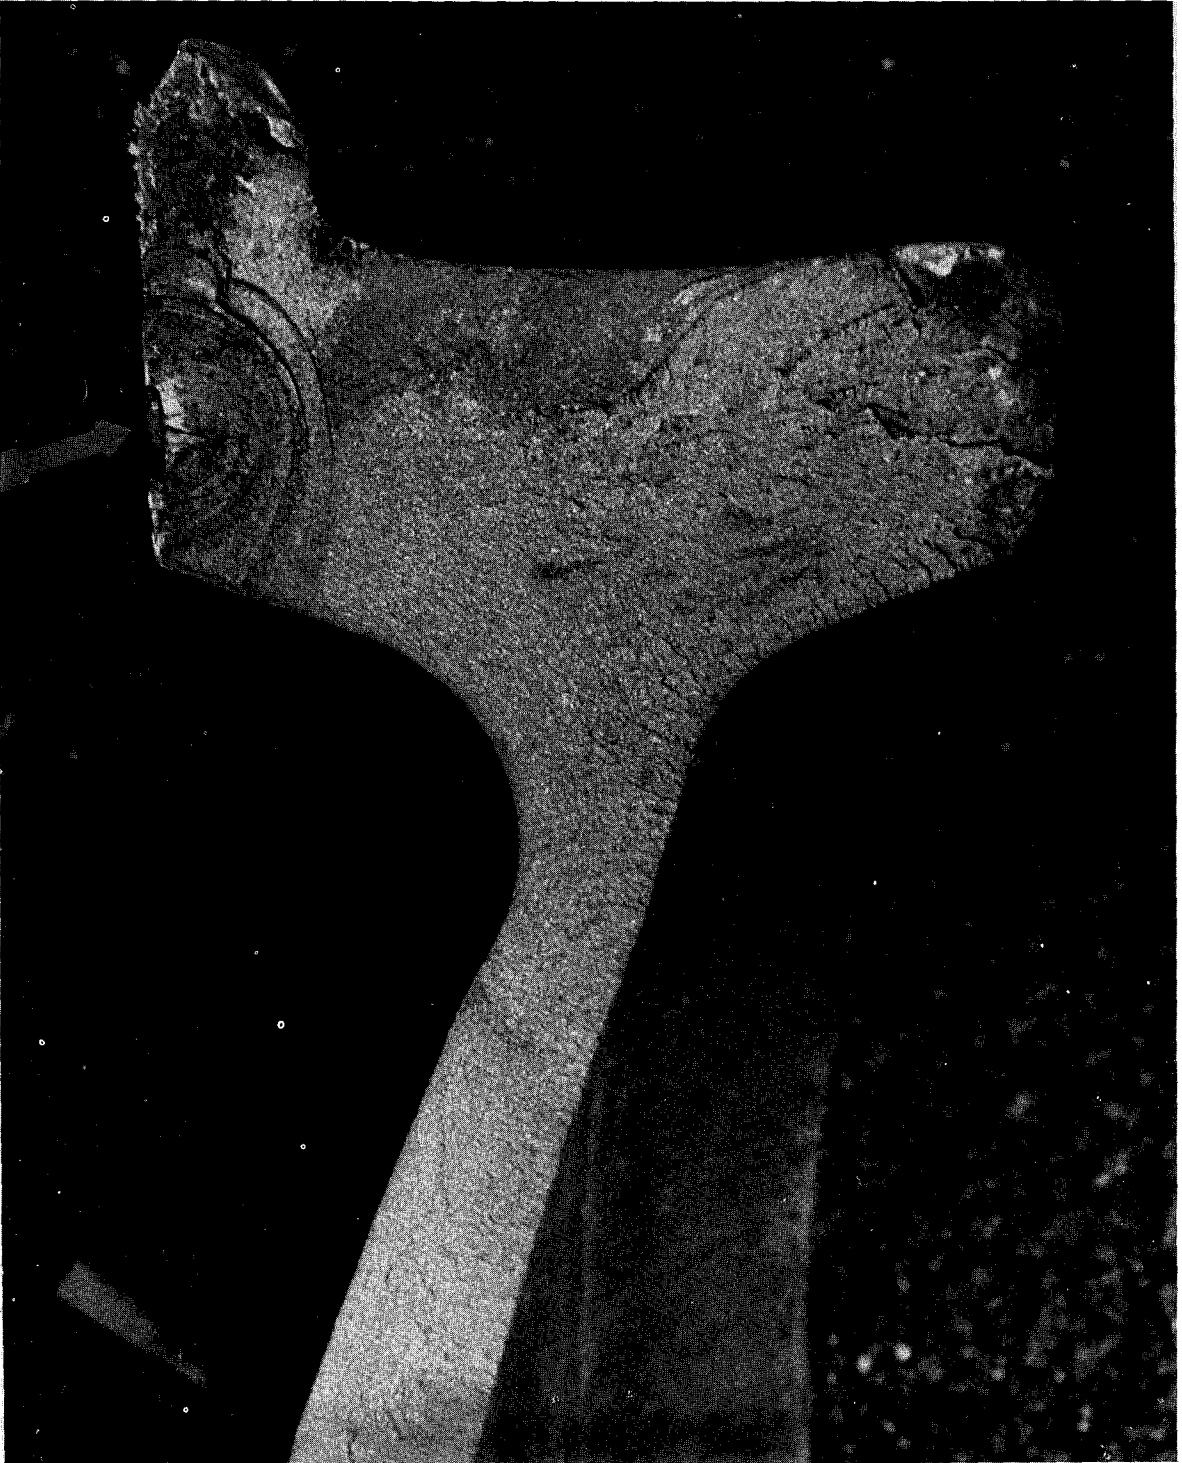
Figure 3. Cross-section of R-3 wheel from car No. 49.

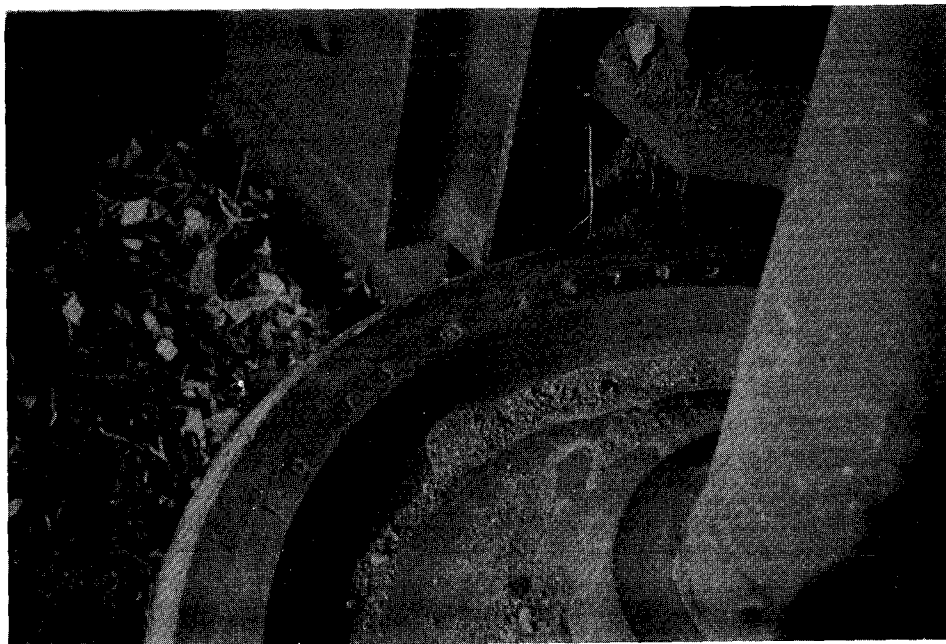
The broken wheel and its mate wheel on car No. 49 did not indicate that they had overheated because neither was discolored on the front and back face of rim and plate immediately after the derailment. (See figures 2 and 5.) After the wheels were allowed to weather, oxidation began to form on the wheel rim and plate. Both the failed wheel and its mate wheel then clearly indicated they had overheated. (See figure 6.)

Figure 5. Car No. 49's R-3 wheel on the day of the derailment.

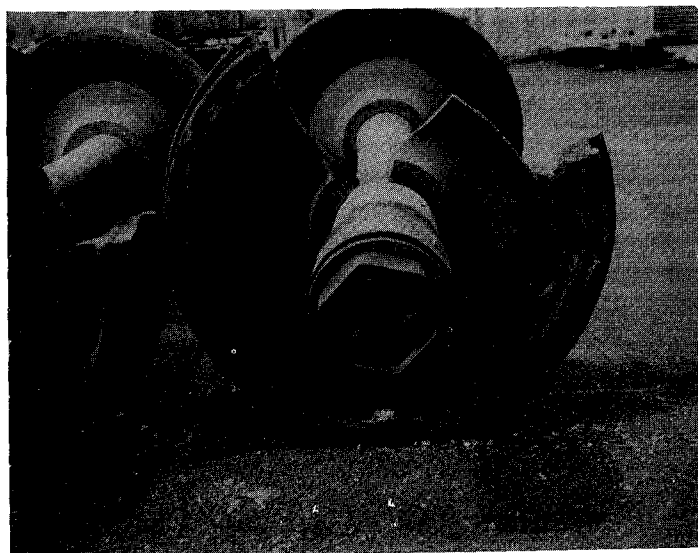
Figure 6. Lorton and Jarratt wheels after weathering.

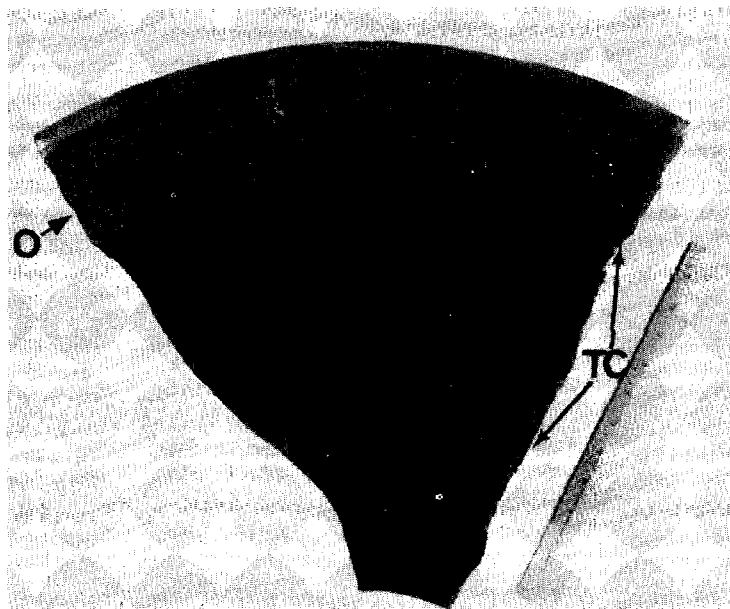
The fracture surface contained markings typical of fatigue emanating away from the bottom of the straight leg of the stamped letter "B" used to designate the class of wheel material (origin area denoted by arrows "O", Figures 1A and 2A; and brackets, Figures 3A and 4A). Propagation by fatigue was from this origin area radially into the wheel to the approximate location shown by the arrowheads in Figure 4A. The remaining fracture outside of this fatigue region appeared typical of an overload separation.

Figure 1A. Overall view of the section removed from wheel for examination. Arrow "O" denotes fatigue origin location. Arrows "TC" indicates line of torch cut made to remove section.

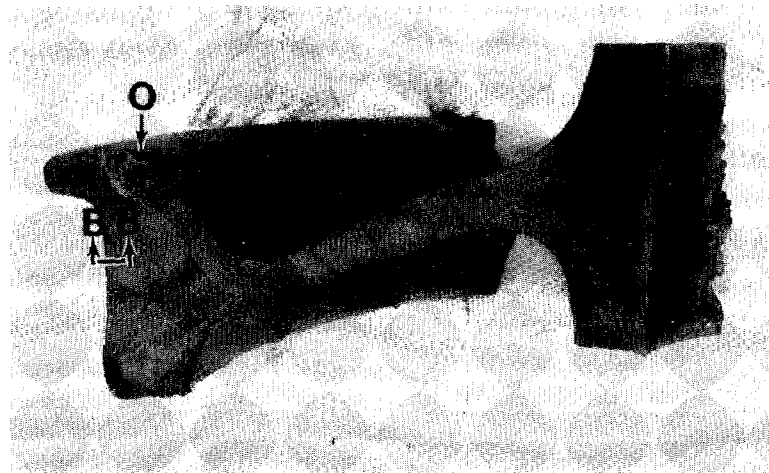
Figure 2A. View of fracture in wheel section. Arrow "O" indicates origin location. X 1/4

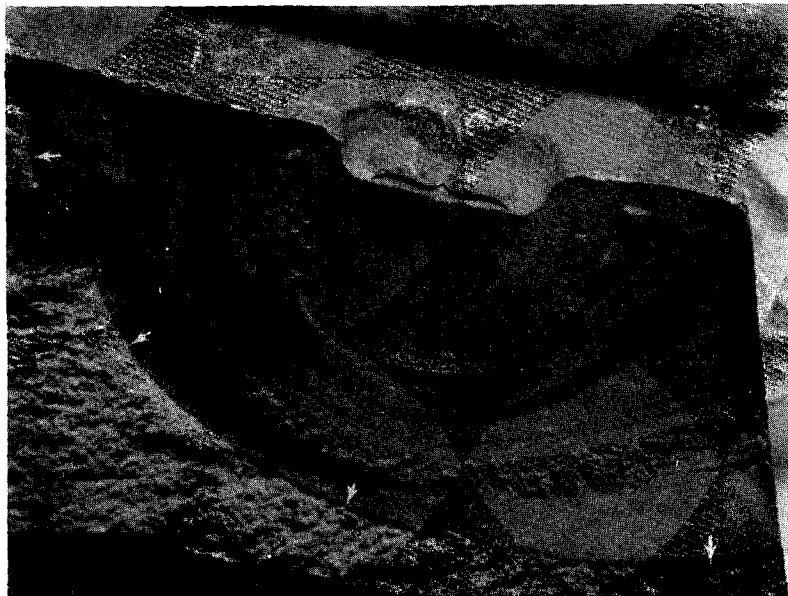
Figure 4A. Closer view of origin shown by arrow "O" in Figure 2A. Arrowheads denote extent of fatigue propagation emanating from the bracket area. X2

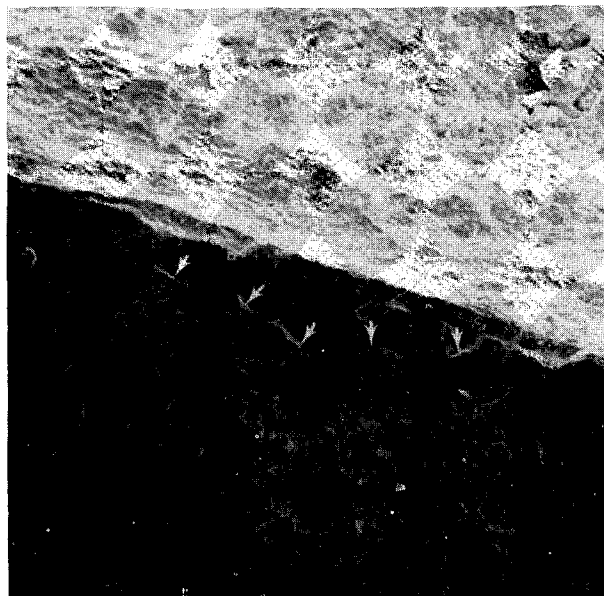
Figure 5A is a closeup view of the fracture surface in the fatigue origin area. The fracture markings indicated that the fatigue crack had initiated at multiple sites along the bottom of the stamping in the areas denoted by the brackets in Figure 5A. Detailed examination of the origin area with the aid of a scanning electron microscope (SEM) showed that the fracture surface was partially obliterated by rubbing and what appeared to be corrosion damage. The fracture appeared typical of fatigue in steel although no clear striations were evident on the fracture surface. There was evidence, however, that the fracture may have initiated in part from small discontinuities in the bottom of the stamping. Arrowheads in Figure 6A outline the bottom of what appears to be one such discontinuity.

Figure 6A. SEM fractograph within the origin area shown by bracket "A" in Figure 5A. Arrowheads outline the bottom of what appears to be a small discontinuity extending from the bottom of the stamping. X100 ultrasonically cleaned in acetone.

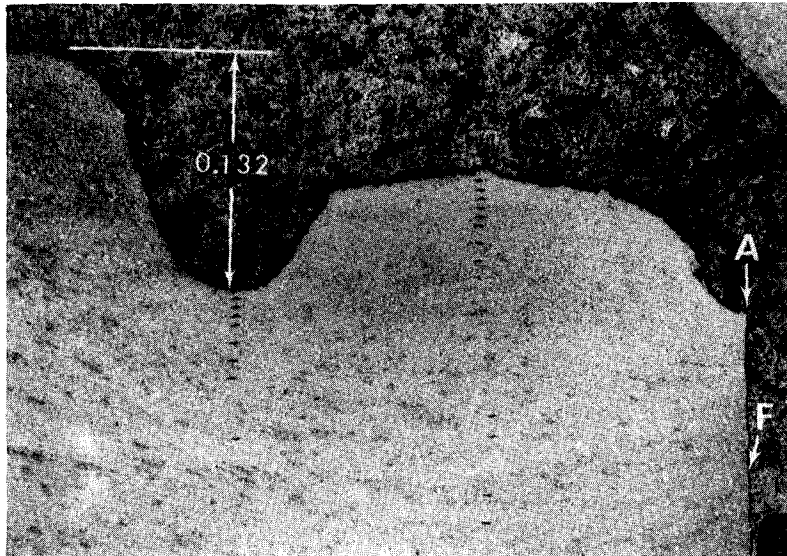
A low magnification photomicrograph of a metallographic micro-section through one of the fatigue origin areas is shown in Figure 7. The depth of stamping in this section measured 0.132 inch on the curved side of the letter (see Figure 7) and 0.134 inch at the origin "A" side.

Figure 7. Metallographic microsection through stamped letter in the origin area shown by bracket "A" in Figure 5A (section A-A, Figure 5A). Arrow "A" indicates origin area in root of stamping and arrow "F" denotes the fatigue fracture surface profile. Diamond shaped marks in section are Knoop hardness indentations. X10 nital etched.

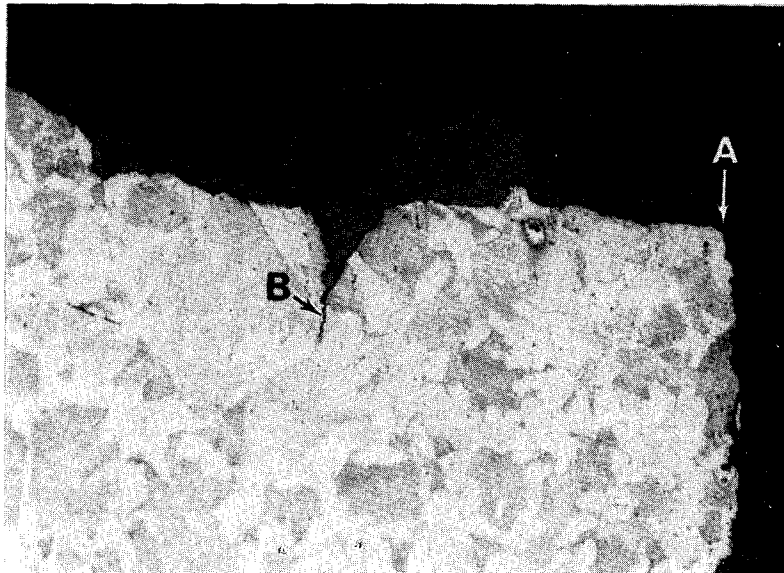
Arrow "B" in Figure 8 denotes a small crack found in the section near the fatigue origin. This crack appeared to stem directly from the bottom of a "V" shaped discontinuity in the bottom of the stamp. The discontinuity was filled with an iron oxide scale.

Figure 8. High magnification photomicrograph of section A-A in origin area "A". Note crack shown by arrow "B" stemming from discontinuity in stamped radius. X500 nital etched.

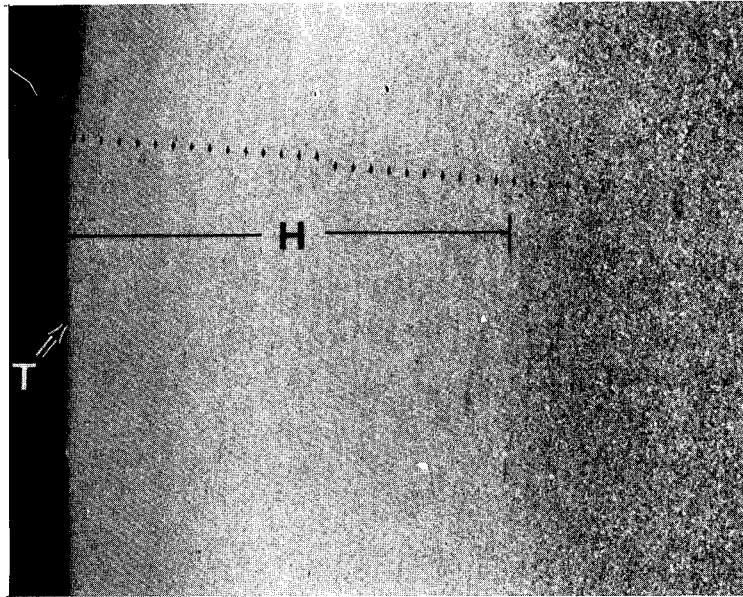
Figure 8 is a low magnification photomicrograph of a metallographic microsection through the tread in the area shown by section B-B in Figure 2A. The first 0.25 inch layer underlying the surface of the tread (area "H", Figure 8) contained a microstructure significantly changed by heat. Representative high magnification photomicrographs of these microstructural changes are shown in Figure 9.

Hardness measurements in this section showed that the overheated region was harder (392 KHN at 0.010 inch depth with decreasing hardness to 292 KHN at approximately 0.230 inch depth) than the underlying bulk material (292 KHN).

Figure 9. Metallographic microsection through the tread (section B-B, Figure 2A). Arrow "T" denotes tread surface shown in profile. Arrow "H" indicates underlying surface layer of tread significantly changed by overheating. Diamond shaped markings in section are Knoop hardness indentations. X10 nital etched.

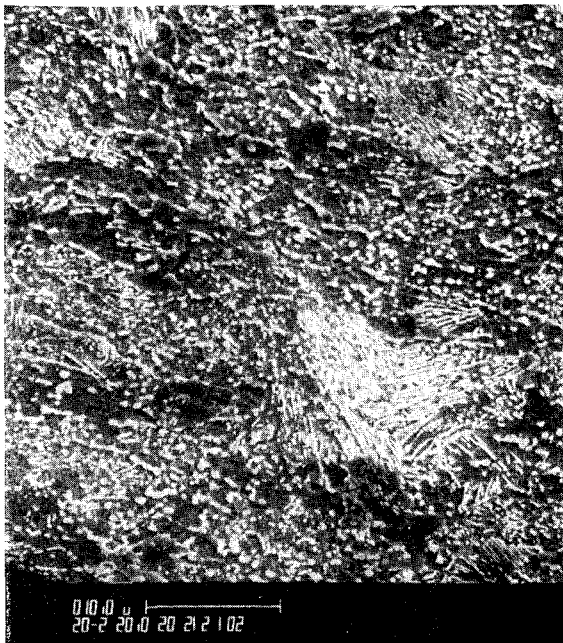
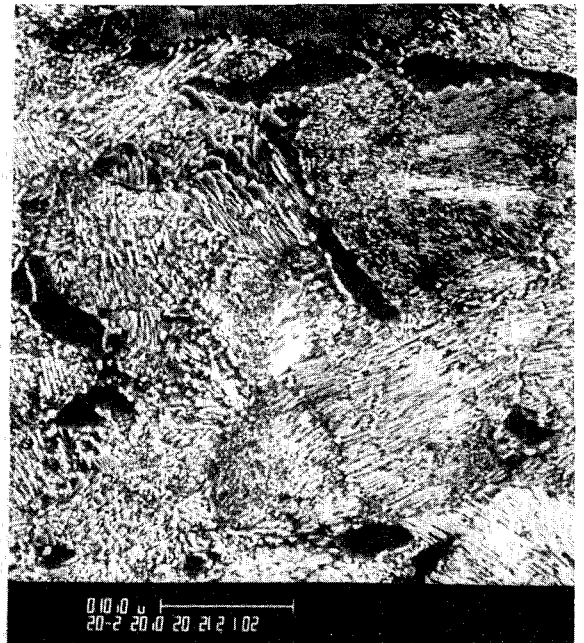
Figure 10. Comparative SEM micrographs of section B-B. Left photograph taken 0.01 inch from tread surface and is typical of area "H" Figure 9. Right photograph was taken approximately 0.5 inch from tread and is representative of microstructure to right of area "H" shown in Figure 9. X2000 nital etched.
