RAILROAD ACCIDENT REPORT

HEAD-ON COLLISION OF
BALTIMORE & OHIO FREIGHT TRAINS
EXTRA 6474 EAST AND EXTRA 4367 WEST
ORLEANS ROAD, WEST VIRGINIA
FEBRUARY 12, 1980

NTSB-RAR-80-9

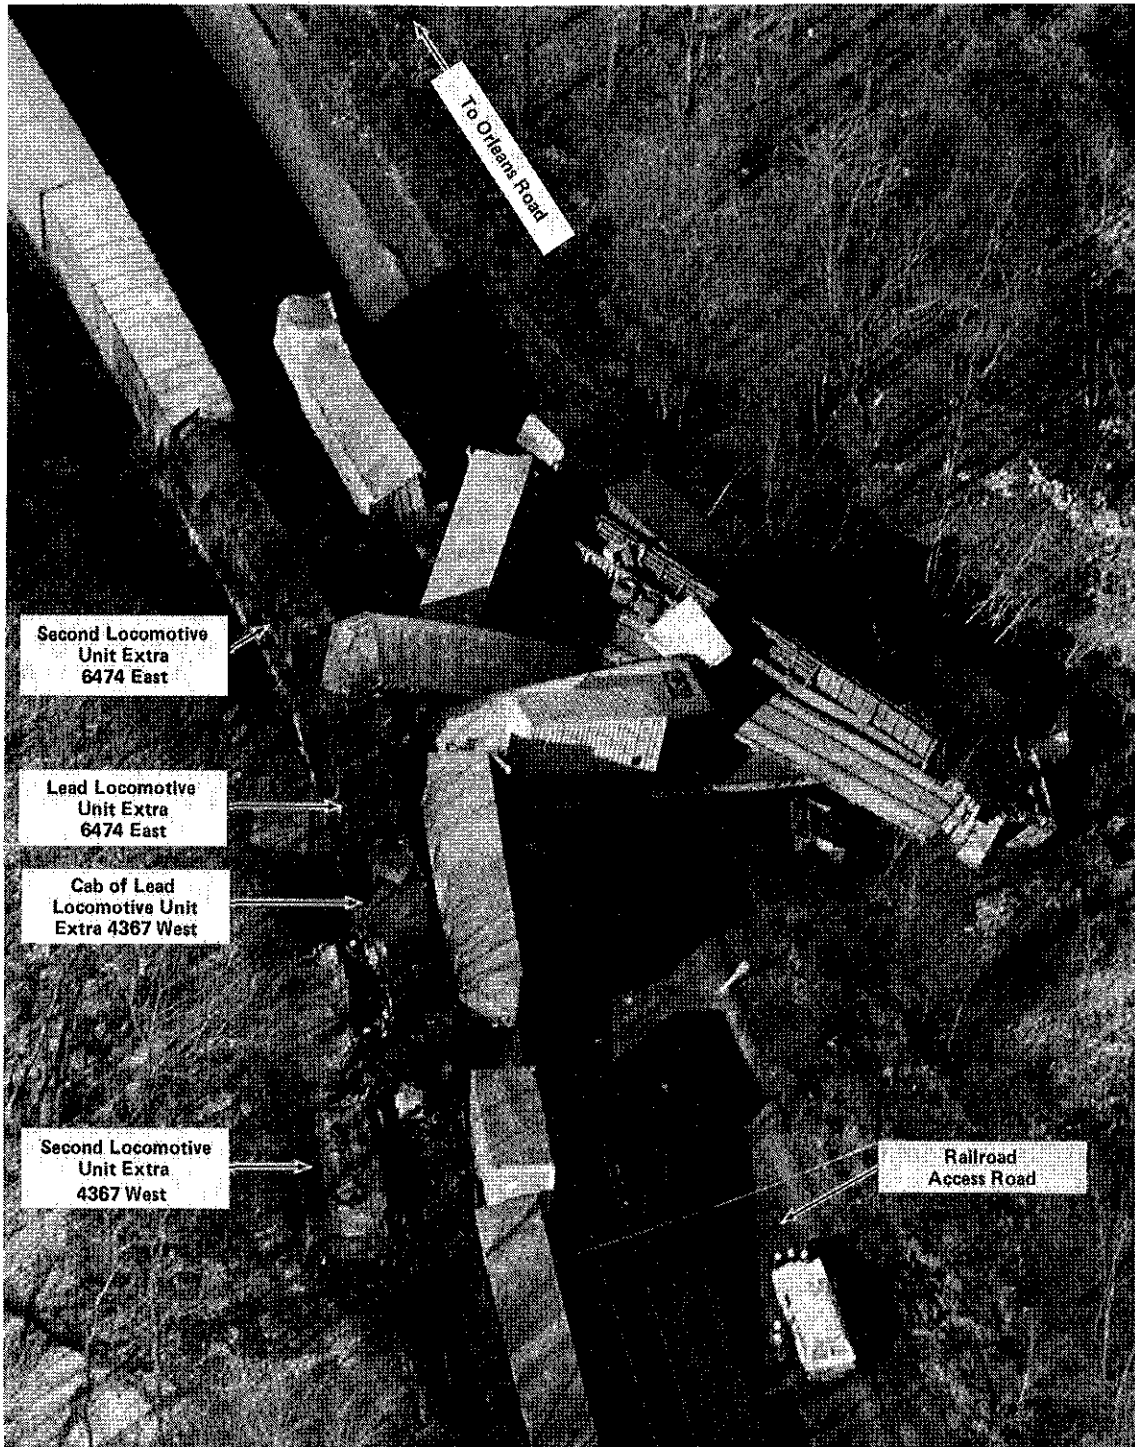
Figure 1.--Head-on collision of locomotives Extra 6474 East (top) and Extra 4367 West (bottom).

The two crewmembers in the lead locomotive of Extra 6474 East survived the collision without evacuating the cab; however, the engineer was injured severely. Neither leading locomotive unit overrode the other, and the cab of unit No. 6474 was not extensively damaged. The engineer was found lying on the walkway behind his seat location and his cab door was open. The head brakeman was thrown to the floor of the cab but was able to get out of the cab after the collision.

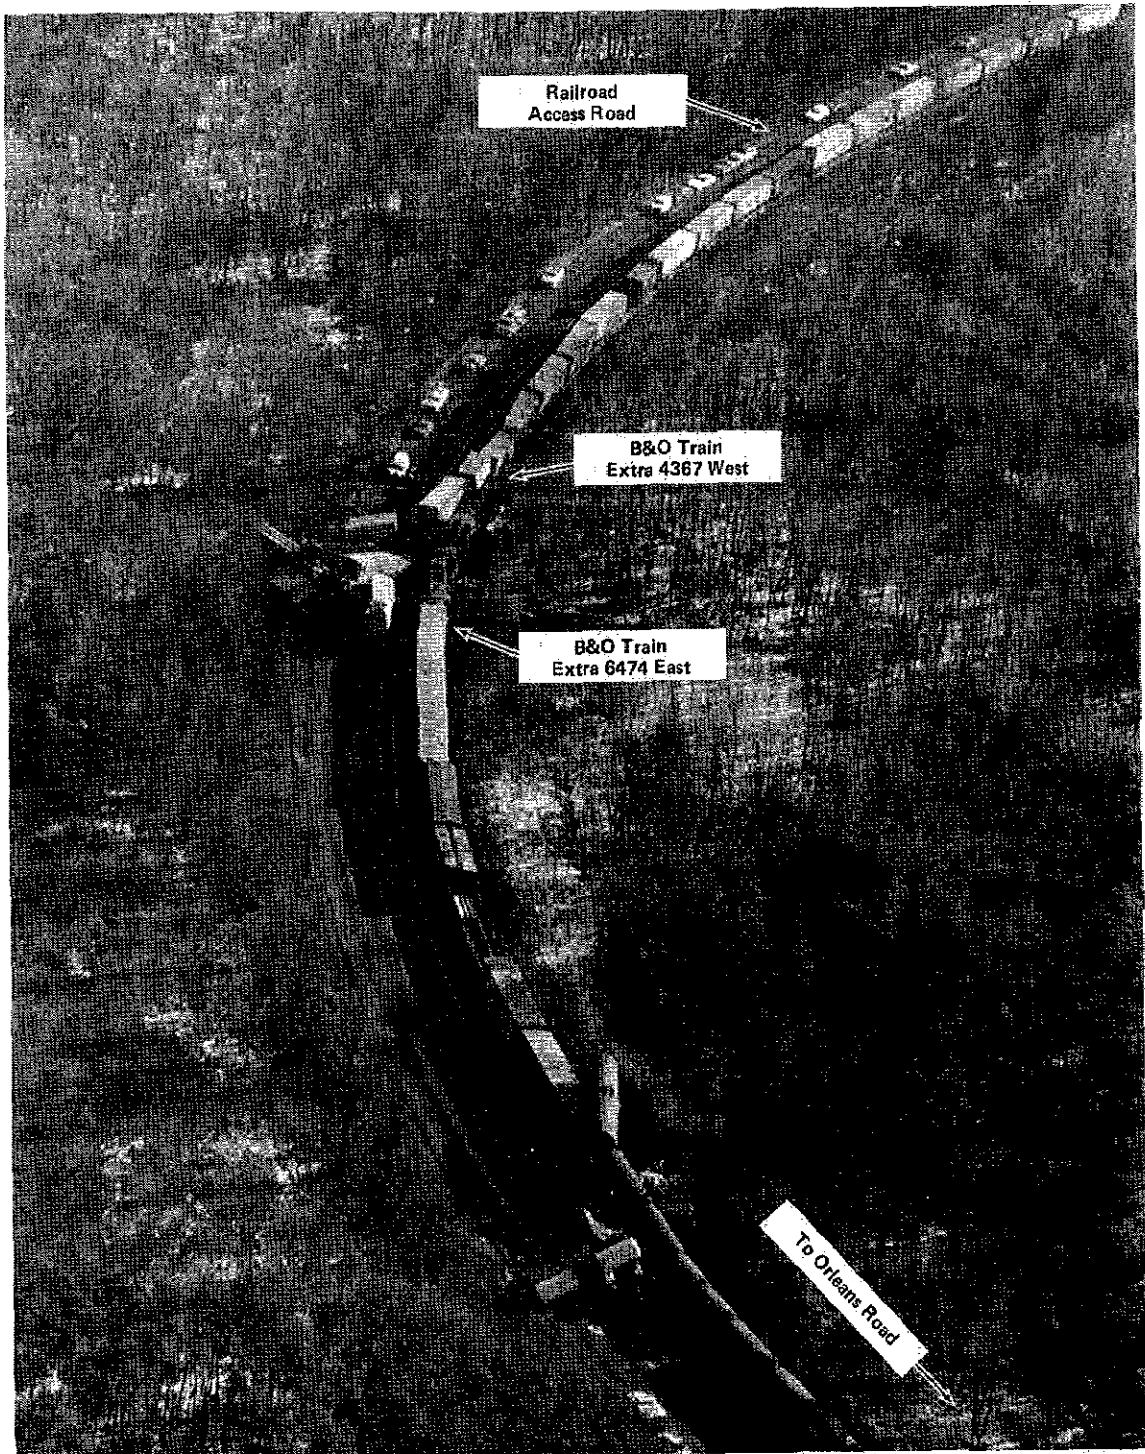
Both locomotive units of Extra 6474 East were derailed but remained upright and parallel to the track after impact. The first through the fifth cars were derailed and upright parallel to and within the track structure. Both ends of each of these cars were crushed by the impact of the collision. The sixth through the eighth cars did not derail, and only the west end of the ninth car was derailed. The 10th through the 14th cars derailed and stopped in various positions on the track.

The lead locomotive unit of Extra 4367 West remained upright, and the second unit was overturned on the south side of the No. 2 track by the collision. The first through the third cars derailed and were on the bank on the north side of the No. 1 track. The fourth car derailed perpendicular to and across the No. 1 track and access road. The fifth car was on top of a walkway on the north side of the lead locomotive unit No. 4367 and was blocking the No. 1 track. The fifth car demolished the engineer's side of the locomotive cab. The sixth car derailed within the No. 2 track, and the seventh car had only its west end derailed. (See figure 2.)

Figure 2.--Derailed cars of trains Extra 7467 West (top) and Extra 6474 East (bottom).

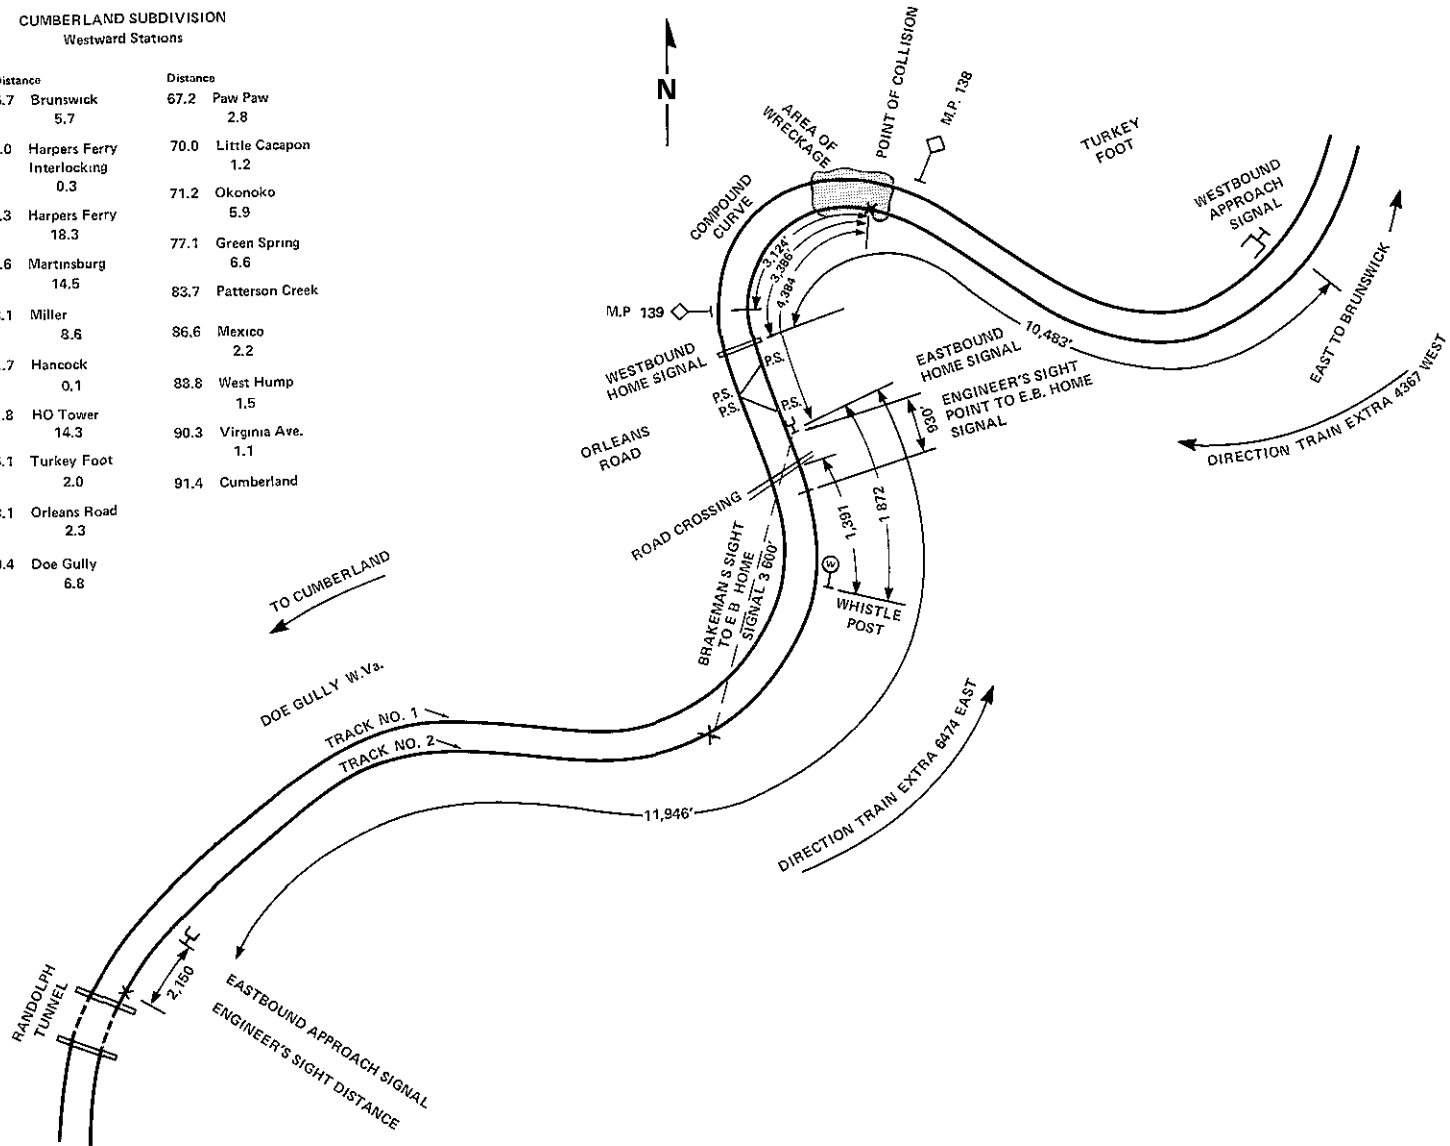
Figure 3.--Sketch of accident area.

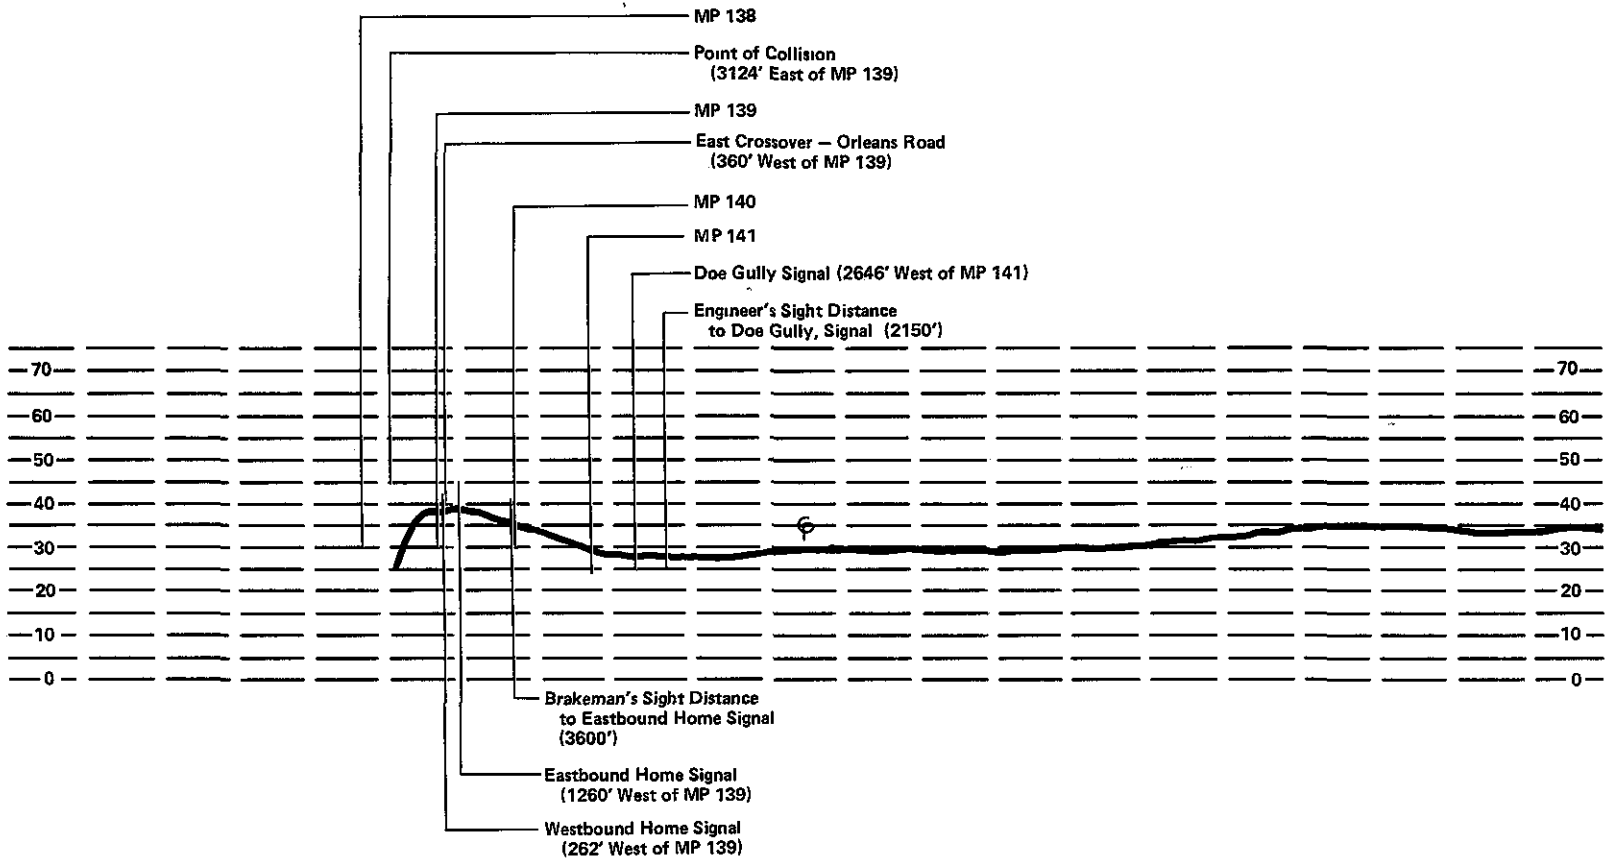
Examination of the speed recorder tape from train Extra 6474 East indicated that the engineer had properly controlled the speed of the train before approaching the approach signal for Orleans. The speed of the train in the 1-mile before the approach signal was 28 mph. The tape further indicated that, after passing the signal, the speed of the train gradually increased to 38 mph as the train passed the home signal at Orleans Road. After Orleans Road, the speed of the train immediately began to decrease to 25 mph at the point of collision.

SPEED TAPE REMOVED FROM THE LEAD UNIT OF EXTRA 6474 EAST AT ORLEANS ROAD

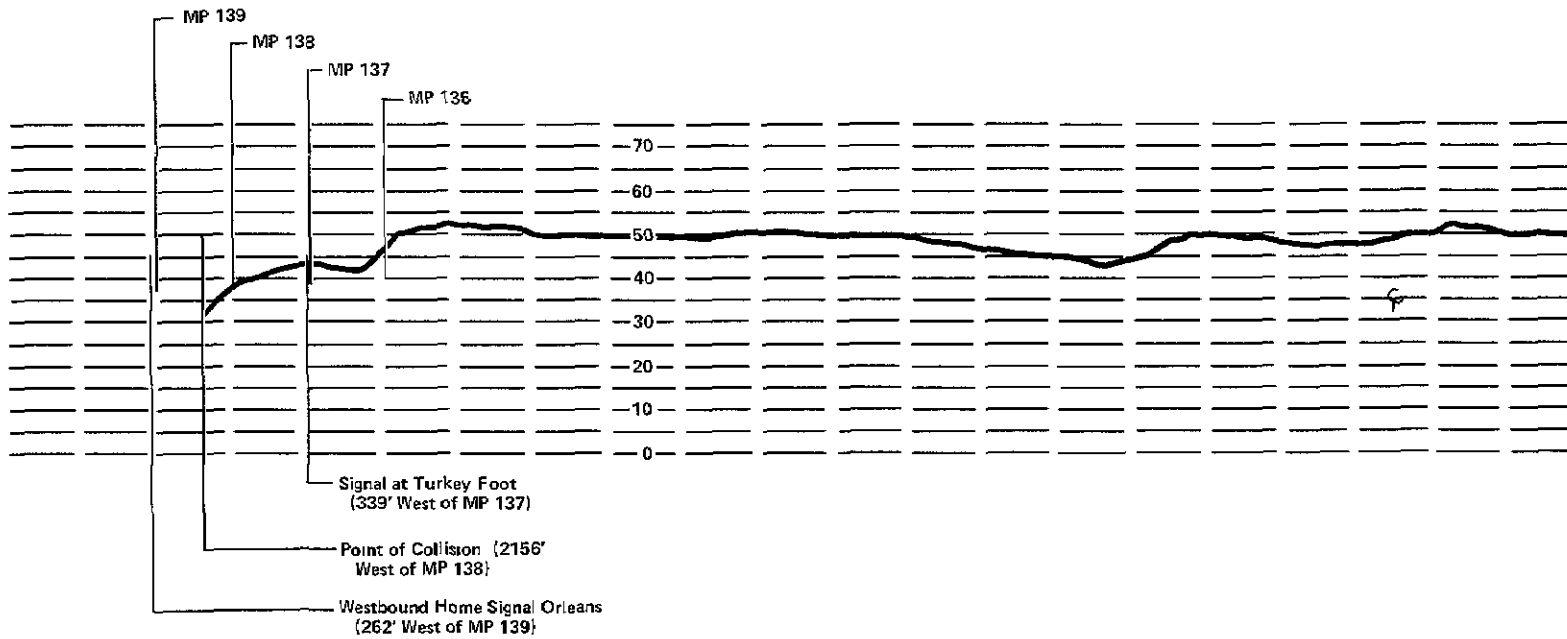
Examination of the speed recorder tape from train Extra 4367 West indicated that the speed of the train had been properly controlled from Brunswick to the point of collision. About 1 mile before the approach signal, the fireman started to reduce the train's speed from 50 mph, and it was 44 mph at the approach signal. The speed of the train then continued to be reduced and was 32 mph at the point of collision. (See appendix D.)

SPEED TAPE REMOVED FROM THE LEAD UNIT OF EXTRA 4367 WEST AT ORLEANS ROAD
