INVESTIGATION NO. 2524

THE BALTIMORE AND OHIO RAILROAD COMPANY

THE ILLINOIS CENTRAL RAILROAD COMPANY

REPORT IN RE ACCIDENT

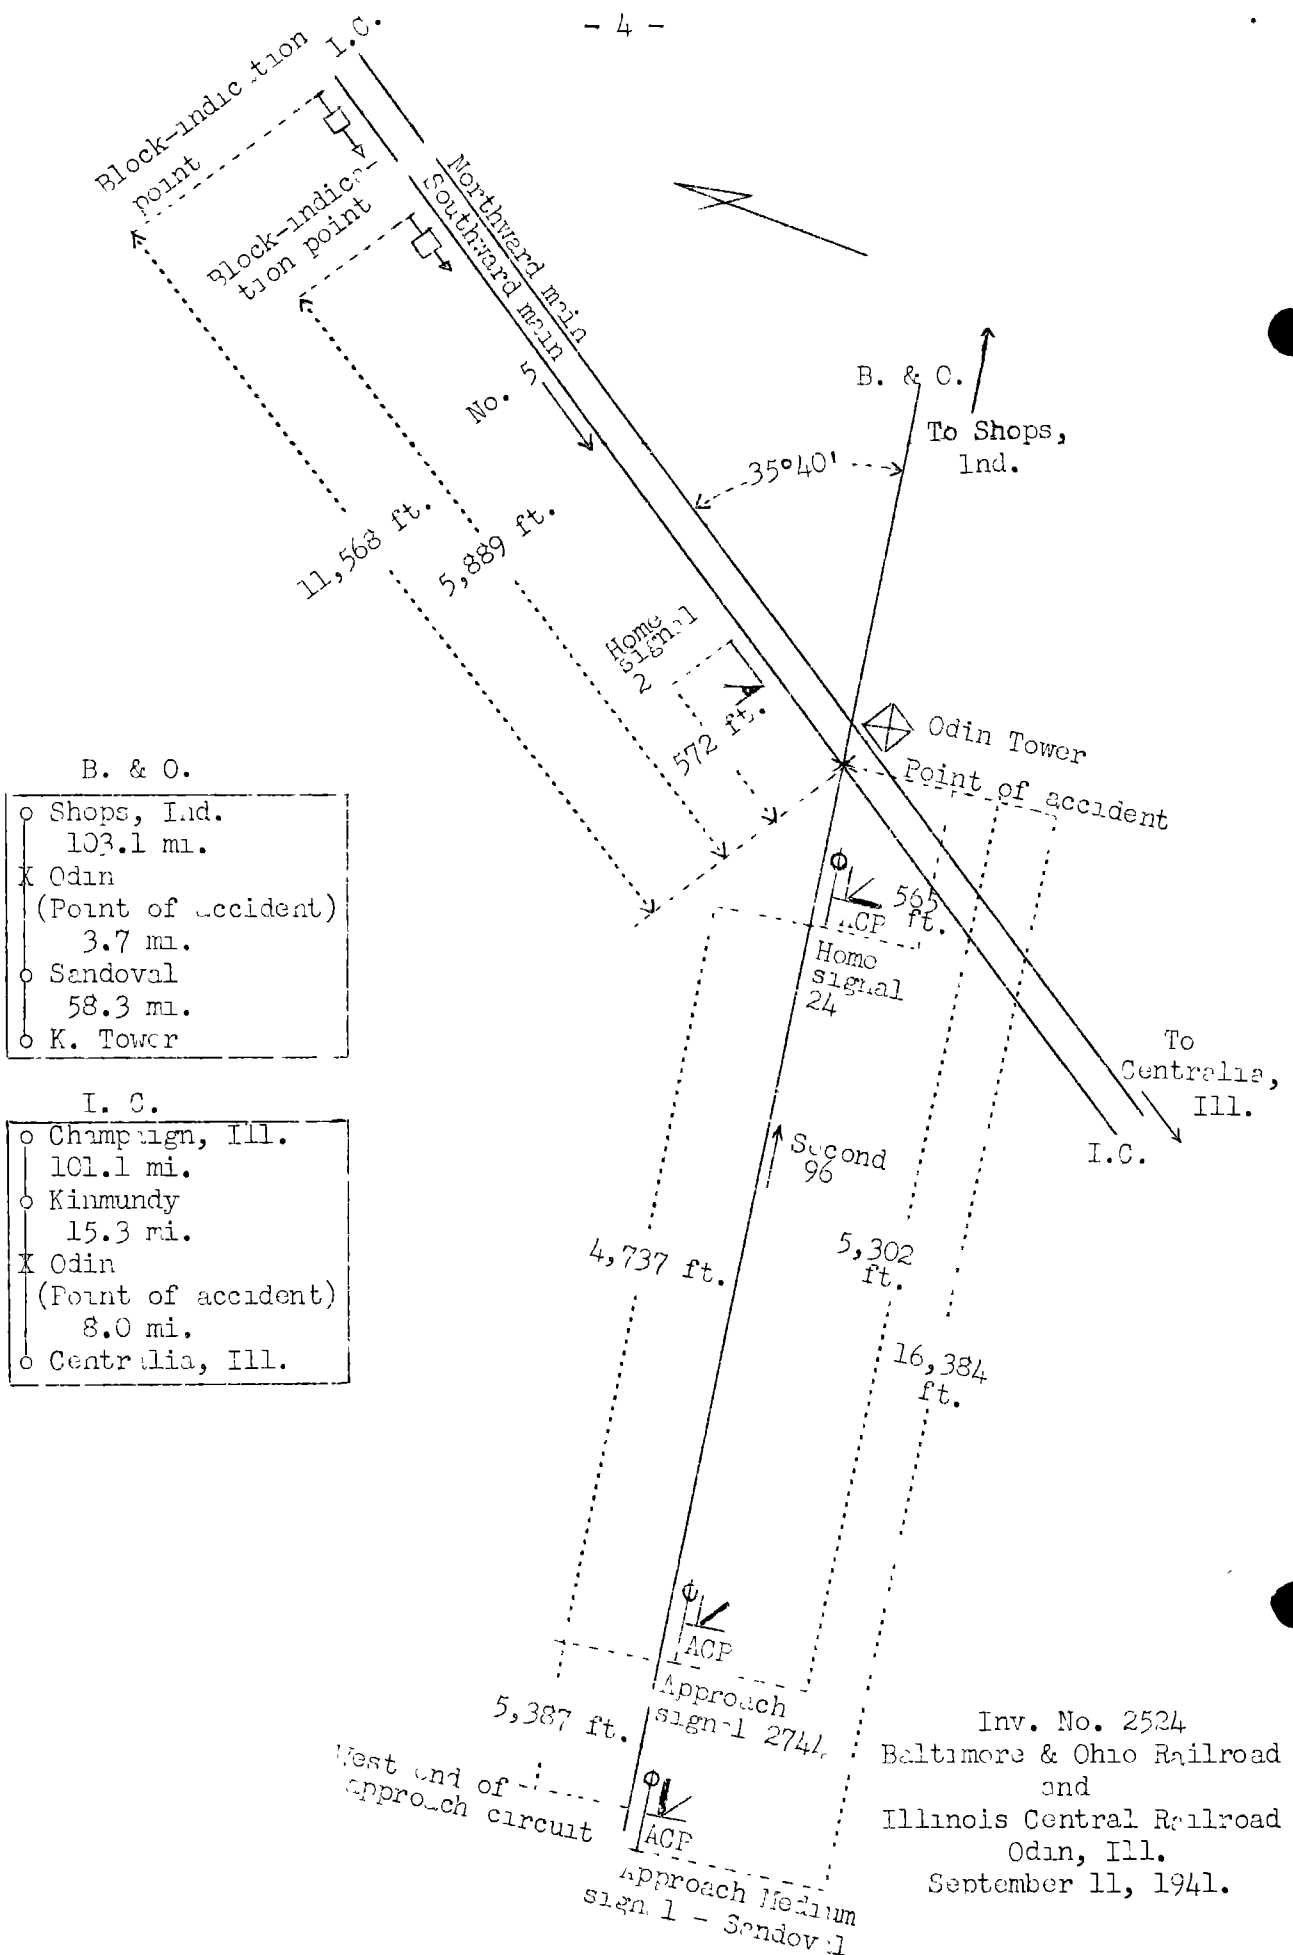
Inv. No. 2524
 Baltimore & Ohio Railroad
 and
 Illinois Central Railroad
 Odin, Ill.
 September 11, 1941.

- o Shops, Ind. 103.1 mi.
- x Odin (Point of accident) 3.7 mi.
- o Sandoval 58.3 mi.
- o K. Tower

- o Champaign, Ill. 101.1 mi.
- o Kinmundy 15.3 mi.
- x Odin (Point of accident) 8.0 mi.
- o Centralia, Ill.

West end of - - - -
 approach circuit
 Approach signal 2741
 Approach Medium
 signal - Sandoval
