RAILROAD ACCIDENT REPORT

**HEAD-ON COLLISION BETWEEN
BALTIMORE & OHIO RAILROAD COMPANY
TRAIN NO. 88 AND THE BRUNSWICK HELPER
NEAR GERMANTOWN, MARYLAND
FEBRUARY 9, 1981**

NTSB-RAR-81-6

Adopted: May 27, 1981

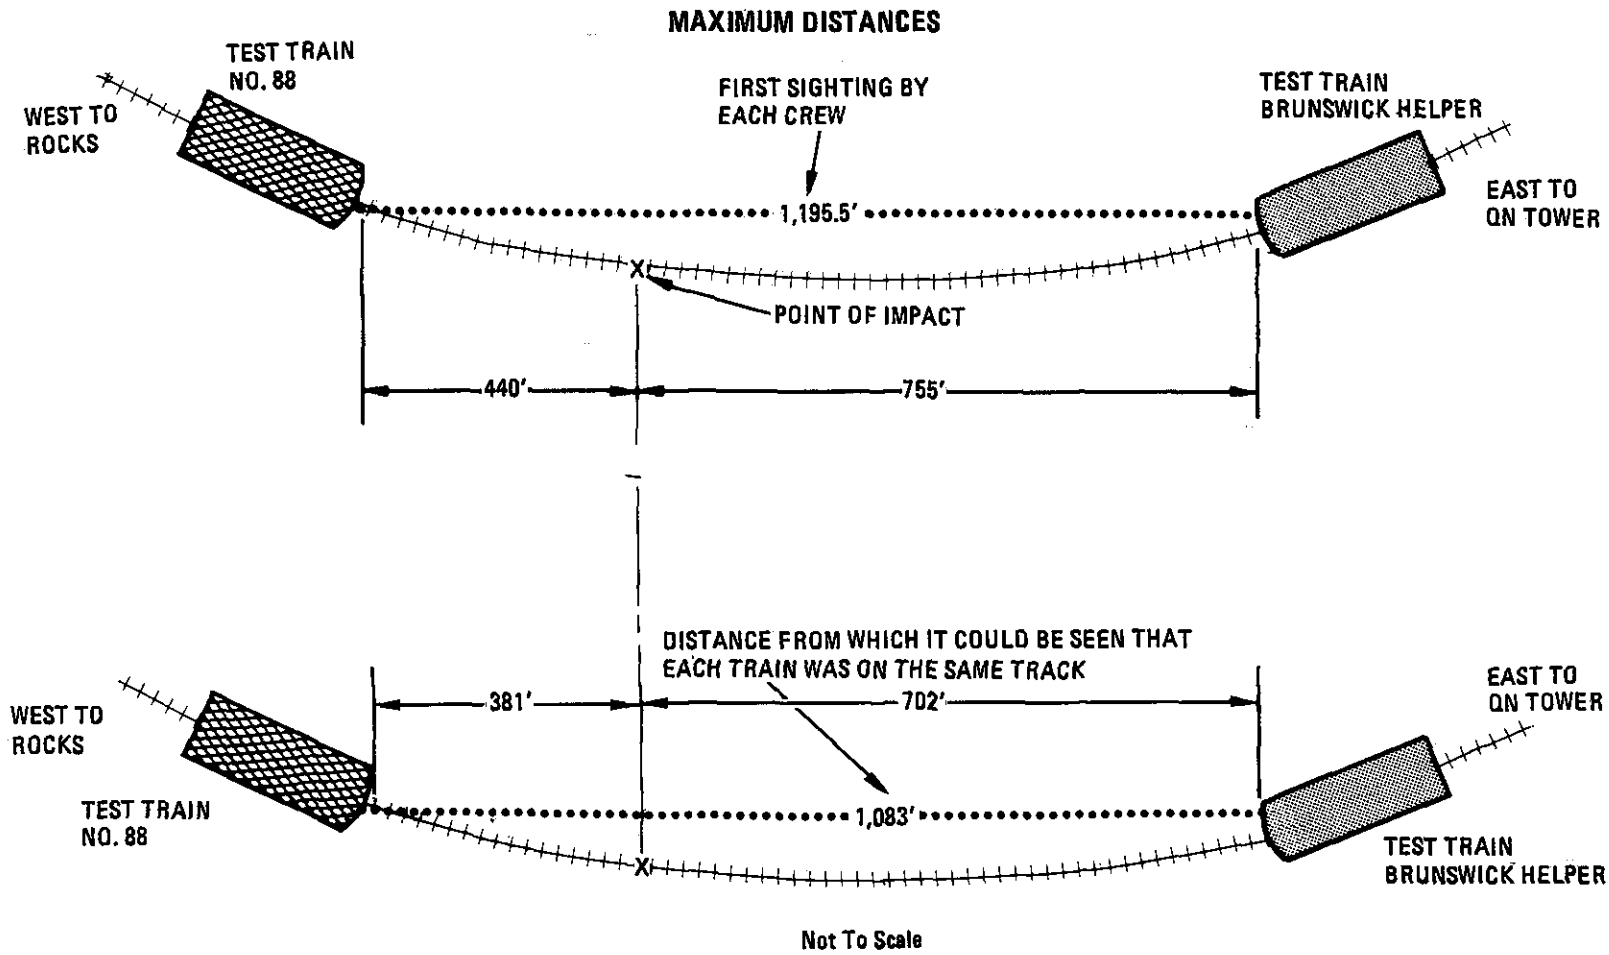
Figure 4.-- Sight distance as determined by test trains.

On February 19, tests were conducted to establish sight distances for the curve on which the trains collided. Locomotive units similar to the units involved in the collision were used and were oriented in the same position and direction as those of the accident trains. Tests simulated the view from each train to the other. (See figures 4 and 5.)
