RAILROAD ACCIDENT INVESTIGATION

Report No. 4116

THE BALTIMORE AND OHIO RAILROAD COMPANY

TOLL GATE, W. VA.

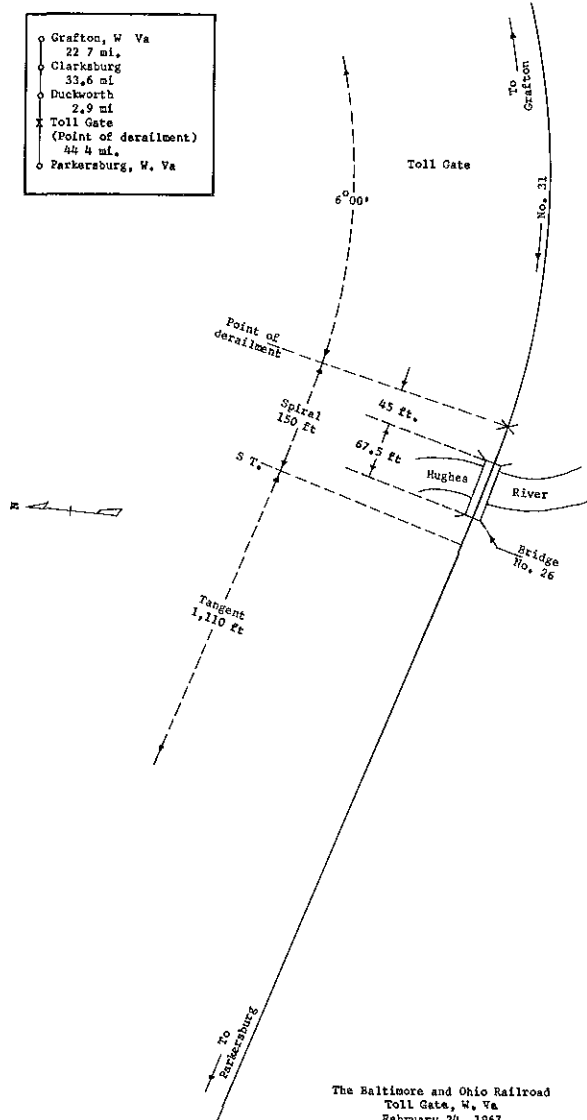
The Baltimore and Ohio Railroad
 Toll Gate, W. Va
 February 24, 1967

The train stopped with the front end 1,393 feet west of the derailment point. The rear truck of the 4th diesel-electric unit and all trucks of the five cars were derailed. Separations occurred between the 1st and 2nd cars and at both ends of the 4th car. The 4th diesel-electric unit and the 1st car stopped upright on and in line with the track structure. The 2nd, 3rd, 4th and 5th cars overturned and stopped on their south sides as shown by the sketch appended to this report.
