**RAILROAD ACCIDENT INVESTIGATION**

**Report No 4009**

THE BALTIMORE AND OHIO RAILROAD COMPANY

WEBSTER, IND

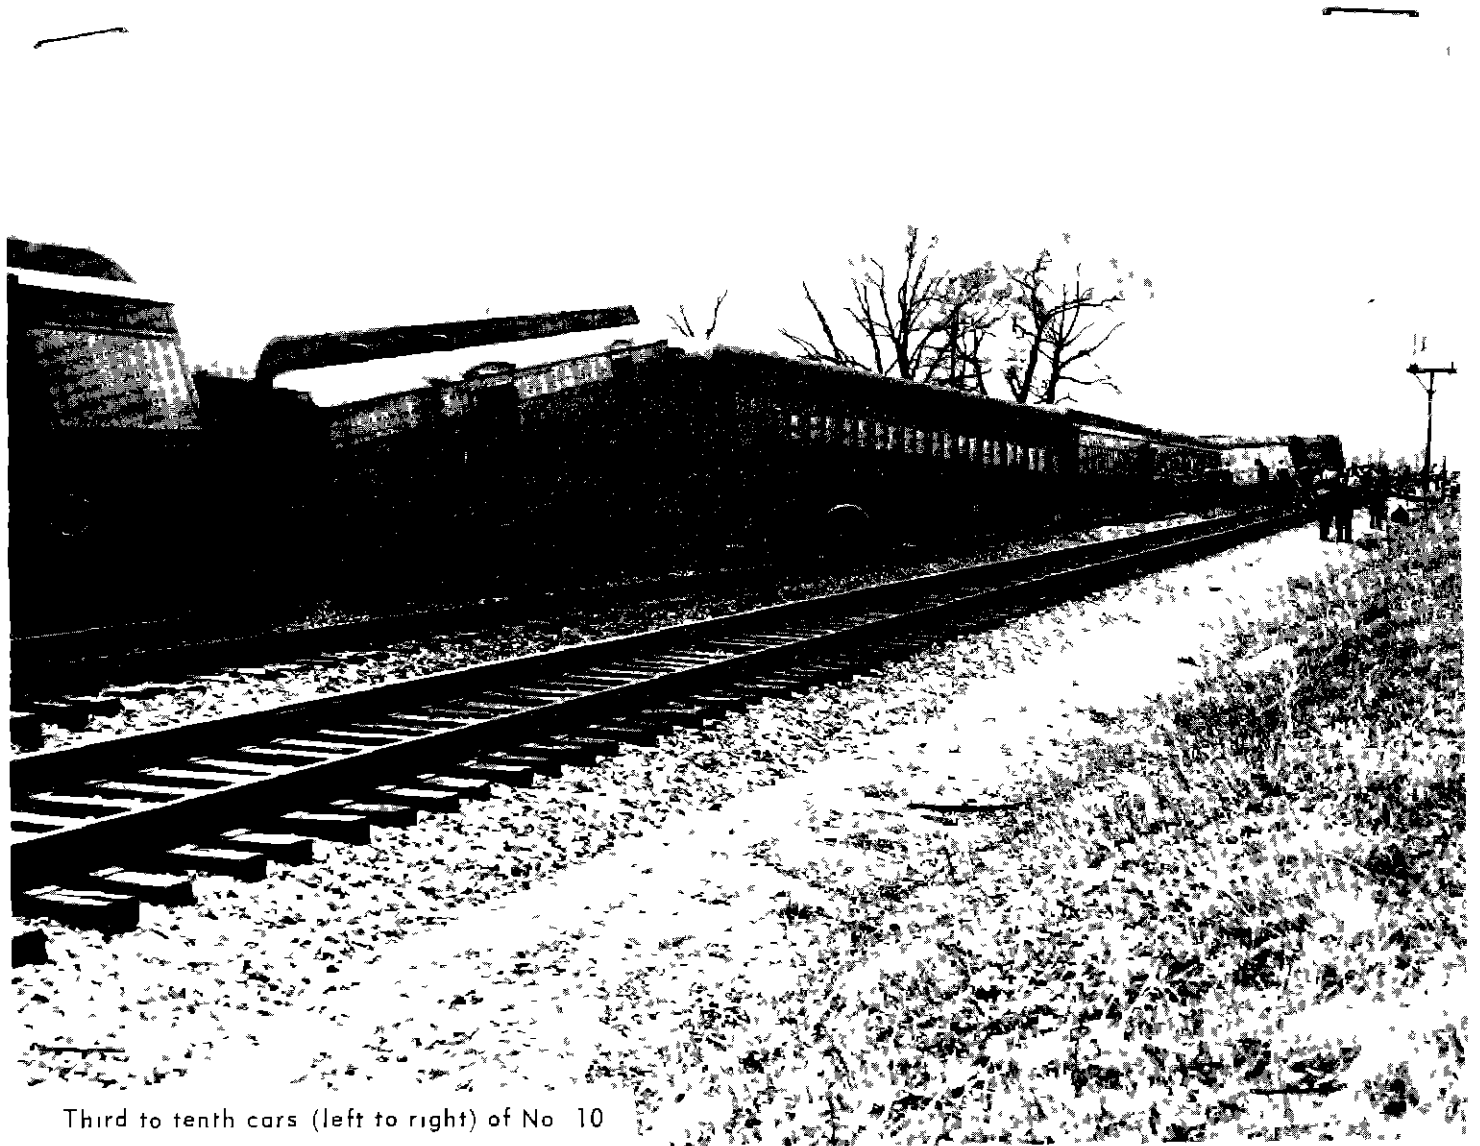
Third to tenth cars (left to right) of No 10

It is evident that due to eastward traffic, rising temperatures, and lack of rail anchors, the rails of track No 2 moved longitudinally eastward and were under excessive compression throughout a considerable distance west of the area where the ballast had been removed from the tie cribs at Webster. As the train closely approached Webster, the excessive compression resulted in the unsecured, skeletonized track buckling under the train.

It is recommended that the Baltimore and Ohio Railroad Company take necessary measures to provide additional protection by issuance of slow orders and placement of speed restriction signs when track conditions require their use for safe operation of trains.
